## Surviving an Extended Power Outage after a Breakdown in the Sub Station

### Abstract

TRIMET Aluminium SE operates the Essen aluminium smelter with three potlines in Germany. On 12 April 2016 a smoke alarm in the substation triggered an emergency shutdown of the whole plant. The smoke alarm was triggered by a short circuit on a 21 kV bus bar. While Potline II and III could be restarted within two hours, the damaged bus bar had to be removed, separating Potline I from the redundant high voltage power supply and fixing it on a single 220 kV transformer. When Potline I was able to be restarted, the 220 kV transformer was found to have an insulation fault. An emergency bus bar replacement was welded in place and Potline I could be re-energized after 5 hours 50 minutes and 30 seconds. Due to the immediate steps taken in the potrooms, any pot loss could be prevented and the potline was back to normal operation in 12 hours.

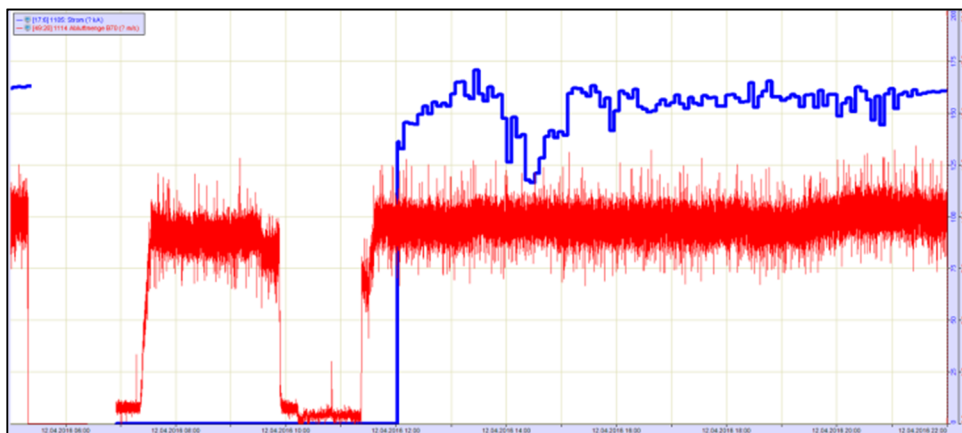
To speed up the process, at 9:50 am the decision was taken with the environmental authority's consent, to power down the GTC. At 9:53 am the GTC was shut down. With the under pressure gone from the ducts, the damper plates could be installed and the GTC could be restarted with 2/3 capacity to service the operational potlines within minutes. The development of the GTC volume is shown in **Error! Reference source not found.**

Figure 2. Line amperage (blue) and GTC capacity (red) during the power outage.

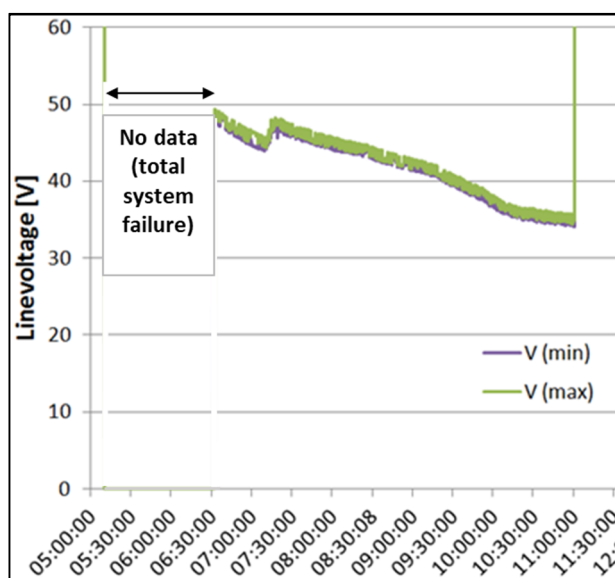
Disconnecting potline I from the GTC significantly slowed the decay of residual voltage on the potline as shown in Figure 3. The voltage dropped by 6 V/h before. This trend was reduced to 2 V/h after placing the dampers. The inflection point is clearly visible in the graph. Internal measurements have shown that during normal operation TRIMET Essen loses about 30 % of the heat to the dry scrubber. By dropping the rate of decay by 60 % when disabling the draft at the

top side of the cells, the mechanics for heat loss during power outage appears to be significantly different.

Figure 3. Residual voltage of Potline I.

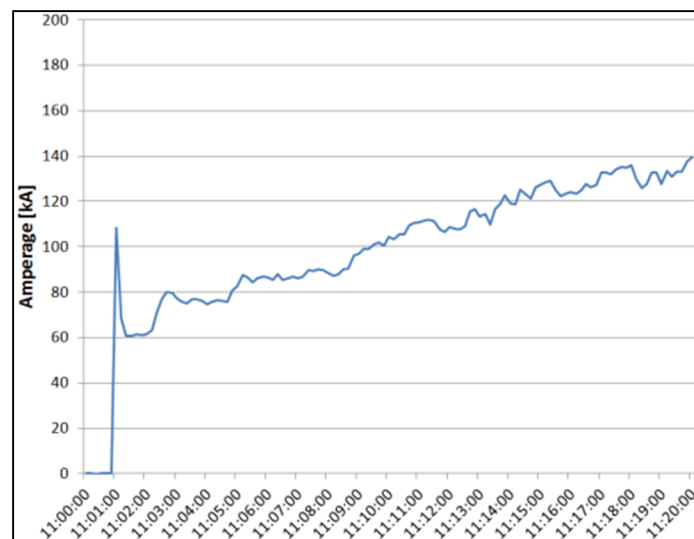
Within 20 minutes after restart, 140 kA was reached (Figure 4 **Error! Reference source not found.**). The rectifier was able to hold the line amperage stable. Line voltage had dropped continuously peaking at 635 V, but during the time it was still around 600 V at 140 kA.

**Figure 4. Line current development immediately after re-energizing.**

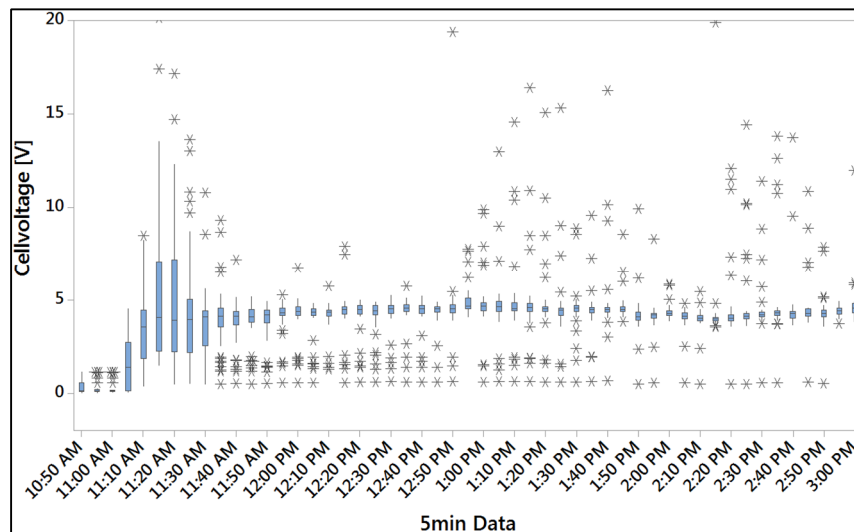
Having stabilized the potline, the attention turned to individual pots. At reaching 140 kA pot voltages varied between 1 V and 20 V (see Figure 5). Even though 32 out of 120 cells reported cell voltages below 2 V, these cells appeared stable. Anodic current distribution showed wide swings, but visual inspection on some cells showed no red stubs or other indications of too high current load. Obviously, a number of anodes had been pushed into the metal to carry the current safely. The cell would not recover by themselves, but ohmic heating was deemed sufficient to avoid further freezing of the cell.

**Figure 5. Boxplots of cell voltages in Potline I. Note that there are many outliers (marked with \* in the graph). These are the cells that need most attention.**

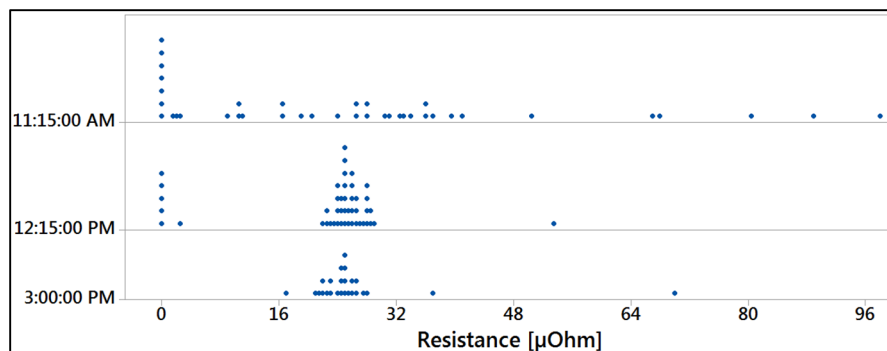
Figure 6 shows cell resistance distributions in time. At 3 PM there was no cell left with a resistance below 17  $\mu\Omega$  (voltage below 4.45 V). The mean cell resistance was 19.25  $\mu\Omega$ ; at a line amperage of 161 kA this refers to a mean cell voltage of 4.80 V. Certainly this is high above the normal setpoint of the potline. However, now that there was enough bath in the cells, the decision was to bring almost as much additional energy into the cell in the next 24 h as there was lost in the 6 h of power outage.

**Figure 6. Cell resistance distribution (1 dot represents up to 4 cells).**

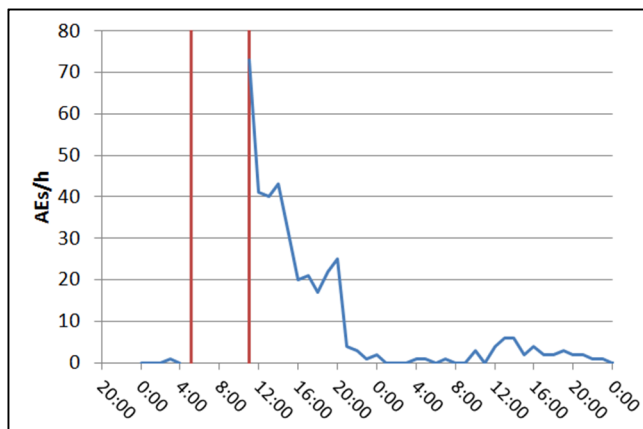
Due to undercooling and lack of superheat, many cells had alumina dissolution problems. Figure 7 shows the development of anode effects following the restart of the line. Immediately after re-energizing, nearly every pot that was not short circuiting reported an anode effect. This number stayed high until 21:00 h, 10 hours later, when the rate rapidly dropped back to more normal levels.

Figure 7. Development of anode effect rate after restart.

Considering the generous amount of alumina added to the cells normally during automatic anode effect quenching, the amount was lowered considerably for all cells in the potline. The consequently lower success rate of the quenching routine was accepted in these circumstances.

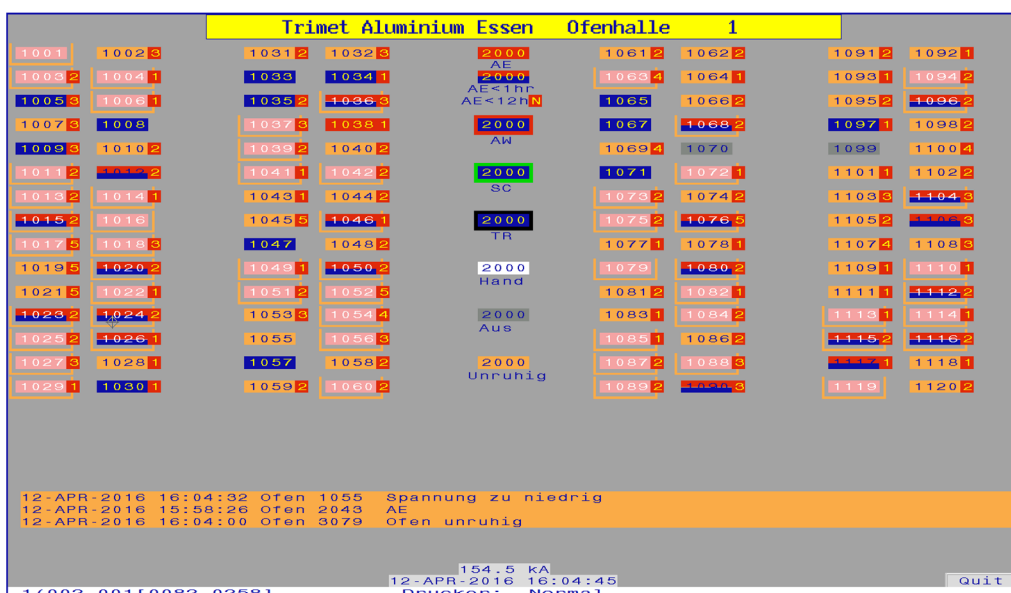
**Error! Reference source not found.** Figure 8 shows the current situation in the pot line at about 16:00 h. Even though the potline was slowly stabilizing, the number of pots registering noise was still high (orange); the number of anode effects is given in red next to the pots. A separate

Figure 8. Screenshot of the process menu at about 16:00 h.

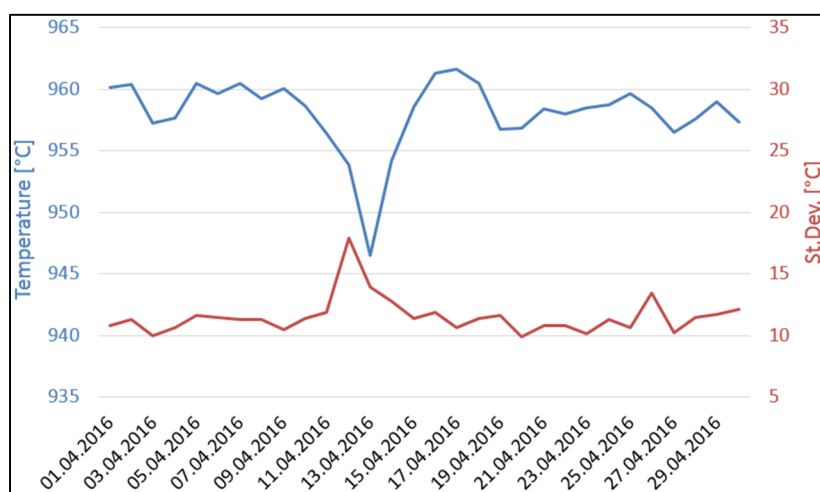
The temperature measurements after the outage recorded a significant drop to 946 °C as average electrolyte temperature in Potline I the following day (Figure 9). Manual additions of soda and raised cell voltages recovered temperatures and chemistry within 4 days (Figure 10). Unfortunately, the chemical additions lead to a swinging of the temperature and liquidus temperature of 1 cycle that lasted for about 2 weeks. Nevertheless, the decision was made to act in the same way if a similar power outage would happen again. Simply the counteraction of  $\text{AlF}_3$  a week later was analysed to not overshoot in the opposite direction again. The standard deviation in Figure 9 shows that individual pot caring was made appropriate so that there did not develop 2 areas of cold and hot cells.

**Figure 9. Mean temperature and standard deviation of Potline I.**

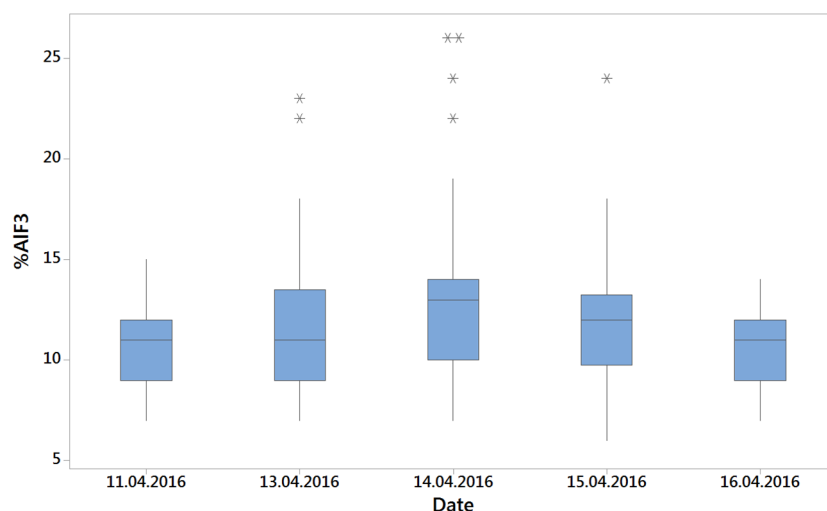
**Figure 10. Boxplots of the  $\text{AlF}_3$  deviation in Potline I. Note that there are a few outliers (marked with \* in the graph) with very high values. These are the cells that need most attention.**
