Surviving an Extended Power Outage after a Breakdown in the Sub Station

Roman Düssel¹ and Till Reek²

1. Reduction Manager, TRIMET Aluminium SE, Aluminiumallee 1 Essen, Germany

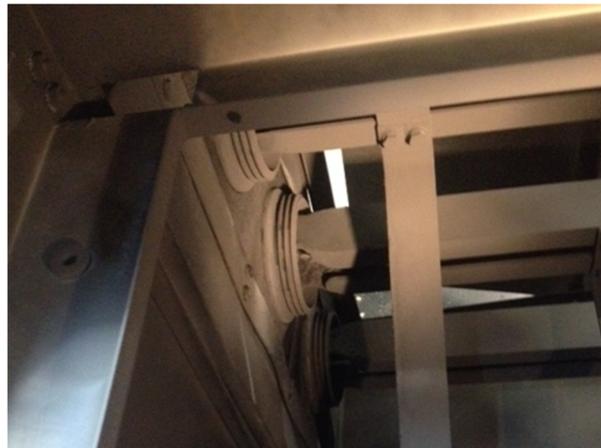
On 12 April 2016 at 05:10:35 h the full plant dropped off-line while a smoke alarm in the building of the medium-high voltage was detected. The fire brigade was called to investigate the cause and did not find a fire source. After ventilation, maintenance was cleared to enter the building (still devoid of power) and found partly scorched and melted bus bars in the 21 kV switch room.

The damaged section was a redundancy cross link enabling potline I to receive electricity from another than a single 220 kV transformer. Thus, the bus bar was perceived as uncritical for the immediate restart. The damaged section is shown in Figure 1.

Figure 1. Scorched 21 kV busbar.

- In one 21 kV panel for the auxiliary power a cable end sealing of one phase failed in isolation towards earth.
- This led to an arcing short circuit with a neighboring phase.
- About 10 ms later a full 3-phase short circuit developed with a short-circuit current of up to 25 kA.
- About 100 ms later the vacuum power switch disconnected the affected transformer as expected.

The damaged section was removed and the plant including the compressed air station, cast house and GTC were smoothly restarted. Potline III and potline II could be restarted at 7:23 am and 7:25 am respectively with slightly more than 2 hours power outage.

With the usual redundancy removed and isolated on a damaged transformer, a contingency plan was needed. The potroom relining department, who also repairs and modifies potroom bus bars when damaged, were called in to prepare an emergency weld to bridge the gap the removed bus bars had created. While this was in preparation the plant was scoured for material that could be used as 21 kV bus bar – both in material quality as well as in diameter and length. Replacement bus bars were welded in place on all three phases and the potline could be reenergized at 11:01am, close to 6 hours after the initial power outage.
