## Pitting on Carbon Cathodes in Aluminium Electrolysis Cells

Samuel Senanu<sup>1</sup>, Tor Grande<sup>2</sup> and Arne Petter Ratvik<sup>3</sup>

Department of Material Science and Engineering, NTNU Norwegian University of Science and Technology, NO-7491 Trondheim, Norway

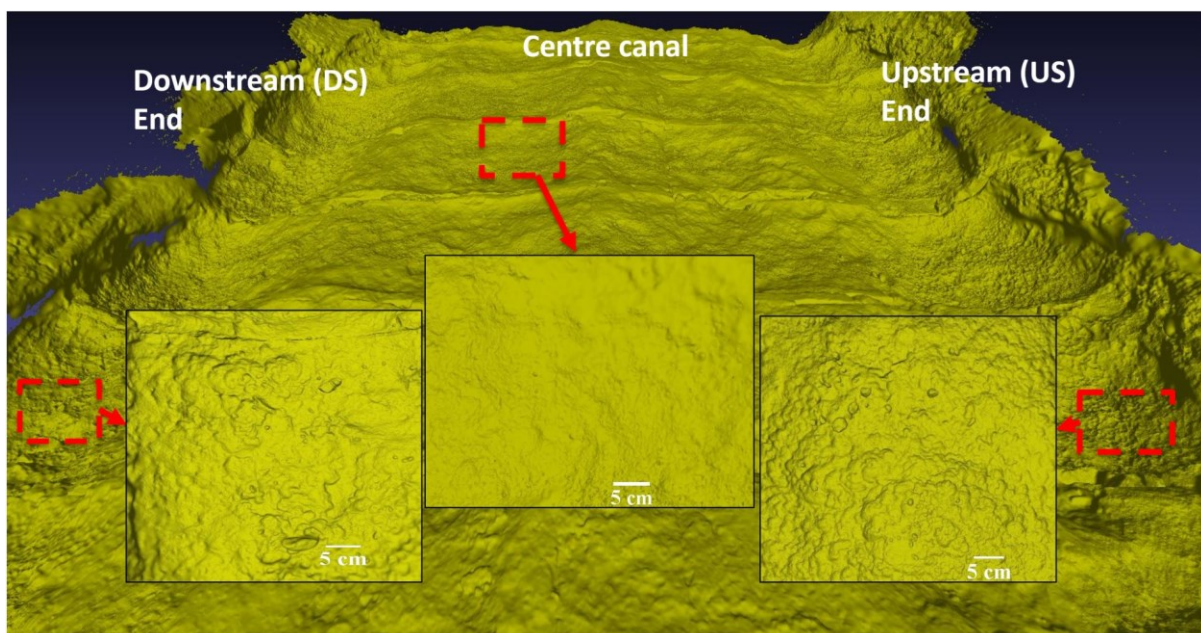
Visual observation of all the five spent potlinings showed trends similar to observations reported from previous autopsies [2, 3, 7, 8]. The maximum wear was located at the ends of the cathode blocks and characterized by pitting (pitted wear). Pitting was observed for all the carbon cathode types (graphitic and graphitized) investigated. Figure 2 is a 3D image of a section of the spent potlining obtained from analysing the scanning data from pot 5. From the 3D image, the count density and size distribution of pitting within a chosen area of the cathode block was obtained from which a histogram was plotted. The histogram for pitting on the upstream and downstream ends of two of the cathode blocks is shown in Figure 3. The histogram shows that the downstream ends of the two cathode blocks have a relatively lower count density of pitting than the upstream ends.

**Figure 2. 3D image of a spent potlining showing the occurrence of pitting at the centre canal as well as the upstream and downstream ends of a graphitized cathode block (pot 5).**

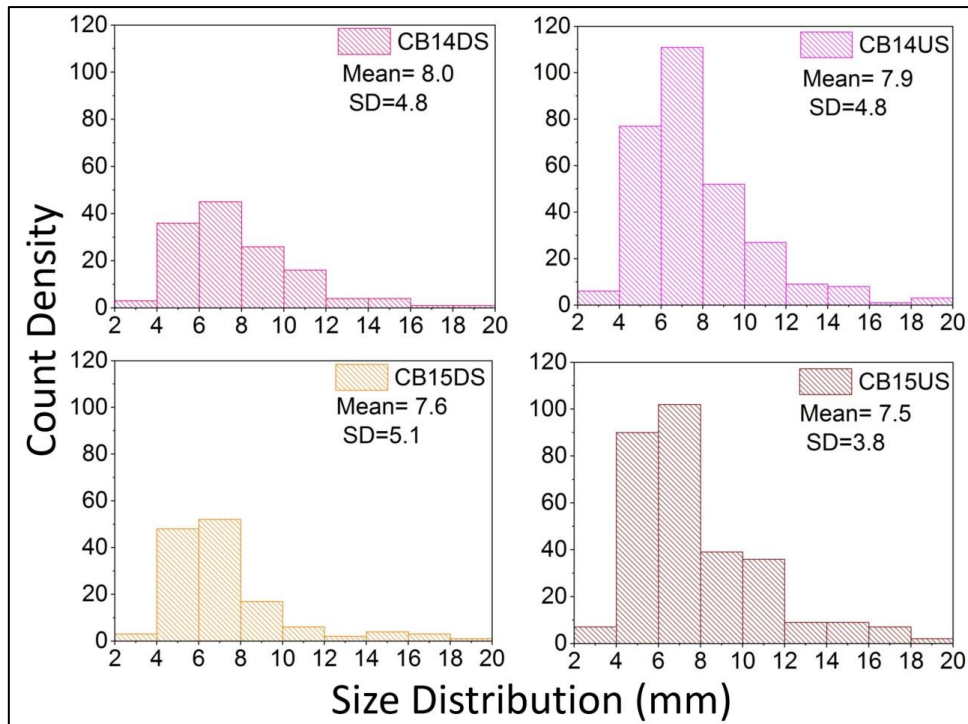
**Figure 3. Histogram showing the count density and size distribution of pitting on the upstream and downstream ends of 2 carbon cathode blocks (cathode blocks 14 and 15) from pot 5.**

In order to verify the particle detachment mechanism, the average grain sizes of the carbon aggregates and the average sizes of the pittings were determined. Figure 3 shows the size distribution of the pittings observed from the autopsy of pot 5. The average grain sizes of the carbon aggregates were also determined by analysing the CT images of the autopsy samples as shown in Figure 7 using the linear intercept methods. Comparing the average sizes of pittings to the average grain sizes of the carbon aggregates did not yield any correlation. This observation does not support grain detachments as the main mechanism for the observed pitting.

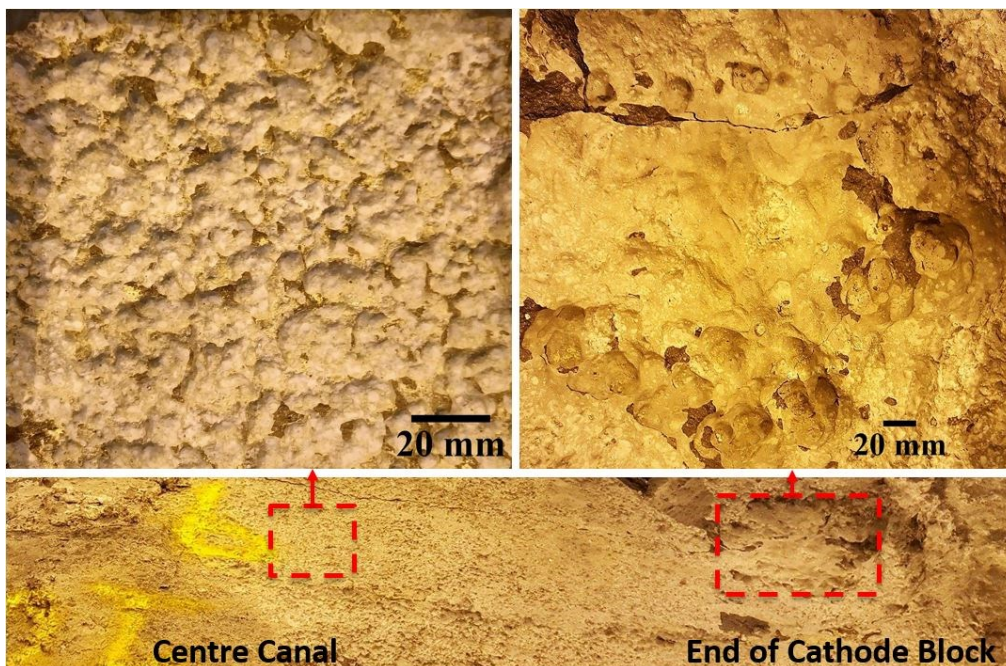
Generally, it was observed that for the graphitic cathode blocks, pitting was present all over the cathode surface. There were, however, differences in the size of the pitting on these graphitic cathode blocks. The pitting closest to the ends of the cathode blocks where the wear was highest, had a relatively larger diameter than the ones closest to the centre canal, Figure 4 illustrates this. For the graphitized cathode blocks, pitting was present mostly at the ends of the cathode blocks where the wear was most pronounced, no distinct pitting was observed at the central canal. This observation is well illustrated by Figure 2.

**Figure 4. Photograph of a spent potlining with graphitic cathode block (pot 6057) showing pitting all over the surface. Highlighted images show the differences in pitting sizes between the centre and side of the cathode block.**

The varying sizes of the pitting on the graphitic cathode blocks with respect to the centre canal and the ends of the cathode blocks as shown by Figure 4 may be explained by the combination of high current densities and faster transport rates. The high current densities at the ends of the cathode block will lead to an increase in the electrochemical formation of aluminium carbide. The high current densities will also induce high electromagnetic movements in the metal and bath leading to an increase in the dissolution and transport of aluminium carbide at the cathode block ends as compared to the centre canals [6, 10]. For the graphitized cathode blocks, the high degree of pitting at the ends as compared to the centre with almost no pittings may also be because of the high current density and the induced high movements in metal and bath and thus higher dissolution and transport of aluminium carbide.

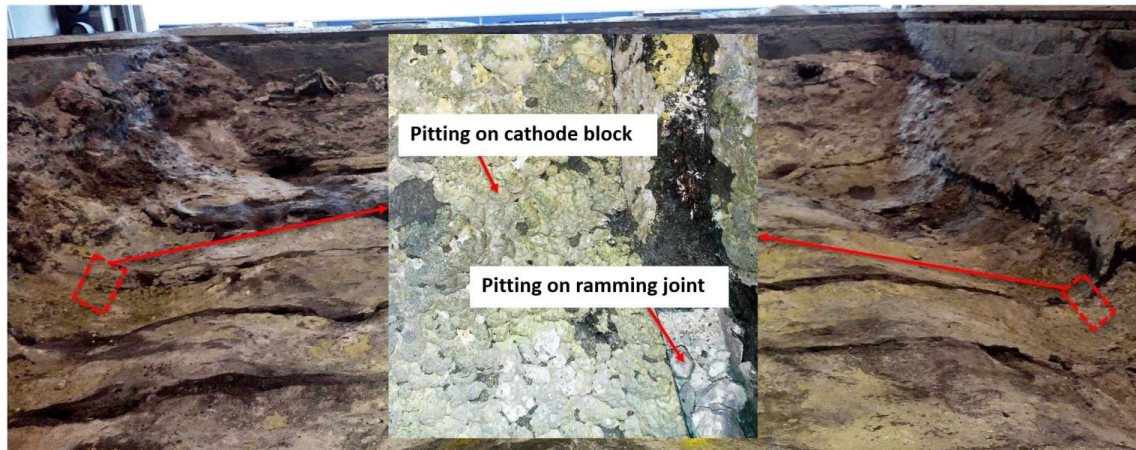
Pitting was also observed on the ramming joints between the cathode blocks at the locations with highest degree of pitting as shown in Figure 5. One of the spent potlinings (pot 5) that was investigated had a tapout through a pothole on one of the carbon blocks. A closer investigation of the location surrounding the pothole revealed a very high degree of pitting. Figure 6 is a picture showing the tapout hole in the cathode block.

**Figure 5. Photograph of a section of a spent potlining with a graphitized cathode block (pot 1) showing pitting mostly at ends of cathode block. The insert image shows the pitting mainly observed at the ends of the cathode blocks and ramming joints.**

All the autopsies conducted demonstrate the presence of pitting on the carbon cathode surface irrespective of the type of carbon material or grade of the carbon cathode block. Figure 5 is a picture showing pitting on both the cathode block and ramming joints. This suggests that pitting is essential for the carbon cathode wear mechanism. There is, however, a difference in the amount of pitting observed on the graphitized and graphitic cathode blocks. While the graphitized cathode blocks showed distinct pitting mainly at the ends of the cathode blocks, the graphitic cathode blocks show pitting almost all over the carbon cathode surface. The images in Figures 2 and 4 show these differences. The appearance of pitting all over the graphitic cathode blocks is assumed to be due to their relatively high porous nature as compared to the graphitized cathodes, resulting in a relatively higher electrical resistivity that contributes to a more even current distribution over the cathode.

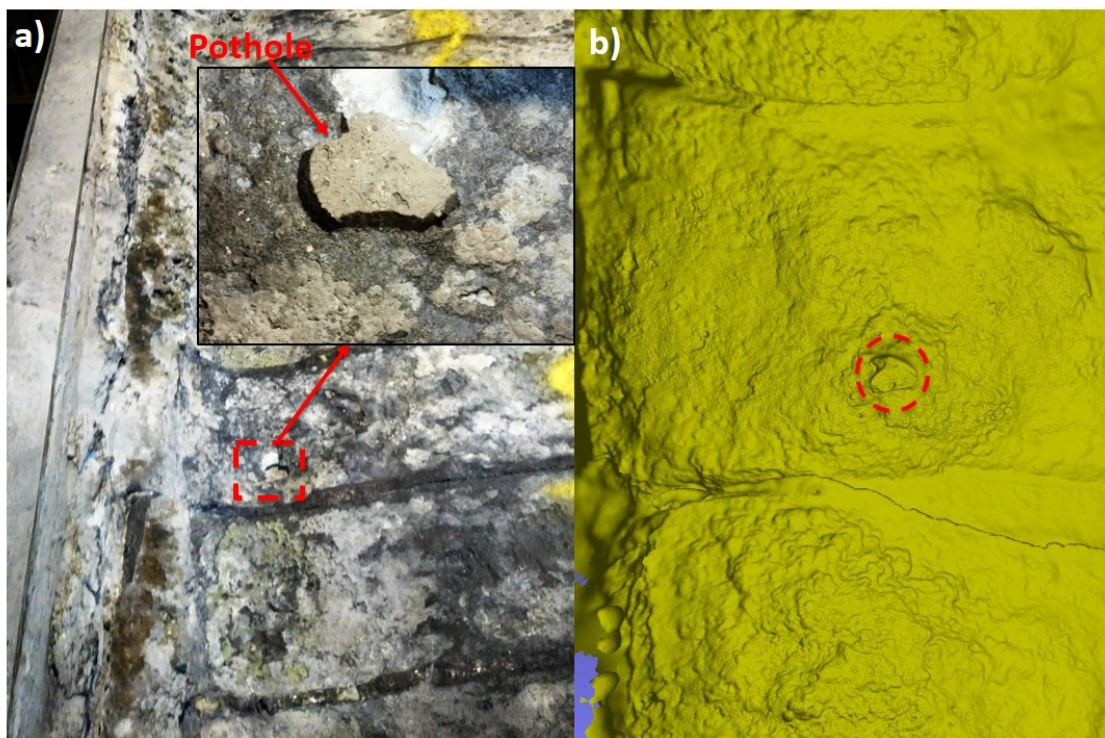
**Figure 6. Pothole formation on carbon cathode blocks from pot 5. a) Section showing location of tapout on carbon cathode. b) A 3D image of the tapout location in the pothole on the carbon cathode.**

Figure 6 shows a pothole that resulted in a tapout of a cell after just 1731 days. The pothole occurred at the upstream end of the cathode block of a spent potlining (pot 5) investigated during the autopsy. Examination, as well as wear measurements by other autopsies, show that the wear is highest at these locations (cathode block ends) [2, 3, 6, 7]. It has also been reported that the wear in these locations is pitted [2, 3], suggesting pitting as a wear mechanism in these locations as shown in Figure 10. A closer look at the 3D image (Figure 6) obtained from the location with the pothole that led to the tapout shows that pitting might have been a precursor to the pothole formation.

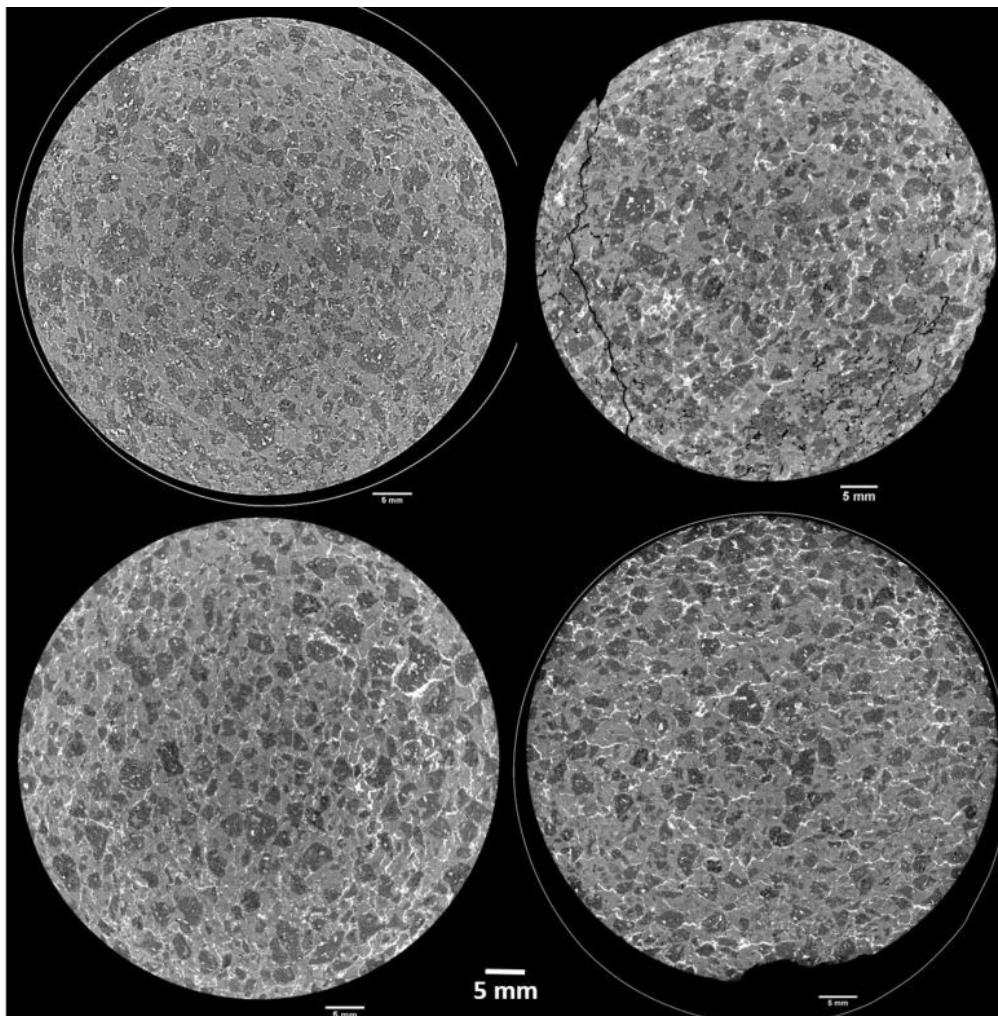
grey, where the coarse aggregates are dark grey and the binder phase with the fine aggregate is light grey. The contrast between the different carbon components allowed for determining the average size of the coarse aggregates using the linear intercept method. Figure 7 shows CT images of four of the cathode samples collected from pot 5. The average coarse grain size was determined by the linear intercept method to be 3.2 mm.

**Figure 7. CT images of the cross-section of the autopsy samples used for the linear intercept method to determine the average grain size of carbon aggregates.**

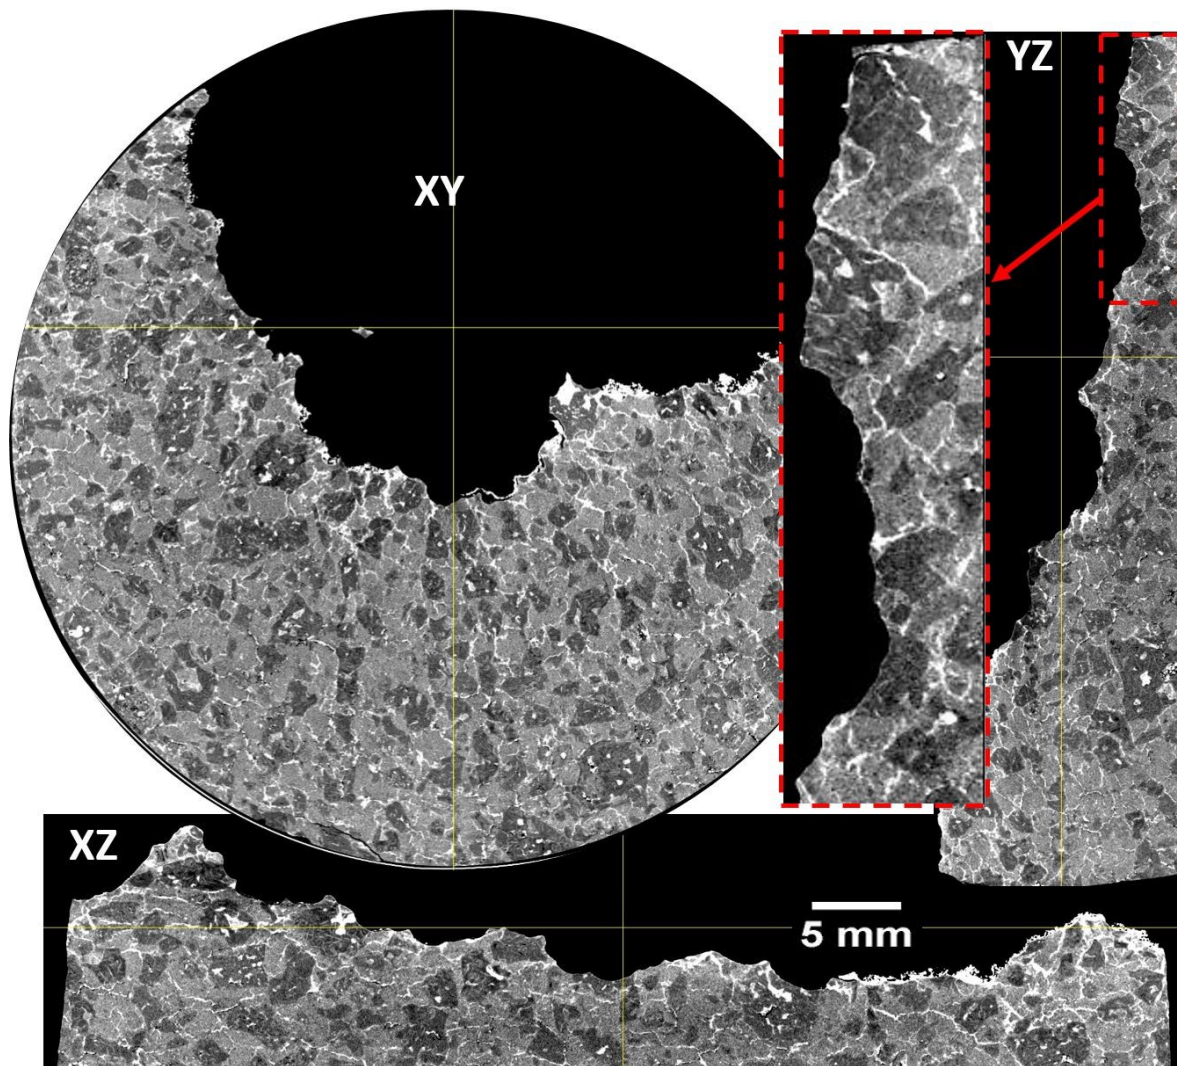
In addition to determining the grain size, the CT images were also used to analyse the topography of the eroded surface of the samples. This was done by three-dimensional investigation of the CT images. A closer investigation of these images revealed that part of aggregates are still within the carbon matrix and partly eroded aggregates were present at the surface. This was observed for all the 5 cathode samples analysed. Figure 8 shows CT images of one of the 5 samples analysed showing remains of aggregates within the carbon matrix.

**Figure 8. CT image of a cathode sample with pitting. Closer analysis of the XZ and YZ cross-sections show remains of aggregate grains within the carbon cathode matrix as illustrated by the highlighted section of YZ direction image.**

Investigation of CT images obtained from the CT analysis of the autopsy samples as illustrated in Figure 8 show remains of the carbon aggregates within the pittings. This would not be the case if particle detachment was the main mechanism for the pitting as the whole grain would have detached out of the matrix. This observation of aggregate remains within carbon matrix was further confirmed by the optical microscope images of the same autopsy samples as shown in Figure 9. Finally, the relatively uniform wear surface within these pittings, as shown by the optical micrographs (Figure 9), suggests that the pittings observed on the carbon cathodes might have formed by a chemical or electrochemical corrosion process other than a physical or mechanical detachment process.

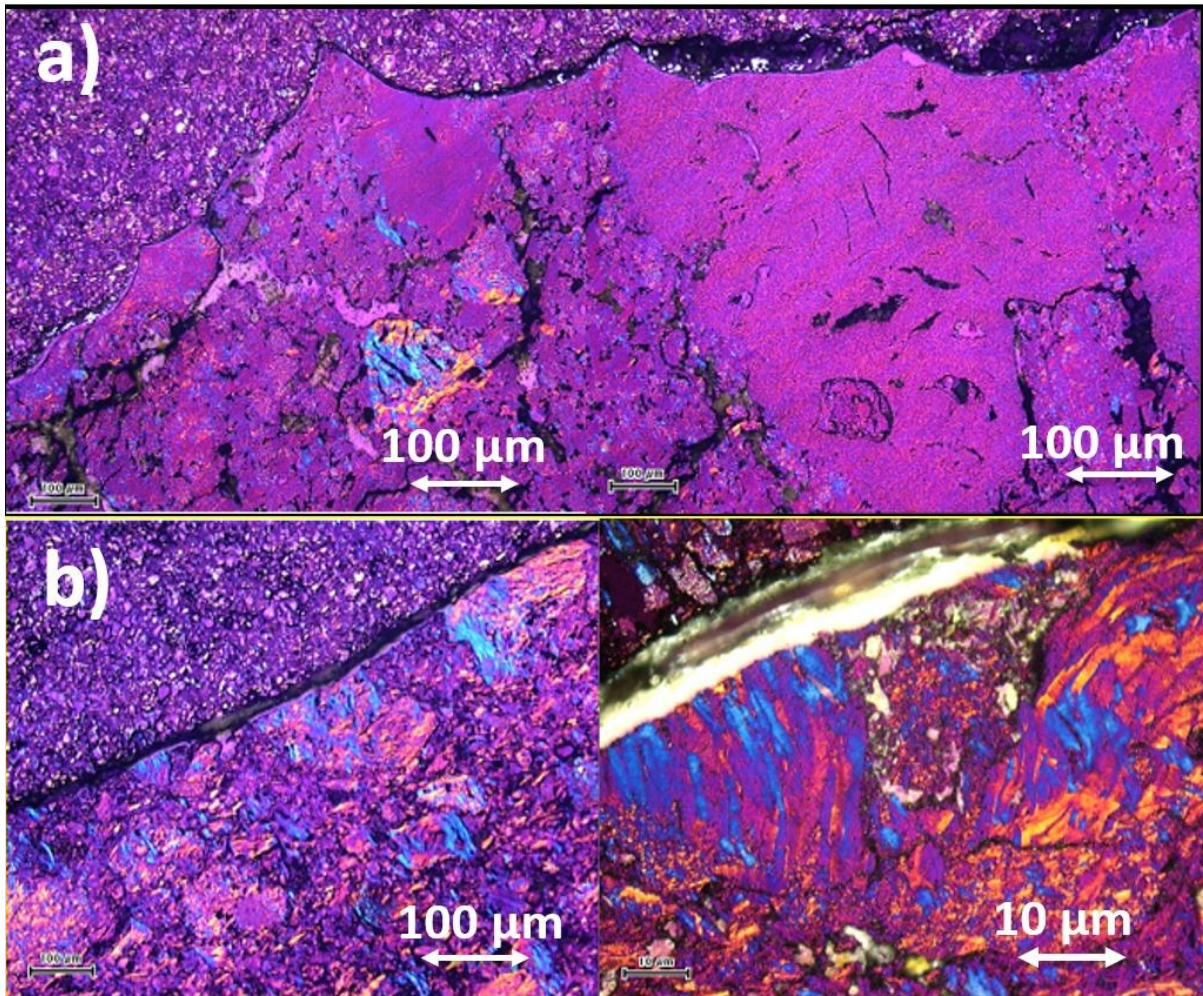
Optical microscopy was also employed to further investigate the interface between the carbon and bath/carbide, specifically at locations with pitting. The interface of all the cathode types (graphitic and graphitized) were evaluated using this technique. It was observed for all the cathode types that remains of the aggregate was left within the carbon matrix. A relatively even eroded carbon interface was observed for all the cathode types. Figure 9 show optical micrographs representative of all the cathode types investigated during the autopsies.

**Figure 9. Optical micrographs of the interface between carbon and bath for the autopsy sample analysis. a) High-density Graphitized cathode block from pot 5. b) Graphitic cathode block from pot 3.**

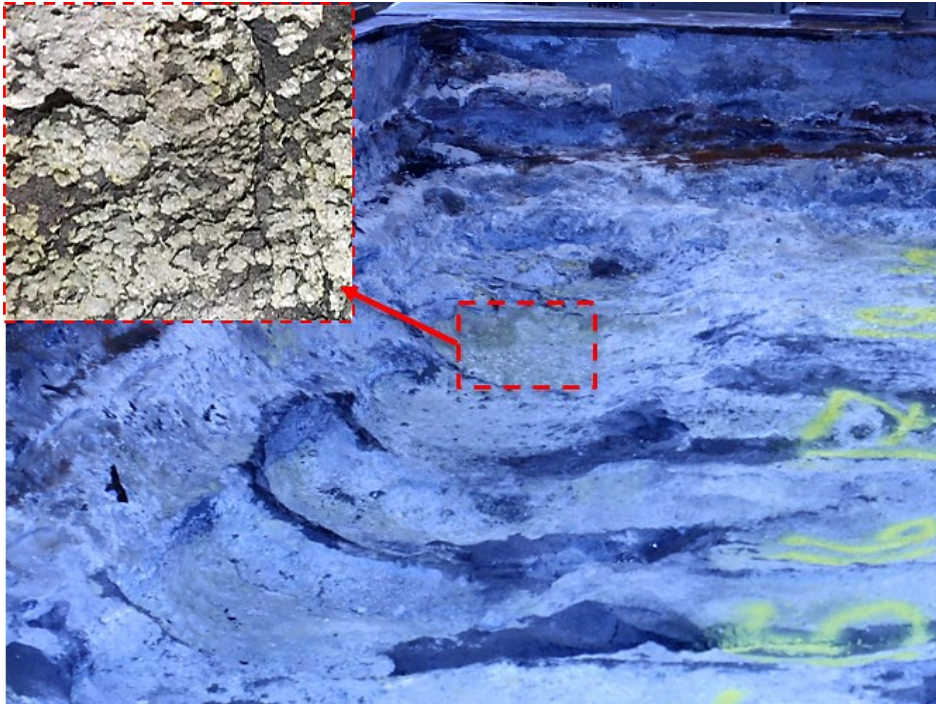
**Figure 10. Pitting on the surface of a spent potlining (pot 1). The highlighted area shows the high degree of pitting that characterizes locations with maximum wear.**
