## **The Failure of the Embankment of the Red Mud Reservoir at Ajka (Hungary)**

**György (George) Bánvölgyi**

### **Abstract**

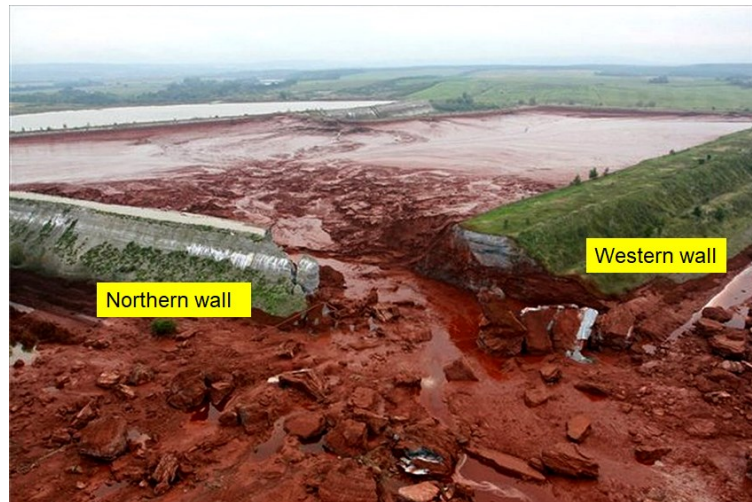
**Figure 2. General view of Reservoir 10 one day after the failure of the embankment.**

The general view of the reservoir one day after the failure of the embankment helps the reader to get oriented. It should be noted that the Western wall of the breach of the embankment is vertical, therefore Figure 3 shows its cross-section. Figures 3 and 4 demonstrates the inhomogeneity of the material of the embankment. The caustic containing supernatant liquor seems to have penetrated into and through the long pocket of sand and clay.

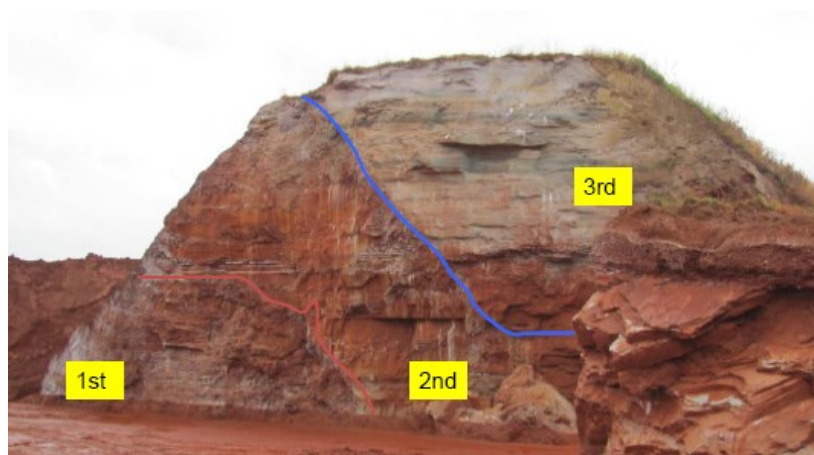
**Figure 3. Stages of building of the embankment [7].**

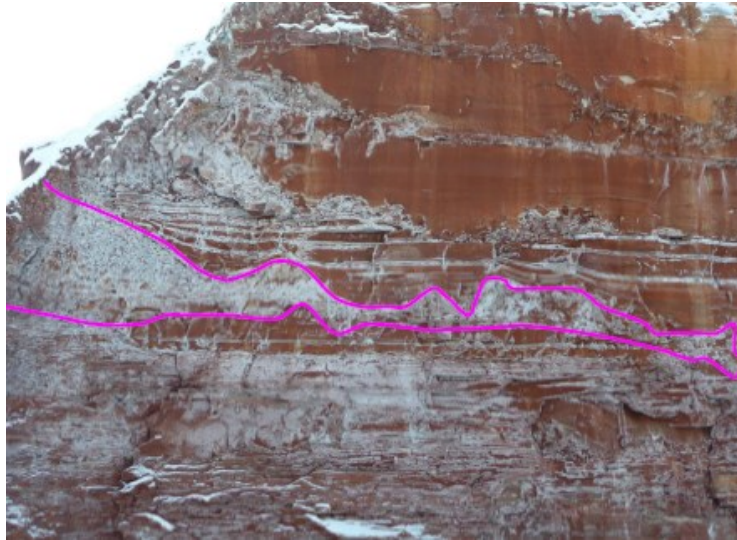
**Figure 4. Caustic corrosion pocket in the embankment [7].**

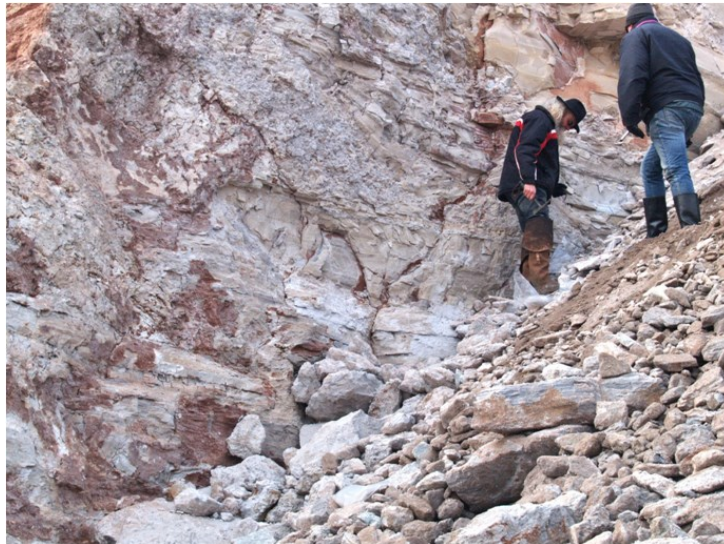
**Figure 5. Western wall having removed the fresh surface of the break [8].**

Fugro Consulting found that the strength of the embankment is highly variable, i.e. there were great differences in strength between the Northern and Western walls of the embankment at the break. There were parts of the embankment which consisted of very low strength fly ash.

It can be concluded that the material of the embankment is highly variable, with sacks of sand and clay. All of these negatively affect the integrity of the material of the embankment.
