Major reconstruction of central casing of open top baking furnace with a view to increase its lifespan and reduce the total costs comparing to full reconstruction

Keywords: anode baking furnace revamping, concrete casing, casing walls, headwalls, fluewalls.

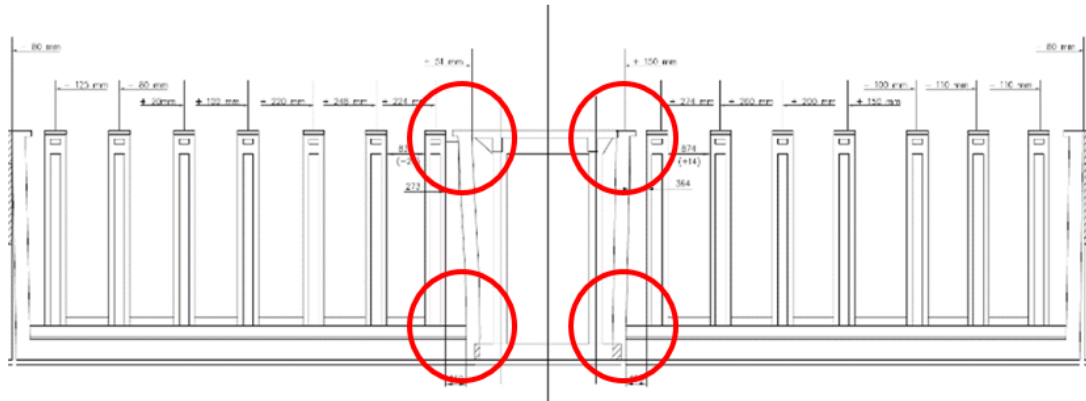
Figure 2. Cross section of ABF furnace. Location of main structural defects observed on concrete casing

Through the decades and due to continuous mechanical and thermal stresses, the concrete casing of the baking furnace moved towards the center. As a result, the upper part of the central vertical casing walls eventually came in contact with the concrete slab and the foundation of the central

platform of the anodes conveyor. The ongoing deformation of the concrete casing and the blockage of the vertical casing walls at their upper end, caused their deformation, Figure 2. Indeed, major cracks and inclinations to these walls were observed.

On the other side of the casing, the side vertical casing walls of the baking furnace were in a fairly good condition due to the fact that they rest on soil as AoG anode baking furnace is built underground. Therefore, only the central part of the concrete casing was decided to be replaced.

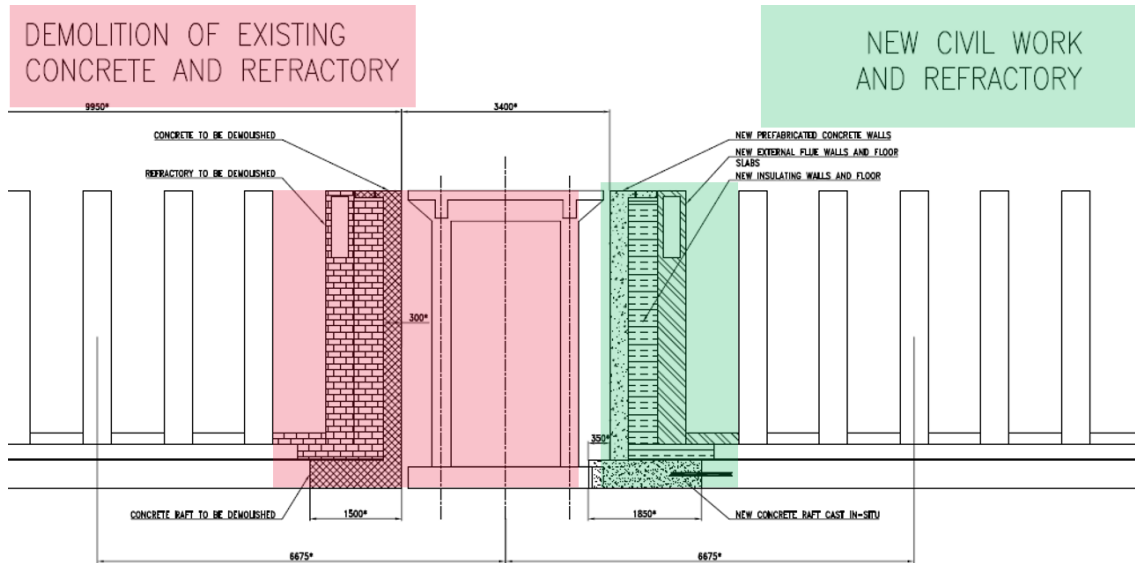
Figure 3. Cross section of ABF furnace. Refractory demolition & central conveyor removal

The main technical challenges to be managed for this partial reconstruction of the central part of the furnace as presented in Figure 3 were:

- Unknown condition of the raft and the internal part of the central walls condition (impossible to inspect);
- Very few repairs done in the past 60 years with only one repair performed in the central part of the furnace and the conveyor in 1988;
- Any intervention should be made 5 meters below the ground level as AoG furnace is built underground;
- Availability of three cranes only to realize all the materials movements
- Tight project schedule with a strict maximum duration of ninety days
- Safety management with all the above listed constraints.

- Demolition of external fluewalls, part of the headwalls and thermal insulation on the central conveyor side;
- Demolition of the casing central walls and the part of the raft;
- Dismantling of the anodes conveyor and its steel supporting structure;
- Installation of new casing central walls and pouring of new raft;
- Erection of new insulation, fluewalls and headwalls;
- Installation of new structure for anodes conveyor;
- Re-installation of existing anodes conveyor.

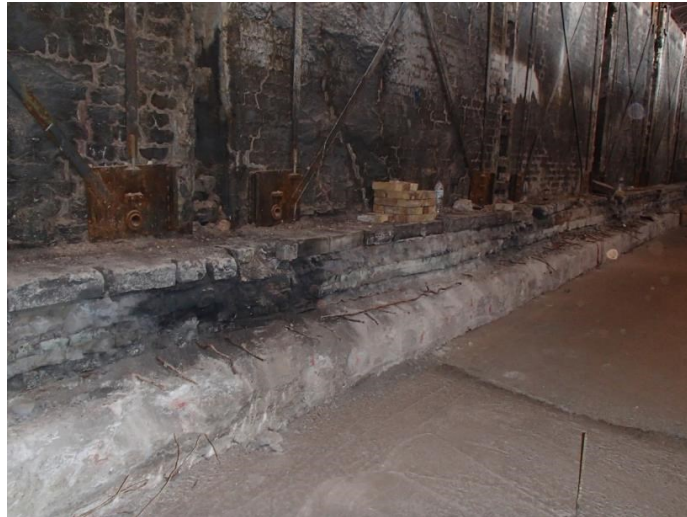
Figure 9. The existing raft condition after cleaning

Once the operations reached the bottom level of the anode baking furnace, two challenges were identified. Firstly, the condition of the raft was worse than the initial assumptions, Figure 9. It was decided by the project team to move the sawing line further away from the 6th wall than originally planned in order to provide extra safety margin against a risk of collapse of the flue wall. The damaged concrete of the remaining part of the raft had to be removed, in order to make the proper connection between the old and the new raft.

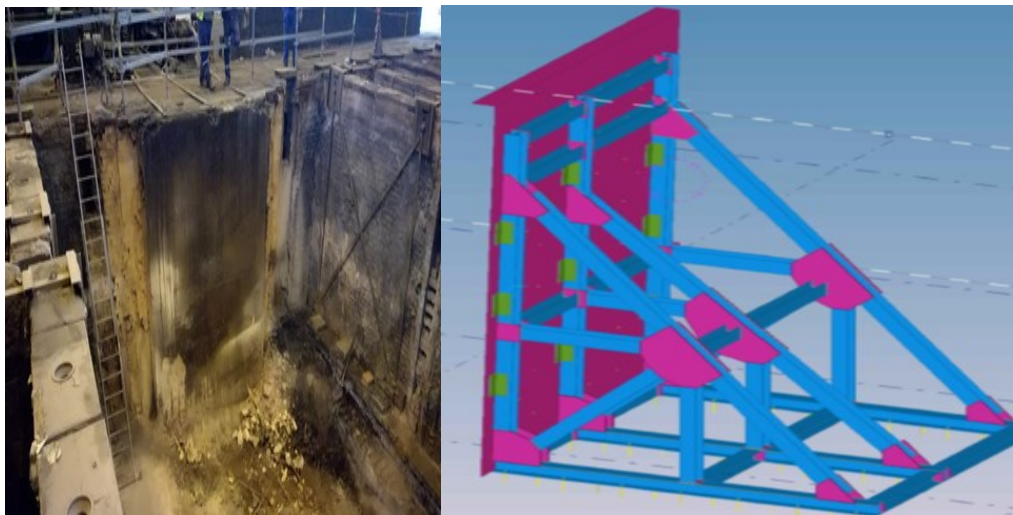
Figure 10. The east terminal crossover concrete wall (left) and stability structure used (right)

Secondly, the end walls of the concrete casing at the crossover passage were suffering from major deformations. A metallic stability system was installed to maintain the end walls of the crossover, Figure 10.
