Major reconstruction of central casing of open top baking furnace with a view to increase its lifespan and reduce the total costs comparing to full reconstruction

Affiliation of Mytilineos Metallurgy Business Unit, Agios Nikolaos Viotia, Greece

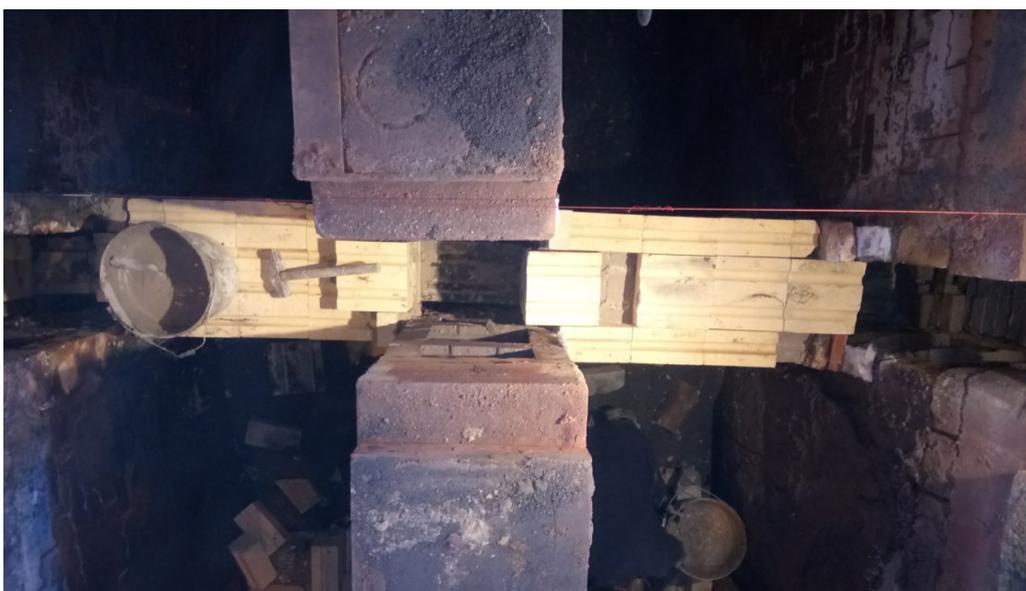
Connections between old and new parts for the insulation and the headwalls was successfully managed by AoG bricklayers thanks to their strong experience, Figure 13. As new and wider insulating walls were installed, the position of the 6th fluewall has been adjusted in order to achieve a proper pit width.

Figure 13. Headwall reconstruction around old fluewalls
