Pot Blasting Abnormality Control at Balco

Bharat Aluminium Company, Korba, India

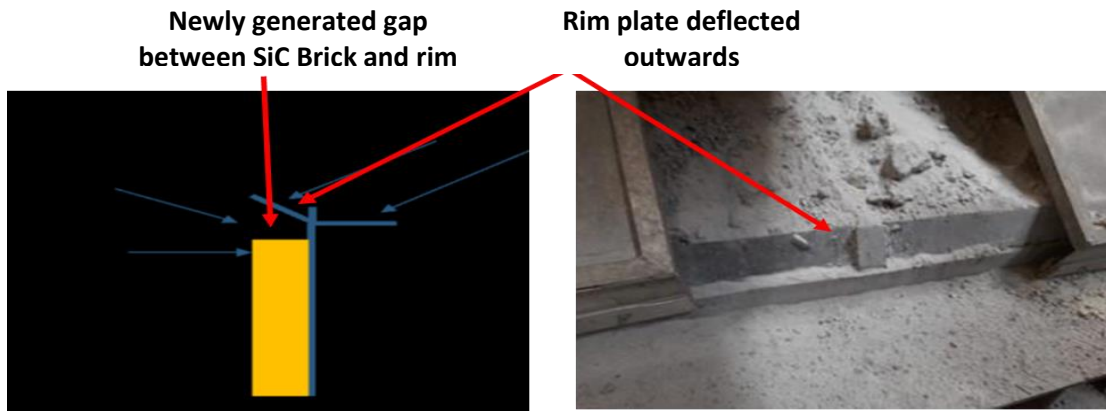
- 6) In almost all blast locations, the rim plate was found deflected upwards at the time of blasting or before (Figure 3).
- 7) In most of the blasted pots, there were 50-60 mm of silicon carbide sidewall left at the bath metal interface and 70-80 mm left at the top of the silicon carbide block. Therefore,

The upwards deflection of the rim plate happens slowly (Figure 4) from the inner edge creating a gap. This damages the grout between the top of the silicon carbide bricks and the bottom surface of the rim plate. When the liquid level is high, this exposes the potshell to impingement of liquid bath directly through the gap (Figure 3).

Figure 3. Deflection occurring in rim plate.

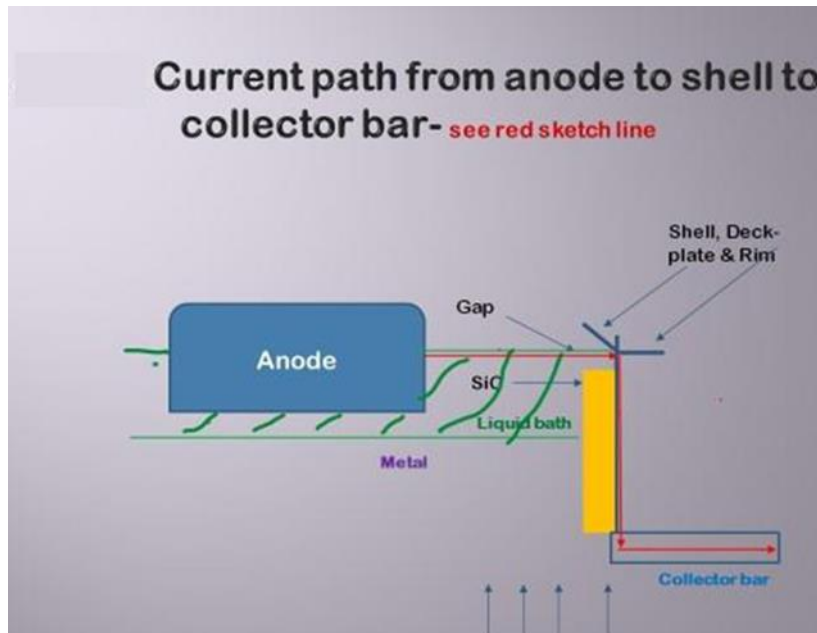
Figure 4. Path of bath penetration from top of SiC brick via gap between shell and SiC brick. The electric current can pass directly from the anode to the collector bars.

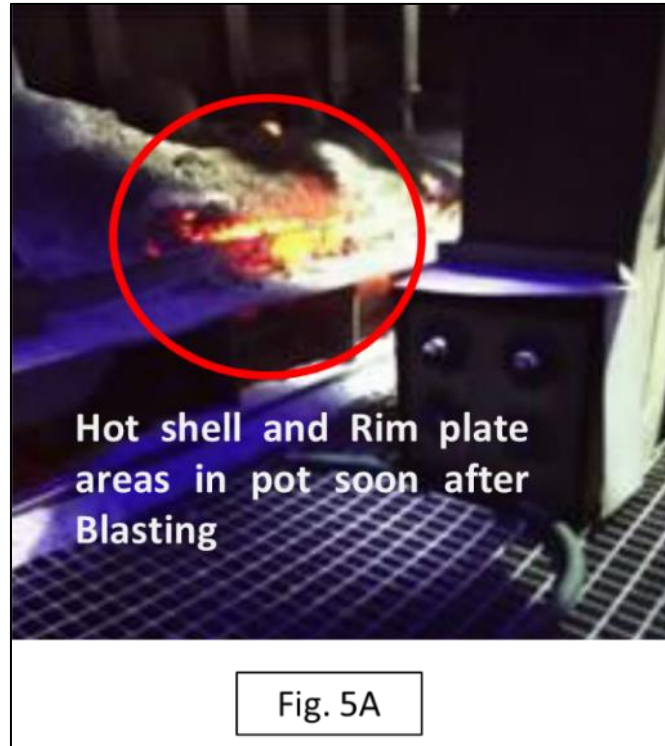
The penetration of hot liquid bath above the silicon carbide block, forming a liquid pathway directly to the steel shell is what causes blasting from inside. If bath penetrates downward between the steel shell and the silicon carbide sidewall blocks, then hot spots would have occurred at the side bottom shell, but instead, hot spots occur at the top of the shell and at rim plate area (Figures

Figure 5 A. Picture of hot blasted area.

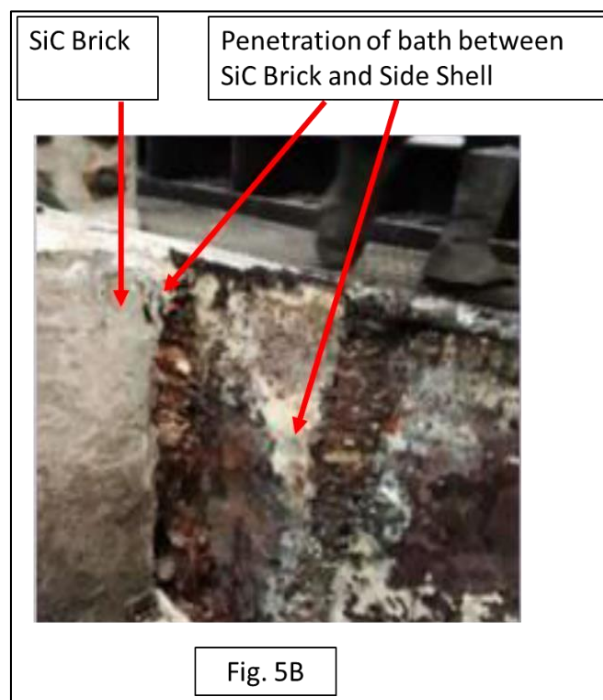
Figure 5 B. Picture of the shell area of blasted pot depicting traces of bath penetration between the shell and SiC from top.

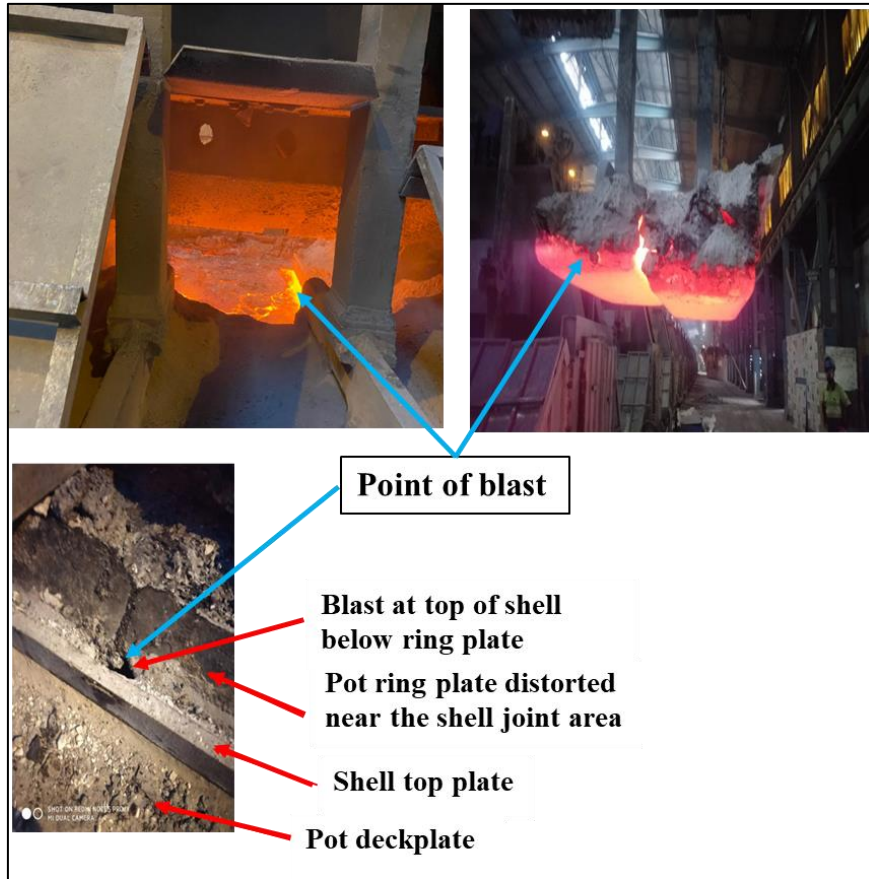
Figure 6. View of blast area - Inner shell (top left), Anode (top right), Rim plate (bottom).

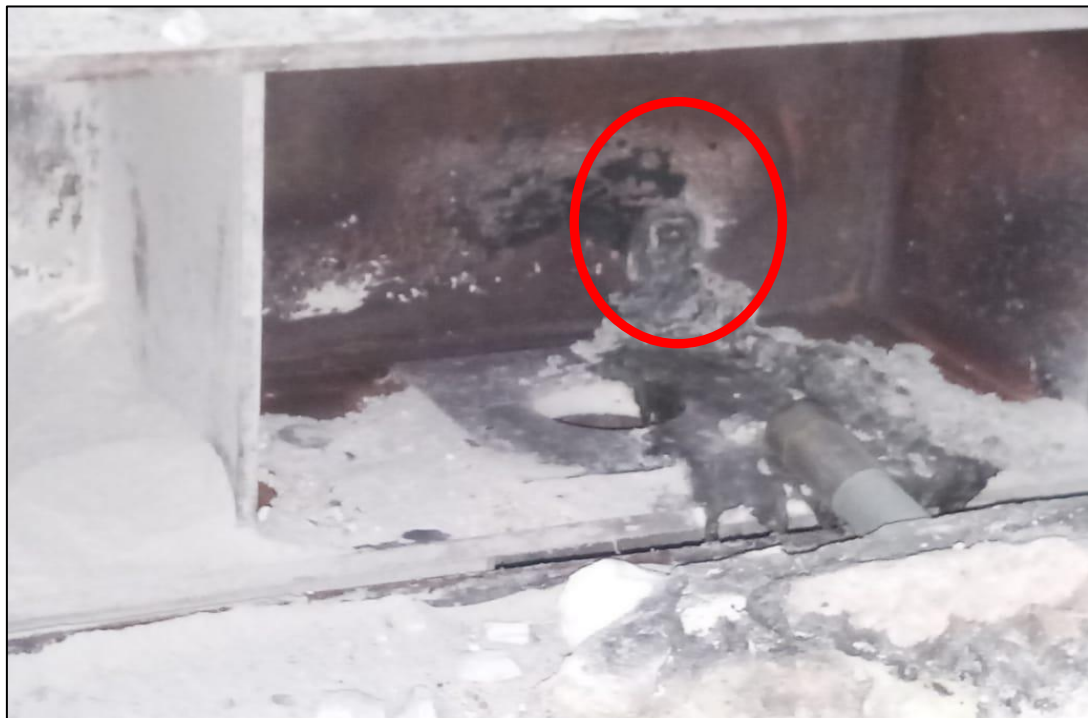
5.A, 5.B). This type of hot spotting can cause the failure of the steel sidewall and ultimately cause the pot to tap out, as has been observed on many occasions (Figure 7). In several cases, Blasting is not likely found causing hotspots when sustained for less than 5-20 seconds.

Figure 7. Pot leakage from side shell through hot spot.
