## Challenges of Prolonging Life of Aged Anode Baking Furnace-1 at Aluminum Bahrain (ALBA)

Aluminum Bahrain, Manama, Kingdom of Bahrain  
Corresponding author: bhoopesh.jain@alba.com.bh

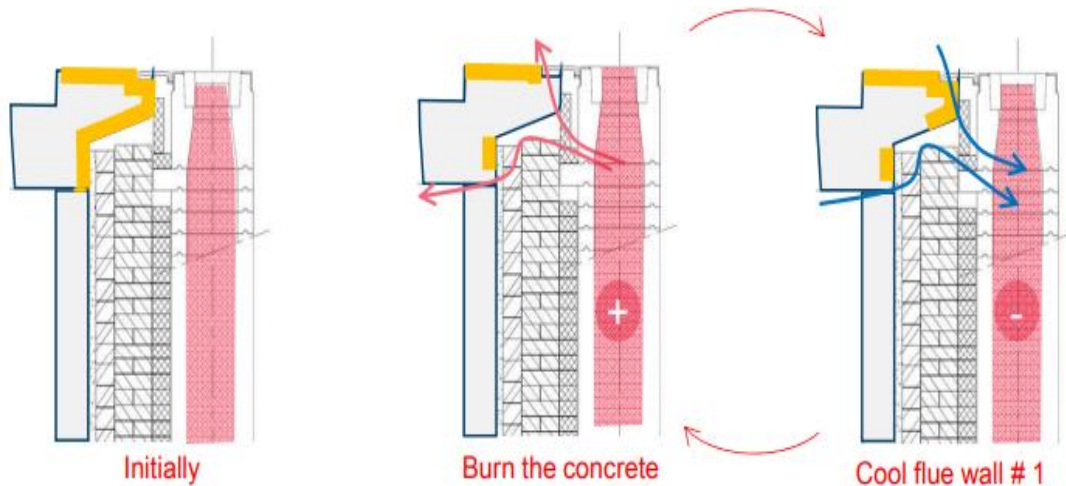
Over the years, the ABF#1 condition has deteriorated significantly. Rio Tinto Alcan (RTA) conducted an audit on ABF#1 to evaluate refractory and civil work during 2019 [7]. The audit report highlighted significant deterioration in the corbel and concrete tub. These areas were the major sources of air inlet (Fig.2 & 3).

Figure 2. Air inlet to flue wall from deteriorated corbel [7].

The refractory team proceeded to repair all the corbels of the 50 sections. It included removal of top blocks, removal of 5 courses of flue wall and removal of 8 courses of insulation for each corbel. The damaged part of concrete of corbel was removed. Casting was done for damaged parts and all the courses of insulation and flue walls were replaced.

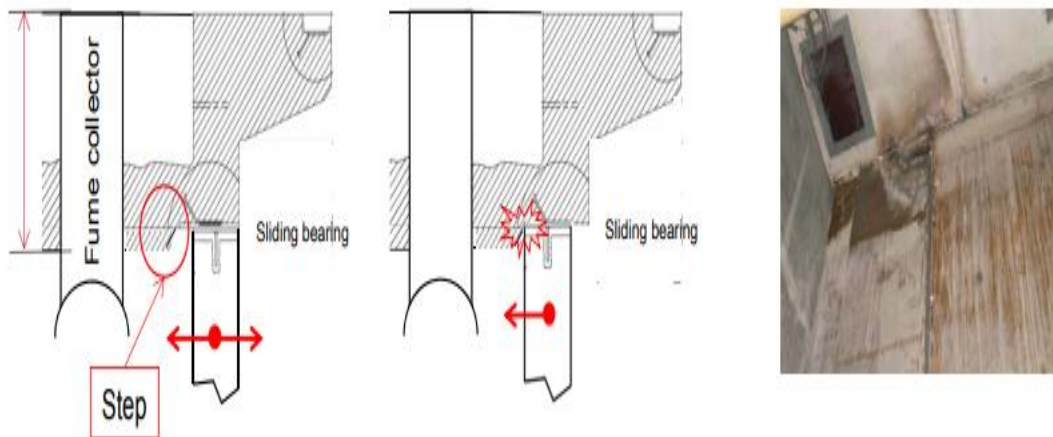
Figure 3. Damaged concrete casing in ABF#1 [7].

Concrete casing: A survey was done to evaluate the condition of the concrete casing. It was observed that there are 19 sections out of a total of 50 (38 %) where the slab sliding bearing was damaged (Figure 9). This happened due to movement of forklifts used for handling of green and baked anodes in the furnace. The marks of the fumes were observed on damaged area. These corrosive fumes also having significant impact over the structural integrity of concrete [5][6]. These damaged portions are very difficult to identify as they are inside the cages which were left during the conversion from closed-type to open-type ABF. These damages were the major source of air inlet [7] which is impacting the baking process of external flue wall number 1 as well as anode rejection due to air burn. The mapping of flue wall draft was done on external flue number 1 for all the affected sections, and it confirmed significant loss of draft across the damaged part of the concrete casing.

A survey was carried out to assess the condition of the concrete casing. 19 out of total 50 numbers of sections were identified where damages in the concrete casing were significantly impacting on the flue wall temperature and draft. Initially it was repaired from the flue wall side. Three layers of side insulation were removed to access the damaged part of the concrete wall. The damaged portion of the concrete wall was sealed with ceramic wool and castable. It survived 2 to 3 fire cycle only, hence it was decided to carry out more extensive repair from the outside with concrete mix. Nevertheless, there were access limitations to carry out such repair and the external concrete wall had to be modified to provide the sufficient access.

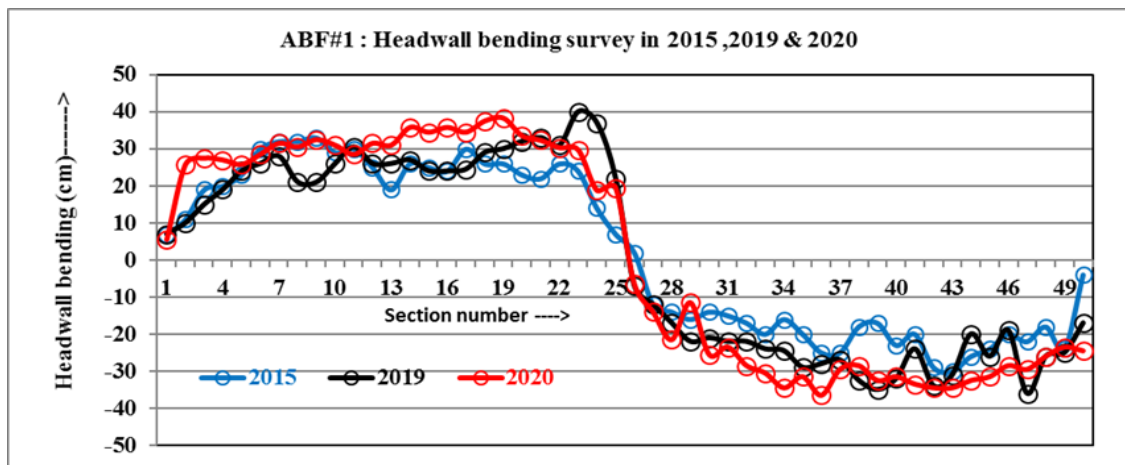
Due to thermal and mechanical stresses, headwalls have deformed vertically as well as horizontally during last 26 years of operation. This deformation with time is typical to any anode baking furnace. Increasing anode size over the years has accelerated the deterioration. The survey for headwall deflection measurements carried out for all the 50 headwalls during years 2015, 2019 and 2020 are summarized in Figure 4. In 2020, 60 % of the headwalls were having deflection in the range of 300 to 350 mm which is significantly high. Section numbers 1, 25, 26 and 50 are the cross over sections having low or no deflection. These sections are placed at the furnace end i.e., cross over sections where fumes are entering. The deflection for 40 % of the headwalls were still increasing compared to survey done in year 2019.

Figure 4. ABF # 1 section wise headwall deformation.

As there was low or no expansion gaps left due to headwall deflection, it was decided to reduce flue wall length. The flue wall length was reduced by 20 mm for the first time in 2008. This has improved flue wall life of 3<sup>rd</sup> generation from 103 fire cycles to 119 fire cycles. In 2013, the flue wall length was again reduced by 10 mm. It has not improved the flue wall life. However, it has helped in controlling the rate of deterioration in flue wall life. Based on the survey of headwall

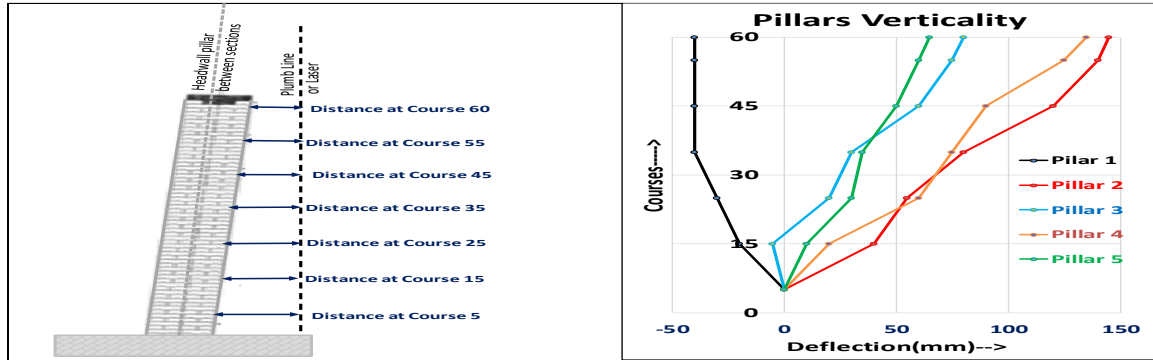
During the year 2021, a survey was carried out to evaluate the verticality of headwalls. Sections were selected randomly to assess the deformation. The magnitude of deflection was found to be varying from 20 mm to 150 mm across the headwall height is summarized in Figure 5.

**Figure 5. Vertical headwall deformation in ABF#1.**

It means the pit length is varying along the height. These deflections (horizontal and vertical) were observed opposite to the fire direction i.e., opposite of the fume flow.

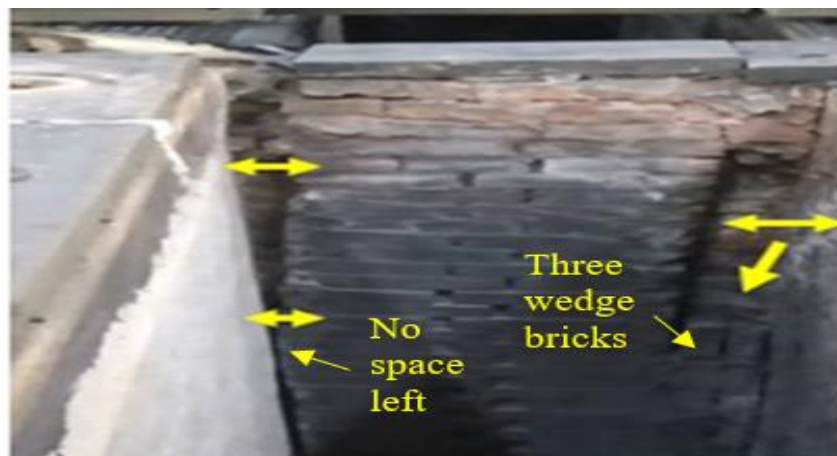
Figure 6 is showing the typical headwall movement and the horizontal deflection of headwall. At the majority of the sections, there is no space between the flue wall and the headwall, while at the other side it is necessary to install two to three wedges as shown below in picture.

**Figure 6. Showing headwall deformation in ABF # 1.**

- Problems in installing new flue wall due to variation in pit length from section to section.
- 60 % of the flue walls do not have space to keep wedge bricks at one side while the other side requires two to three wedge bricks (deviations from the original design).
- The headwall window is not aligned with the flue wall window in 80 % of the cases.
- 90 % of the sections had variations in flue wall expansion gap from top to bottom, even some part of the flue wall touching the headwall i.e., no expansion gap.
- Around 30 % of the flue wall came out of the headwall groove, which required to fix wedge bricks horizontally to hold the flue wall.

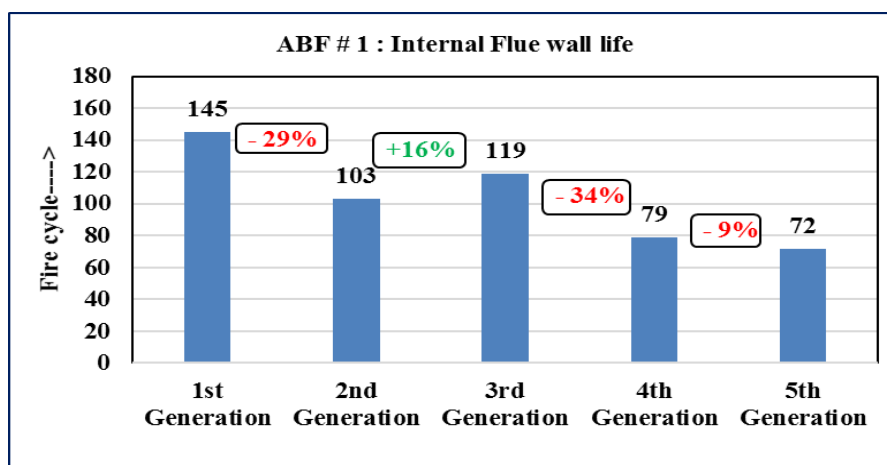
The conditions in the baking furnace has significantly reduced the flue wall life as shown in Figure 7, and the headwall conditions have deteriorated faster along the generations of the flue wall. Flue wall life has reduced from 145 fire cycle for the first generation to 72 fire cycle for the fifth generation.

Figure 7. Generation wise flue wall lifetime in ABF # 1.

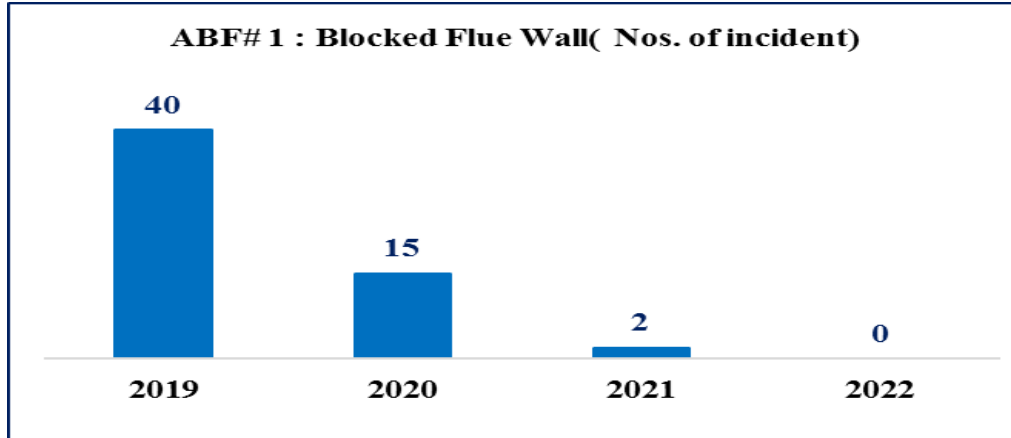
flue walls (Figure 8) increased significantly (40 cases in 2019) causing process disruption and safety risks. Temperatures deteriorated to an unacceptable low level. The furnace started to produce tar, and this posed a risk of fire to the system. It became a challenge maintaining good health and safety close to the furnace.

Mapping of process temperatures and poor draft were carried out for every flue wall to identify the very bad flue walls. A joint physical inspection team of process controllers, operation and the refractory team was assembled to assess the flue wall conditions and take joint decision accordingly. All the details such as cracks, pinching, type of deformations, blocked flue wall and tie bricks condition recorded for each flue wall was noted. This helped the team to prepare a plan for refractory maintenance. Operational activities and resources were aligned to spare the sections for maintenance and flue wall replacement. The need for flue wall replacements was significantly reduced from 2020 to 2022 in ABF#1, due to these measures.
