Ma'aden Reduction Potline Partial Failure Incident and Recovery

Ma'aden Aluminium Company, Ras Al-Khair, Saudi Arabia

Keywords: Potline crisis, Potline recovery, Amperage increase, Anode failures, Pot relining.

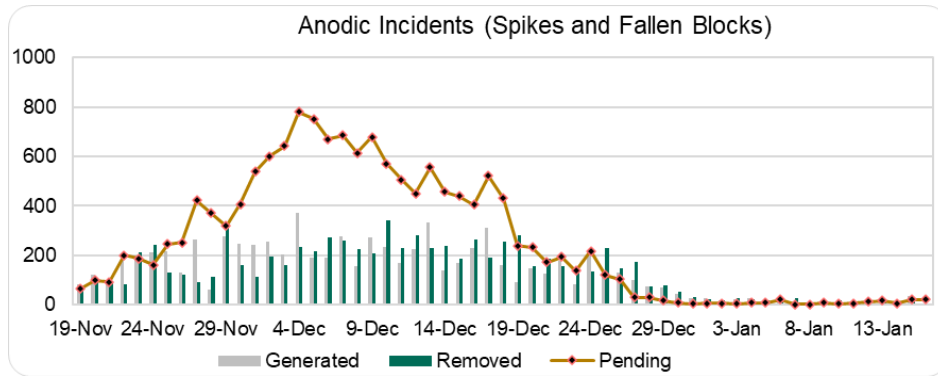
- Many pots with multiple anodic incidents, spikes and fallen blocks (Figures 1-2), put the potlines at risk of having open circuit if not removed on time.
- High number of pending unscheduled anodes, spikes and fallen blocks increased workload in equipment and manpower.
- Late work in potlines increased due to high number of anodic incidents removed.
- Number of critical pots with high silicon increased sharply in potlines with many pots with red shells and also a few pots tapped out from side shell due to high instability.

Figure 1: Trend of anodic incidents and fallen blocks.

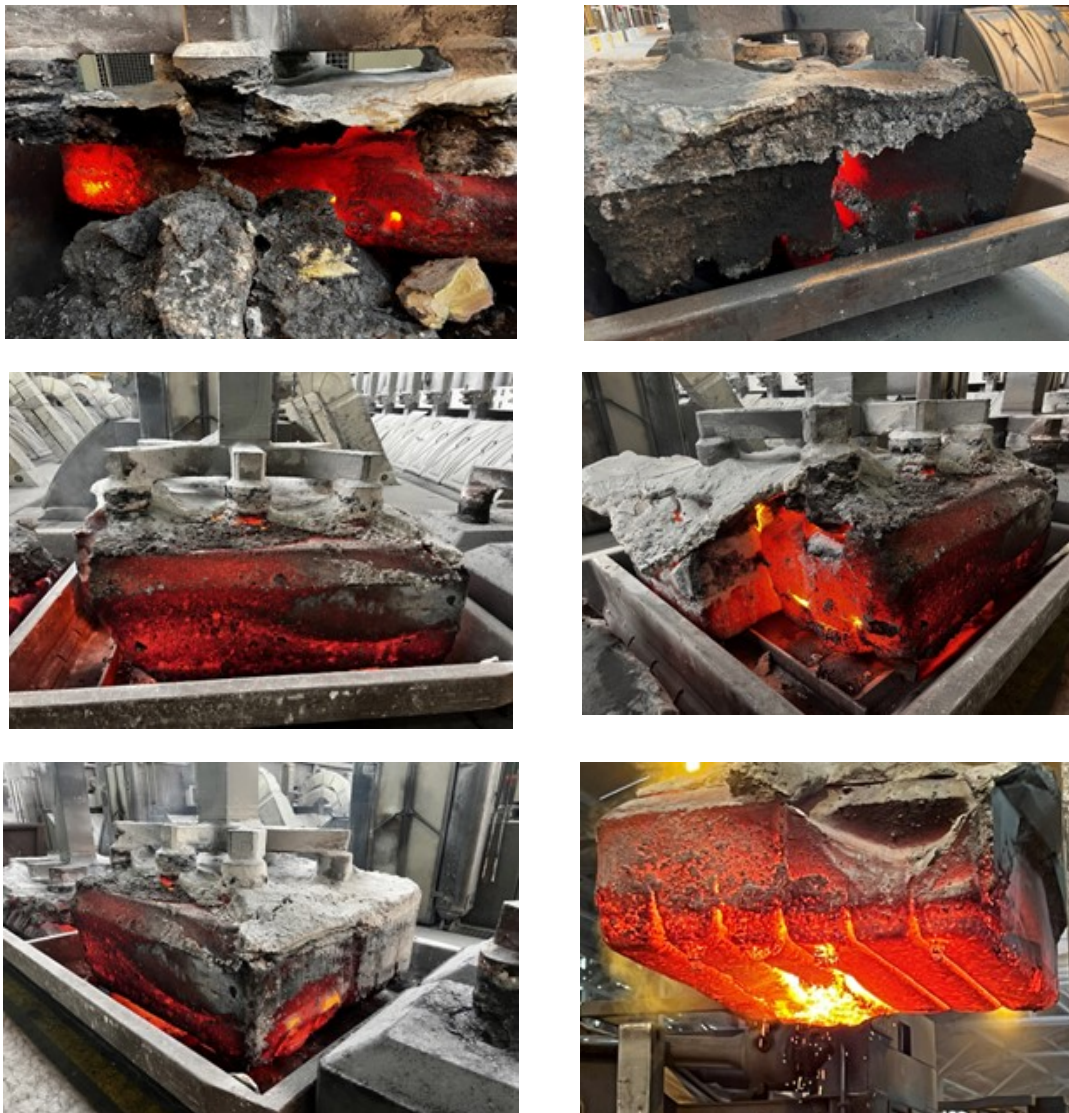
Figure 2. Type of anodic incidents and fallen blocks.

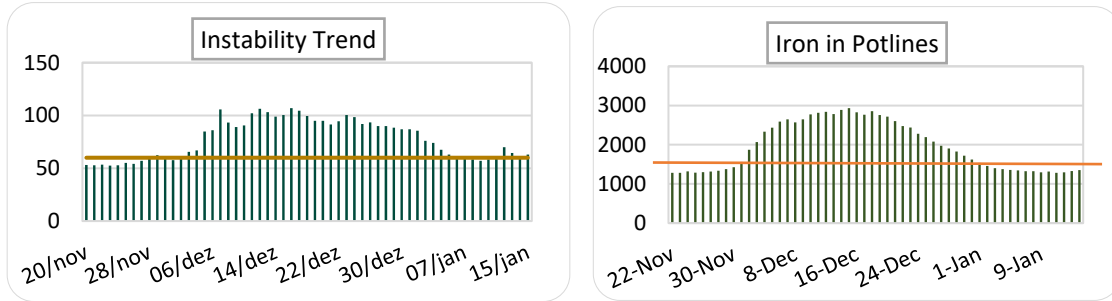
Pot instability increased from 45 nΩ to above 100 nΩ in mid-crisis, at the end December 2022 (Figure 3). When improvements in the potlines were made, and good anodes were supplied, the instability started to improve in January 2023.

Iron content in metal was affected by high number of anodic incidents specially fallen blocks; the level of iron jumped from 1100 ppm to more than 2500 ppm during the peak of anodic incidents and decreased in January 2023 (Figure 3).

Figure 3. Instability (nΩ) and iron content (ppm).

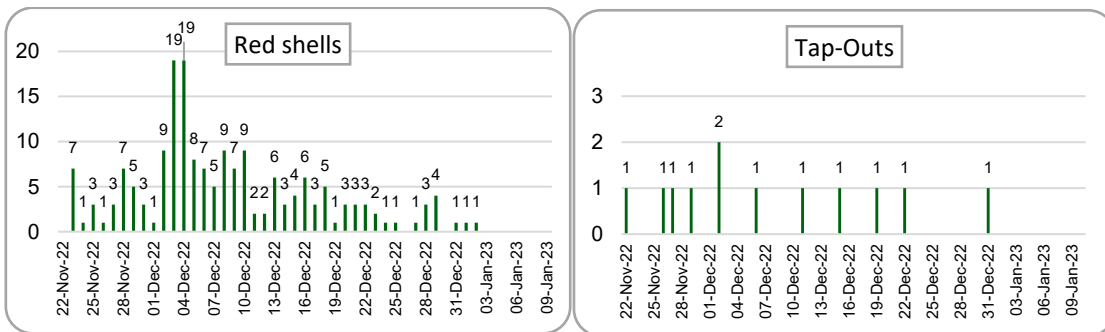
Due to upset condition during December 2022, the red shell events started to increase, and at the same time 12 pot tap-outs occurred (Figure 4). The team started to be proactive, which helped to identify and treat red shell before tap-out.

Figure 4. Number of red shells and pot tap outs.

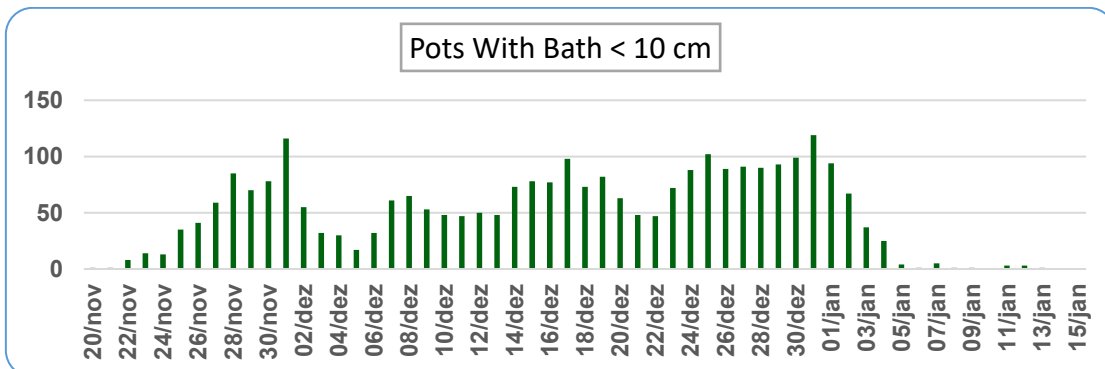
Pending anodic incidents increased in potlines, bath levels dropped drastically, and many actions were taken to improve the level of bath to improve line stability and to avoid any risk of bath shortage during December 2022 (Figure 5).

Figure 5. Number of pots less than 10 cm bath height.

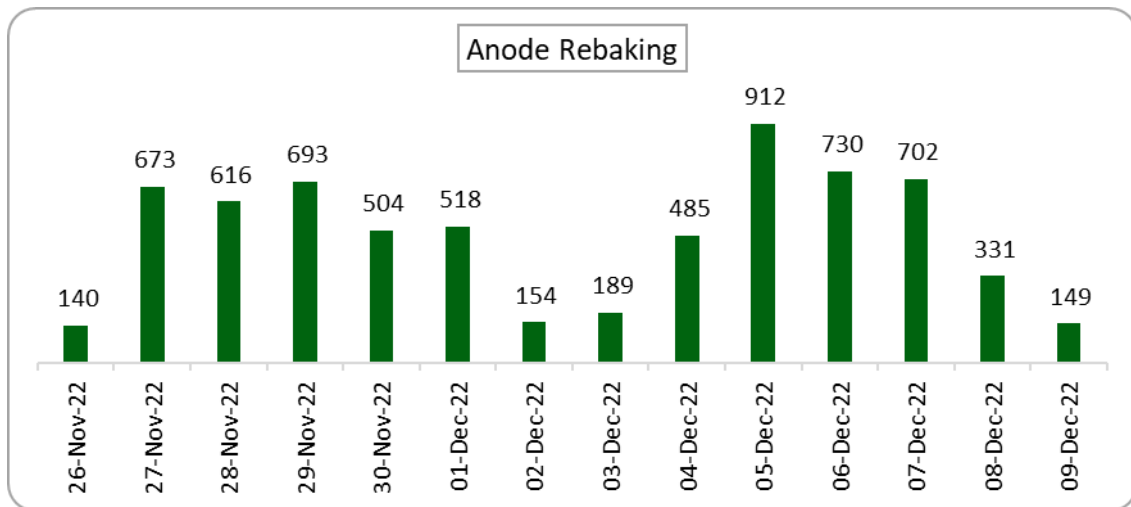
Figure 6. Number of anodes re-baked.

- Potline amperage was reduced from 410 kA to 370 kA in steps to minimize the instability and red shell pots.
- Potline instability action room was established around the clock with all functions to safely and effectively manage the situation and ensure plant was returning to normal operating condition.
- Stop the supply from the anode baking furnace (ABF) for sections with lower baking temperature by re-baking anodes to ensure that all anodes reached the desired temperature. Anode re-baking started for underbaked anodes to support built inventory and meet reduction demand (Figure 6).

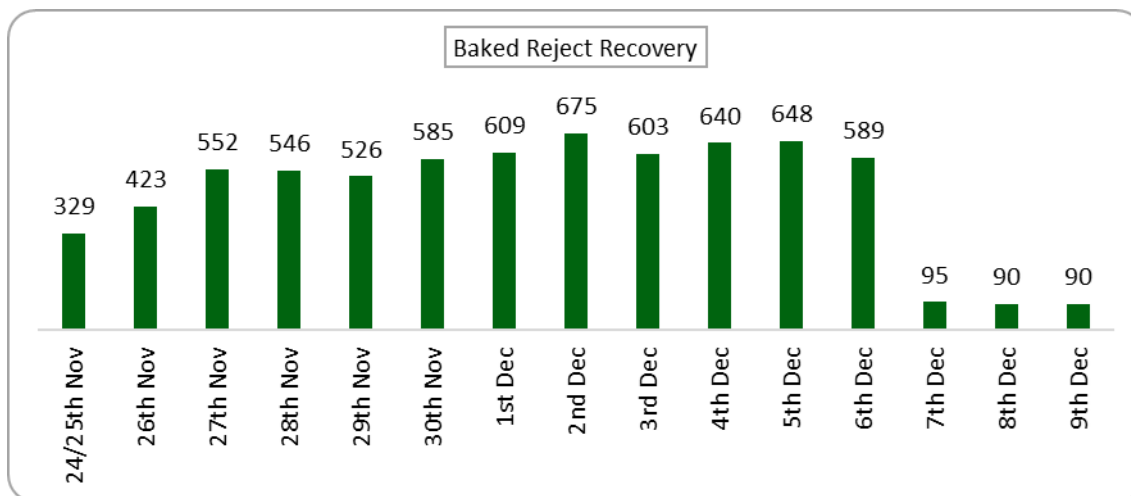
Figure 7. Number of baked-reject recoveries.

- Utilize the rejected baked inventory to segregate and use only anodes having healthy ABF temperatures. This action resulted in a baked reject recovery of around 7 000 anodes from the available stock of 19 750. This activity took place from 24 November to 9 December (Figure 7).

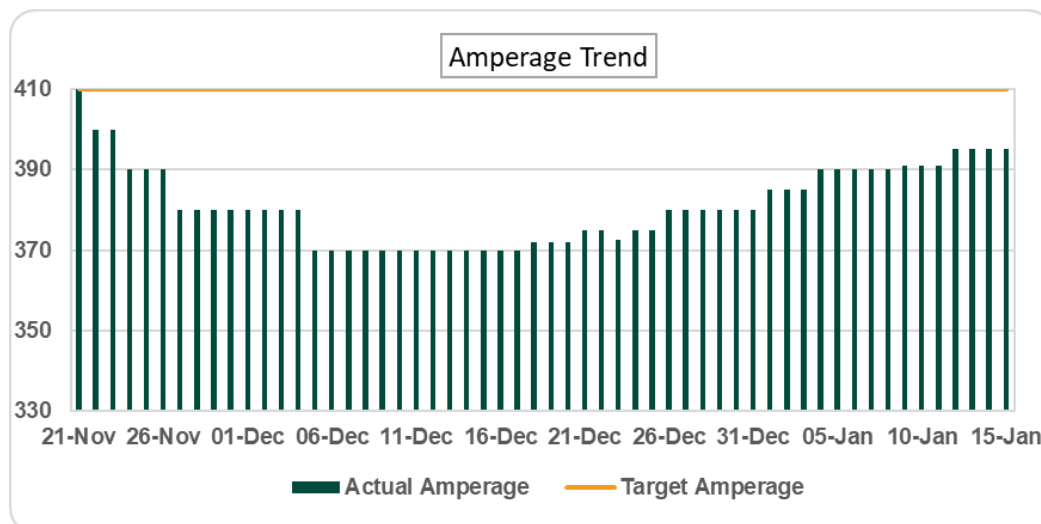
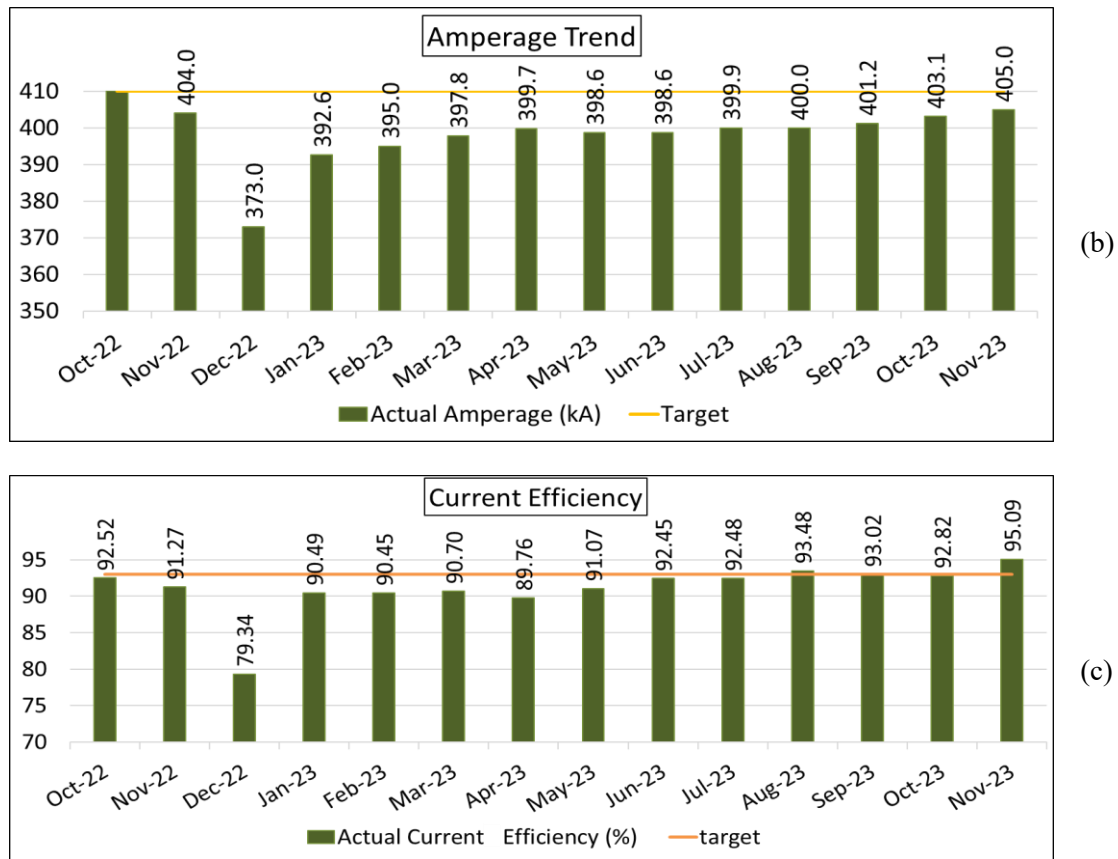
- To reduce potlines demand from carbon plant, the anode set cycle was changed in parallel with amperage change.
- The first amperage reduction was on 22nd November. Later, and with daily evaluation of lines condition and KPIs, the amperage was reduced to 370 kA (Figure 8a and 8b).
- Potline indicators were closely monitored every shift to decide on amperage steps. The first amperage increase was on 18th December after evaluating the potlines and carbon plant situation and inventory improvements.
- In spite of amperage decrease, the carbon crisis had a large impact on current efficiency, with the low of monthly average of 79.3 % at the top of the crisis in December 2022 (Figure 8c).

Figure 8. Potline amperage (kA) – daily average (a) and monthly average (b). Potline current efficiency (%) (c).

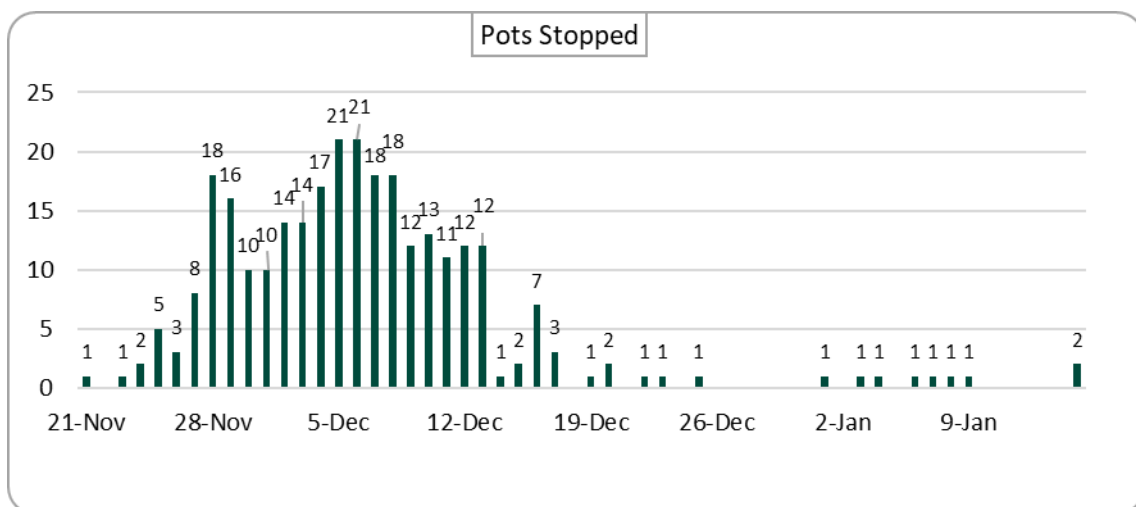
One of the actions to control the situation in the potlines was stopping any critical pot to avoid the risk of tap-out or open circuit. The team was preparing a daily list of critical pots in shift basis to treat and deal with these pots. A total of 304 pots were stopped during the crisis period (Figure 9).

Figure 9. Number of pots stopped.

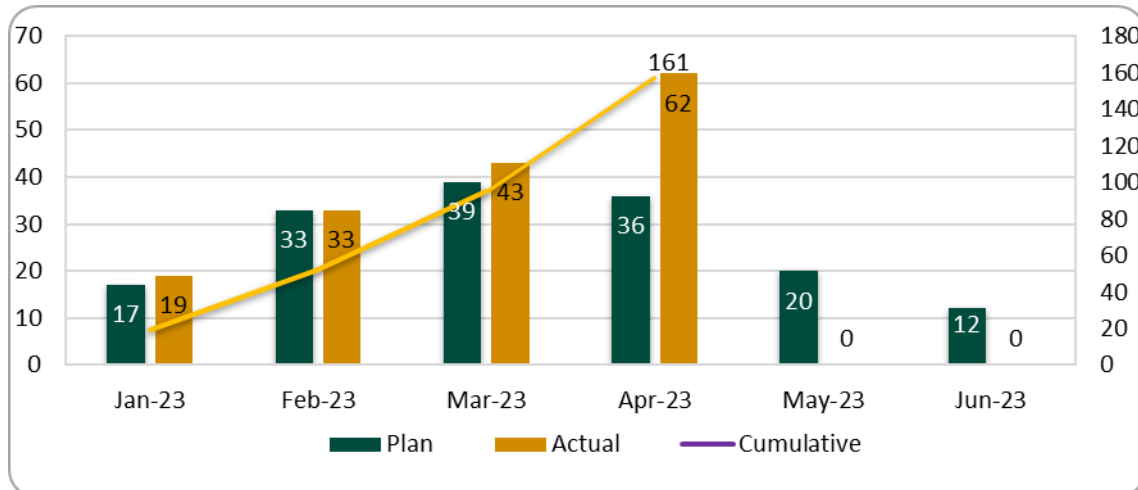
Pot in-situ cleaning was completed earlier than the plan. In total, 161 pots were cleaned and re-started (Figure 11). Cathode condition was physically checked and verified by experienced team dedicated for this activity. All re-started pots were being closely monitored during energization to avoid any incidents related to non-uniform current distribution.

Figure 11. Pot in-situ cleaning.

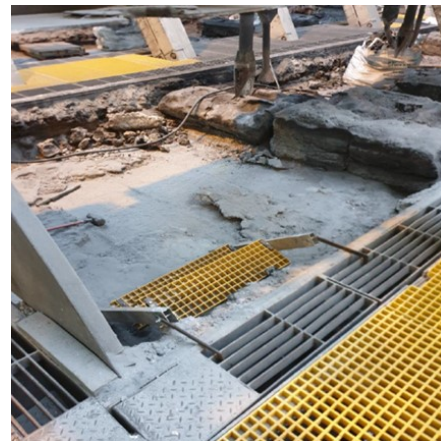
After removal of loose material, an initial examination was performed to determine whether a superstructure should be removed or not (Figure 16). The following criteria were adhered to during this inspection:

- The quantity and size of anodes,
- The size and thickness of metal pad,
- The volume of the bath mixed with the metal,
- The feasibility of safe removal without any harm to individuals, equipment, or property.

Figure 16. Initial inspection.

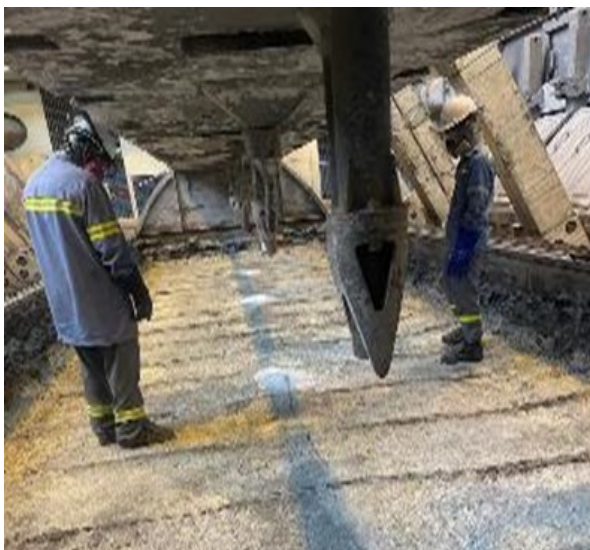
After thorough cleaning of both cathode surface and sidewalls, the technical department of Ma'aden proceeded to examine and accurately determine the condition of the cathodes and sidewalls (Figure 23). If the sidewall or ramming of the pot required necessary repairs, the repair team was provided with a detailed scope of work by the technical team.

Figure 23. Cathode inspection.

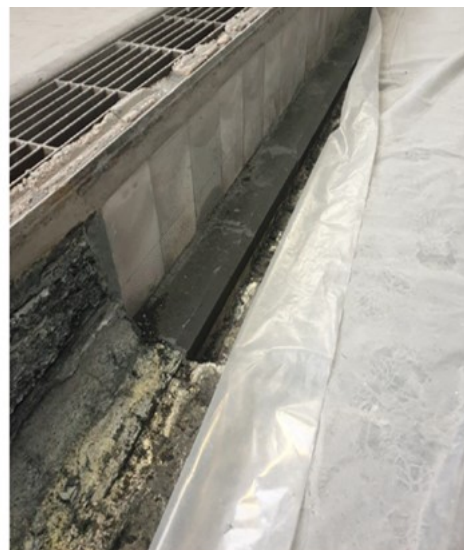
Figure 24. Side wall repair.

Upon receiving instructions from the technical team, the repair crew proceeded to break the sidewall as indicated by the team (Figure 24). It is important to note that in the process of breaking the sidewall, there exists a possibility of harming the upper brickwork, which must then be fixed before the sidewall can be installed. It is worth mentioning that these repairs are extensive and require a substantial amount of time to complete. Additionally, other repairs may involve the removal of metal penetrations in the rammed fillet.

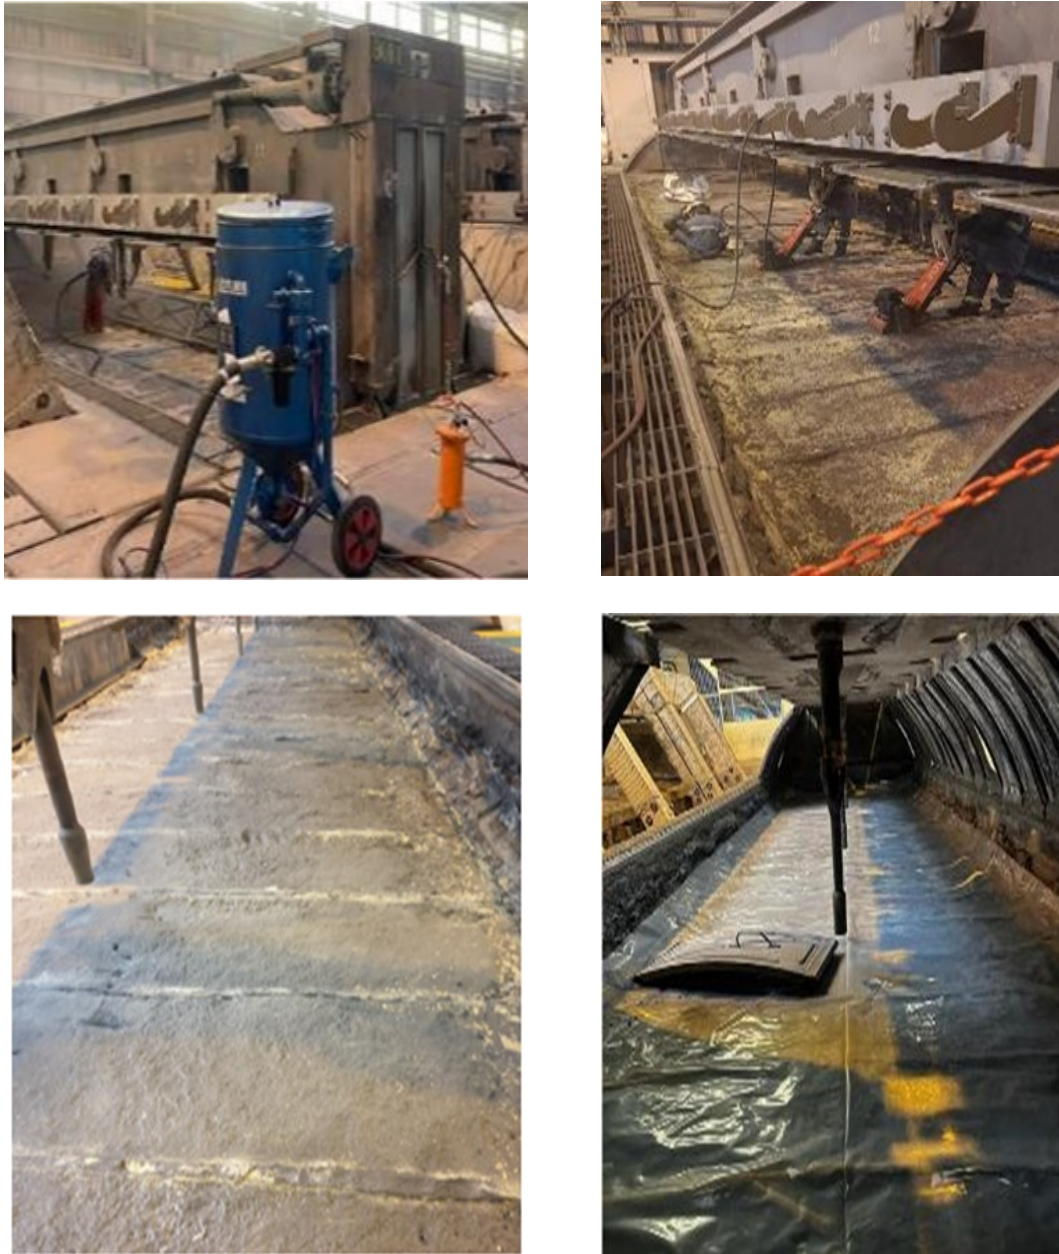
Figure 25. Shot blasting of the cathode surface.

Cathode surface shot blasting is a crucial step that shouldn't be overlooked after pot repair. This process entails directing a high-velocity stream of abrasive particles onto the cathode surface to remove unwanted material. Once the cathode has undergone the process of shot blasting, it is essential to safeguard the cathode surface against oxidation by covering with a plastic sheet. This precaution is necessary to sustain the integrity of the cathode and ensure its readiness for subsequent pot preparations.

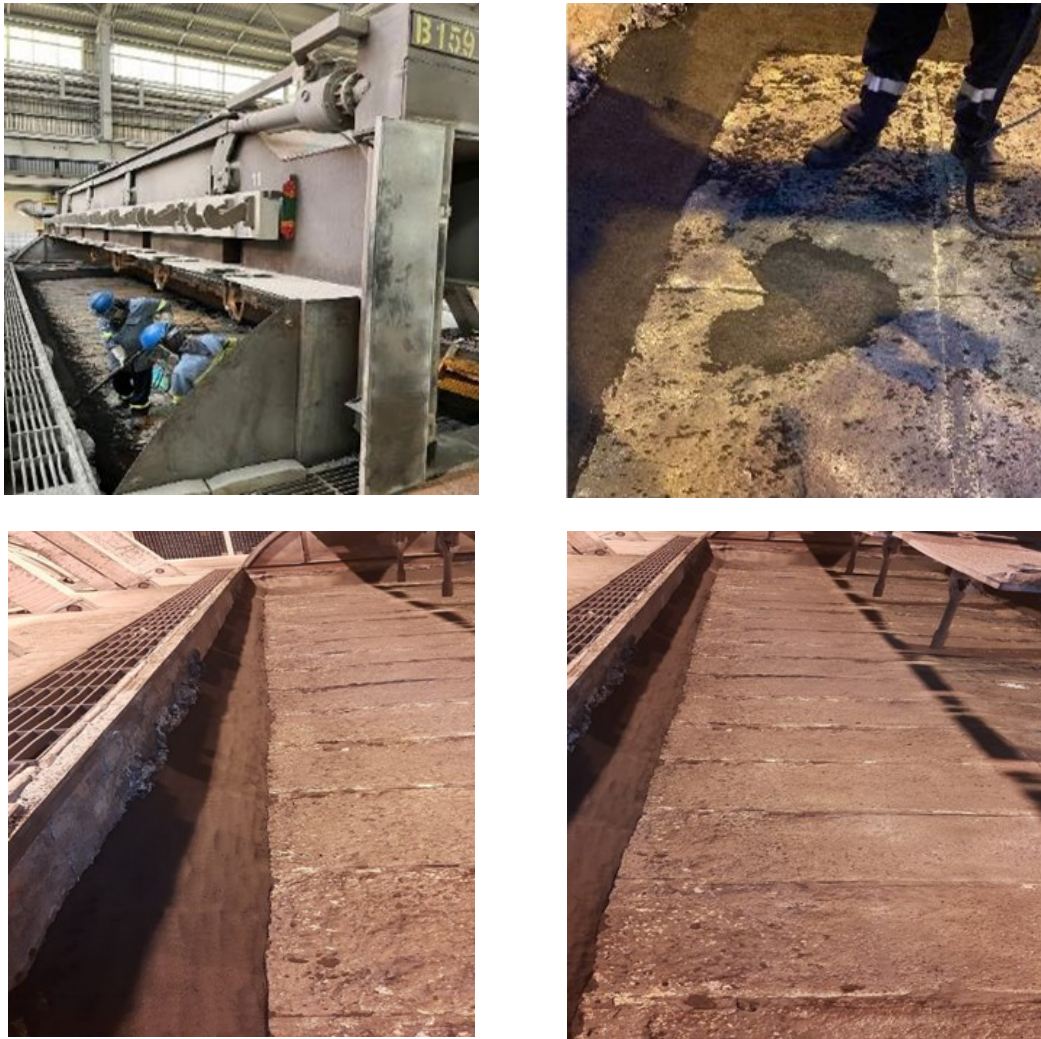
Figure 26. Sidewall and fillet ramming.

Sidewall ramming plays a vital role in ensuring the optimal performance and longevity of aluminum reduction pots. By effectively ramming the sidewalls, the pot can maintain its structural integrity, prevent sidewall erosion and enhance pot life. Sidewall ramming commenced 24 hours prior to pot preparation. Following the completion of this concluding phase, the pot was transferred to the start-up team.
