Ma'aden Reduction Potline Partial Failure Incident and Recovery

Ma'aden Aluminium Company, Ras Al-Khair, Saudi Arabia

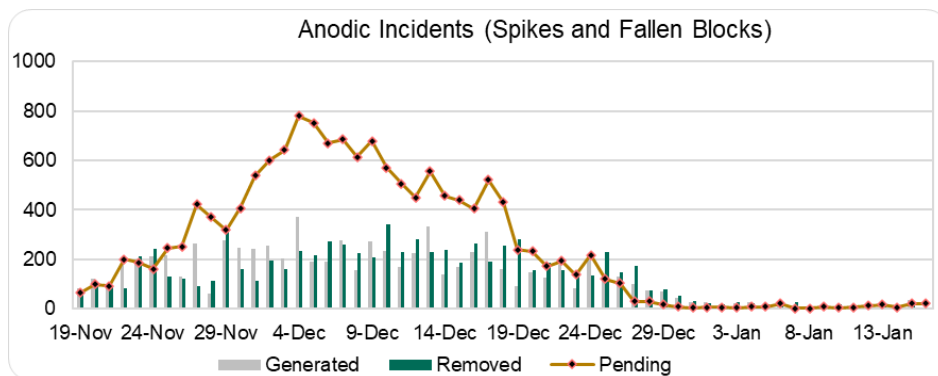
- Many pots with multiple anodic incidents, spikes and fallen blocks (Figures 1-2), put the potlines at risk of having open circuit if not removed on time.
- High number of pending unscheduled anodes, spikes and fallen blocks increased workload in equipment and manpower.
- Late work in potlines increased due to high number of anodic incidents removed.
- Number of critical pots with high silicon increased sharply in potlines with many pots with red shells and also a few pots tapped out from side shell due to high instability.

Figure 1: Trend of anodic incidents and fallen blocks.

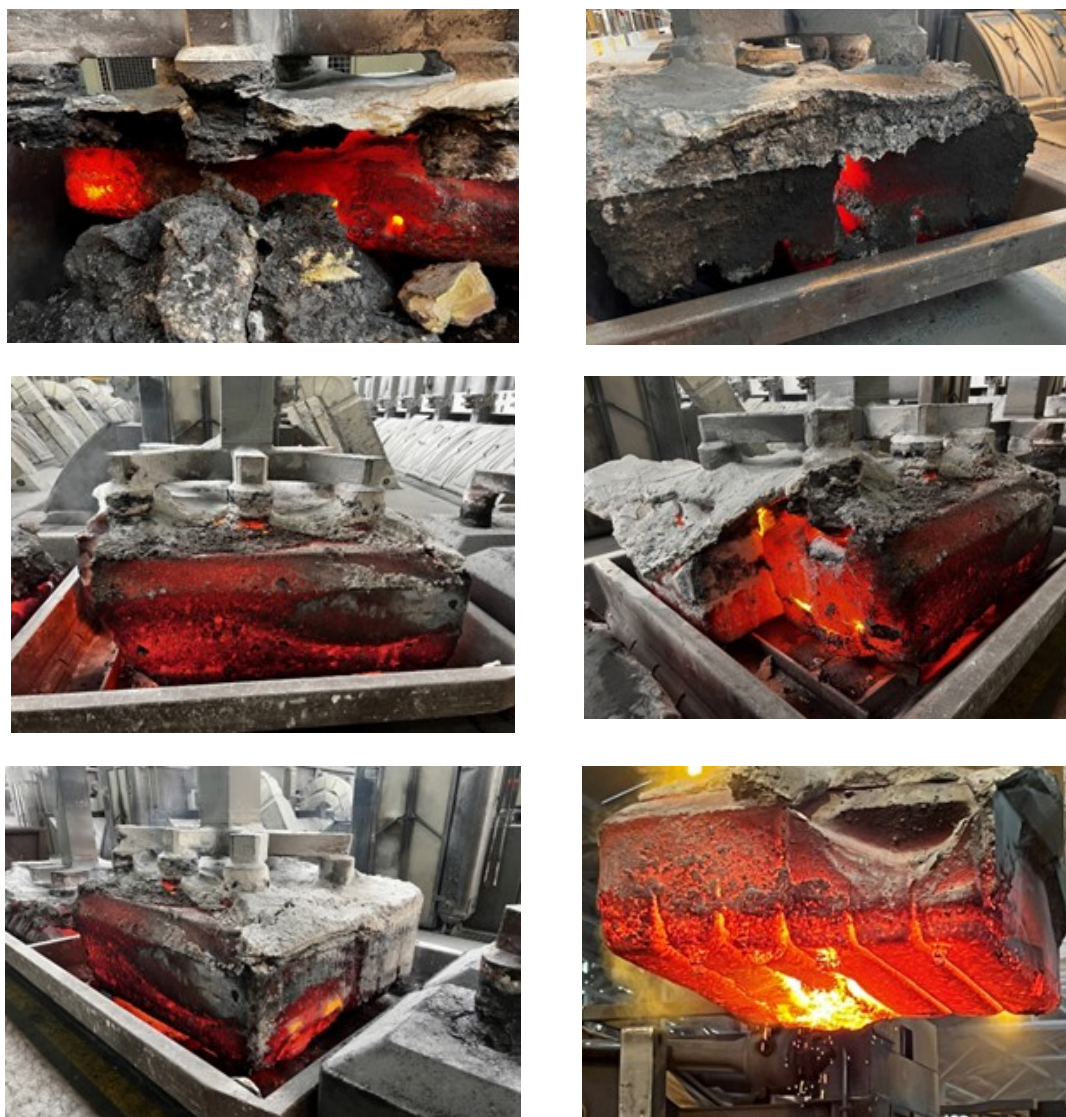
Figure 2. Type of anodic incidents and fallen blocks.
