Laterrière Smelter Experience During Low Amperage Operation Due to Rectifier Problems

Abstract

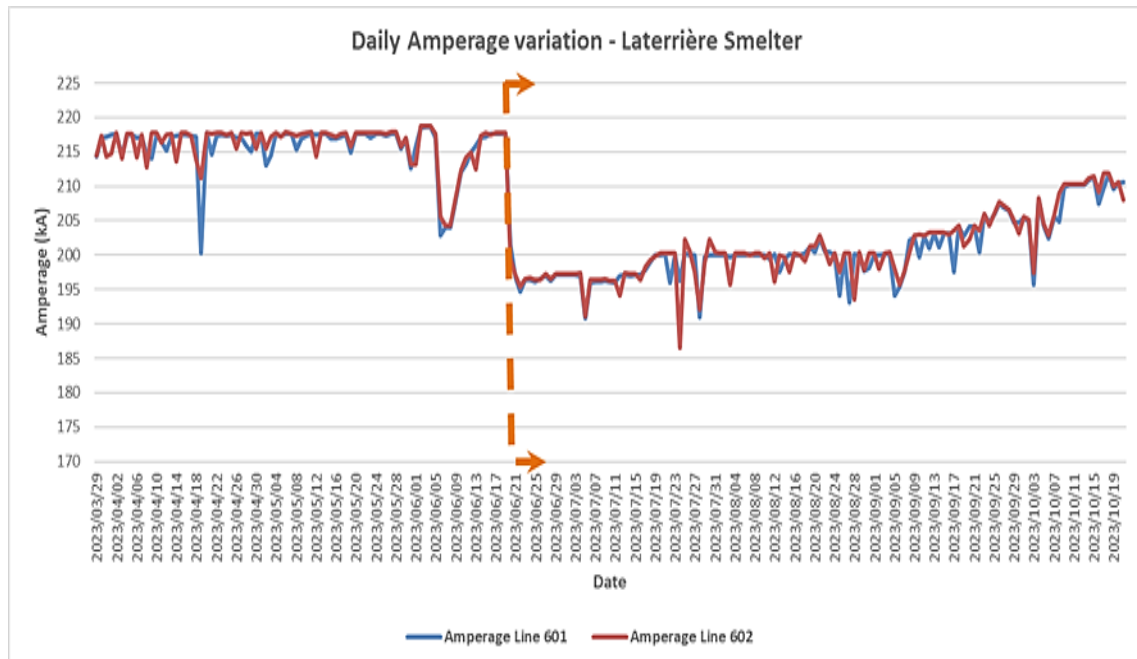
increased slowly (Figure 1) by controlling the internal temperature inside the rectifiers - which is strongly dependent on the external ambient temperature that was cooling down during that period.

Figure 1. Daily amperage of the two potlines.

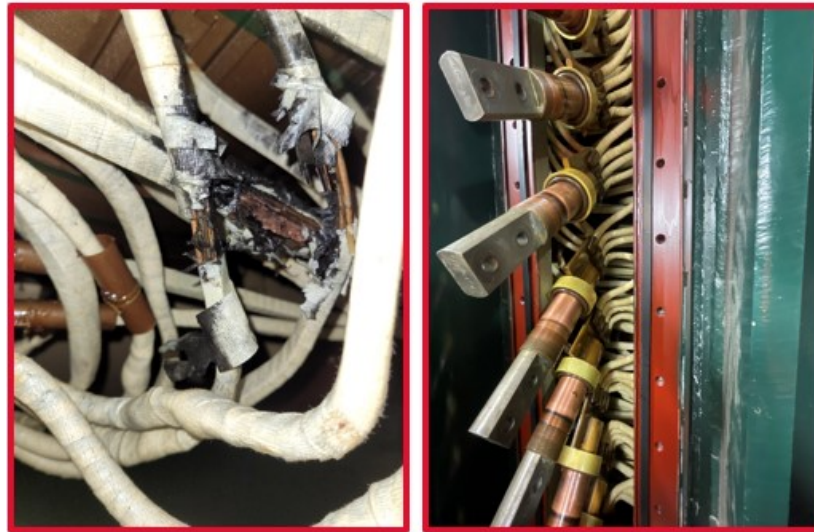
The investigation of the breakdown failures of the two rectifiers demonstrated that operation temperature inside the equipment was above the maximum recommended by the supplier. An underperforming cooling system of the units was found to be the root cause of the diode failures in the equipment (Figure 2).

Each half-rectifier has 6 wheels of 12 diodes (total 72) and the substation has 16 half-rectifiers for a total of 1152 diodes to replace. It was found during the inspection that the break-down failure of an old diode impacts the life of a new diode. The project had to improve the air circulation of the 16 half-rectifiers. The illustration of a rectifier and its 6 diodes wheels is presented in Figure 3.

Figure 2. Illustration of the type of damage found in the rectifiers due to overheating.

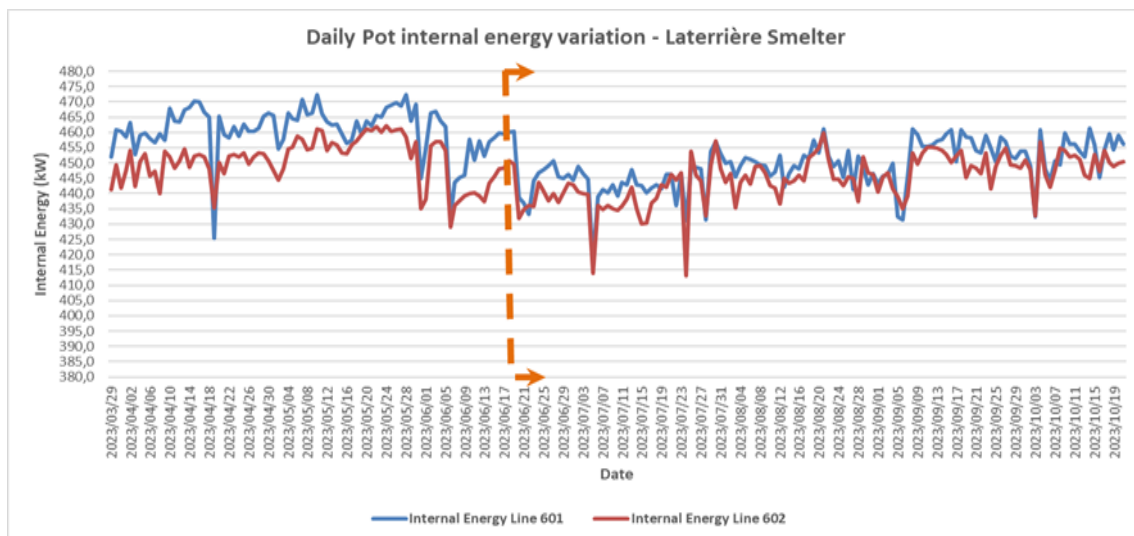
The 20 kA drop induced a decrease in the pot internal energy of 20 kW (Figure 5), even if the anode-cathode distance (ACD) was increased by 1 cm (Figure 6). Part of this energy drop is also imputed to the pot stability at higher ACD (Figure 7), generating less extra-resistance at the pot (Figure 8).

Figure 5. Daily pot internal energy (calculated at 94 % of current efficiency).

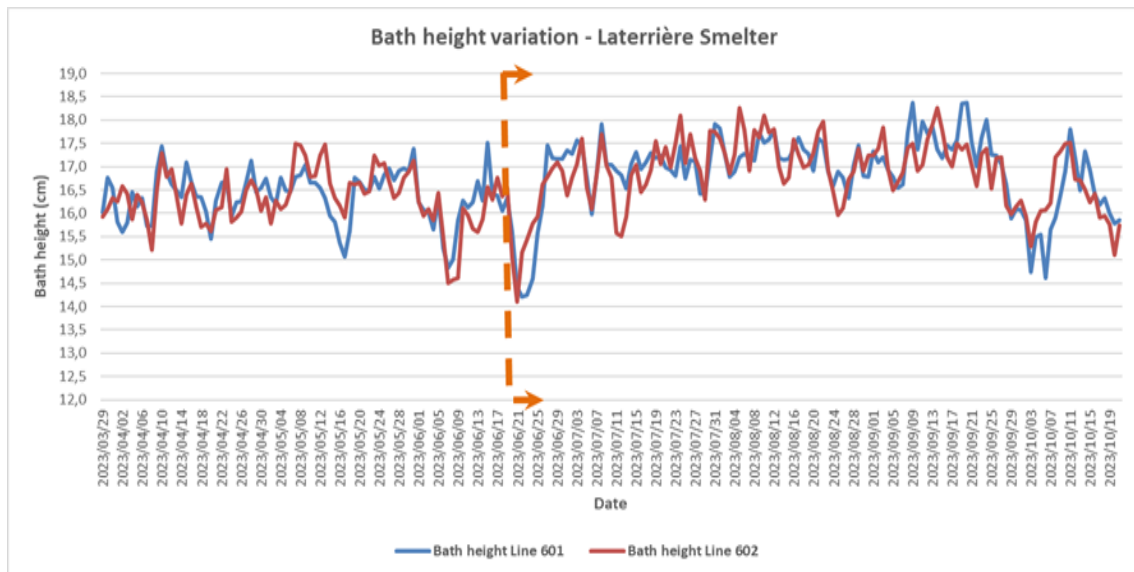
When the event occurred, and the amperage was suddenly dropped, the ACD was increased rapidly to mitigate the heat loss, which created a shortage of liquid bath (Figure 9). To mitigate this, a contingency plan was put in place (see Section 6.2). To generate rapidly liquid bath, donor pots were put in place, where a special team was generating bath to be transferred to the other pots.

Figure 9. Daily variation of the bath height.

Also, alumina content in the anode cover material was slightly decreased to dope the pot's natural bath generation. Finally, pot's bath height target was increased by 1cm to compensate the high ACD (anode immersion) and the heat balance deficit.

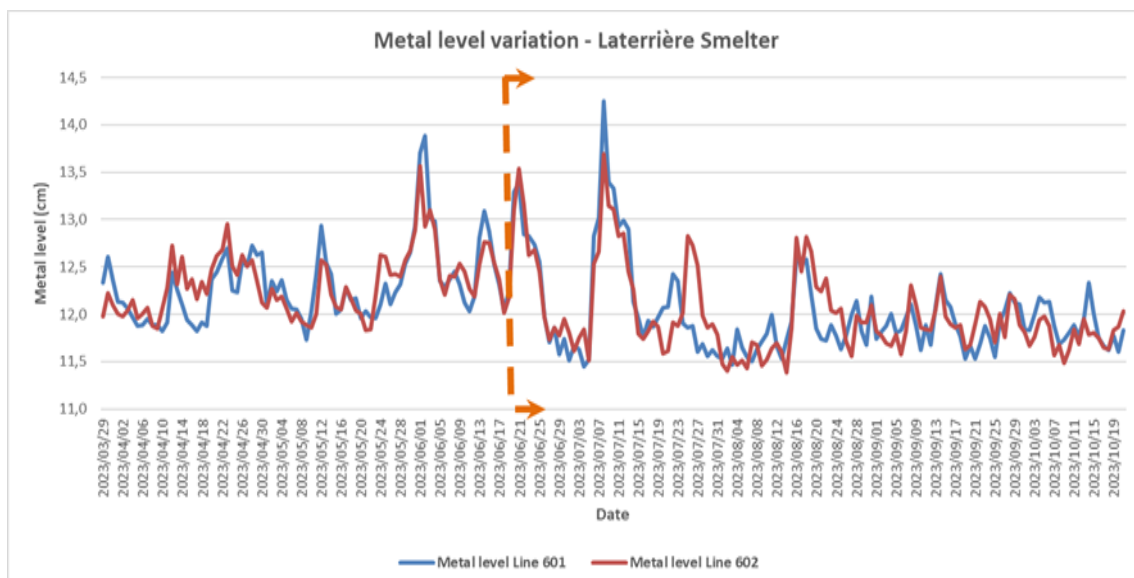
To compensate the heat balance deficit, the metal level target was decreased (Figure 10), but different events affecting actual metal level occurred during the summer. Metal flow problems coupled with crane breakdowns during the month of July put pressure on the pots for more than a week. Freeze on the cathode was the main problem observed during this period.

Figure 10. Daily variation of the metal level.

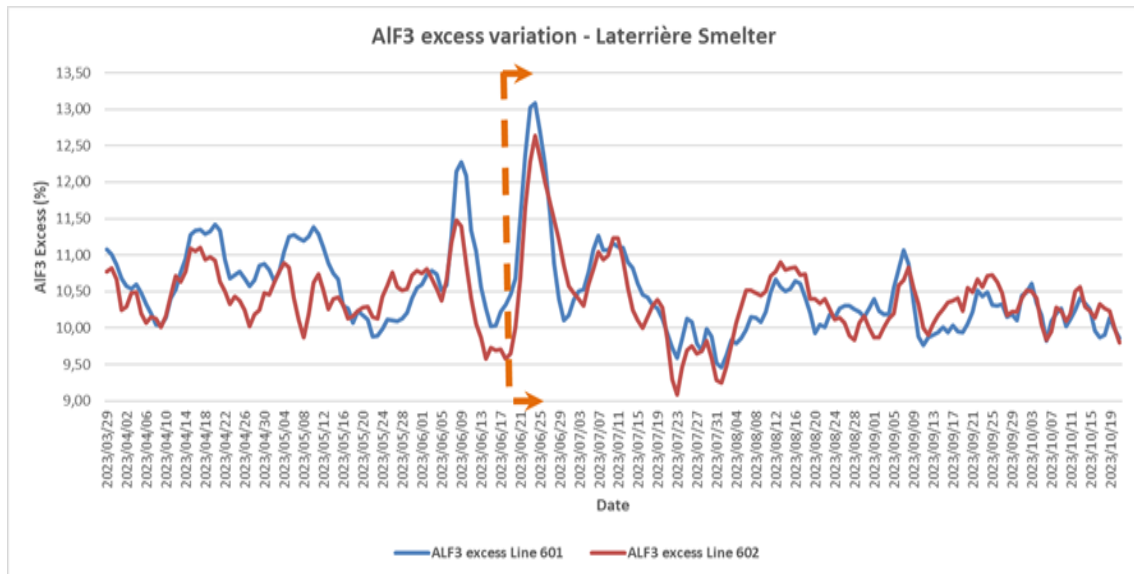
The event induced a sudden increase in the bath AlF_3 excess content (Figure 11) and standard deviation (Figure 12). This was rapidly mitigated by cutting the AlF_3 input in the fresh alumina. Sodium carbonate was also added to the pot with very high AlF_3 result which helped to lower the standard variation and generate bath.

Figure 11. Daily variation of excess AlF_3 in the pots.

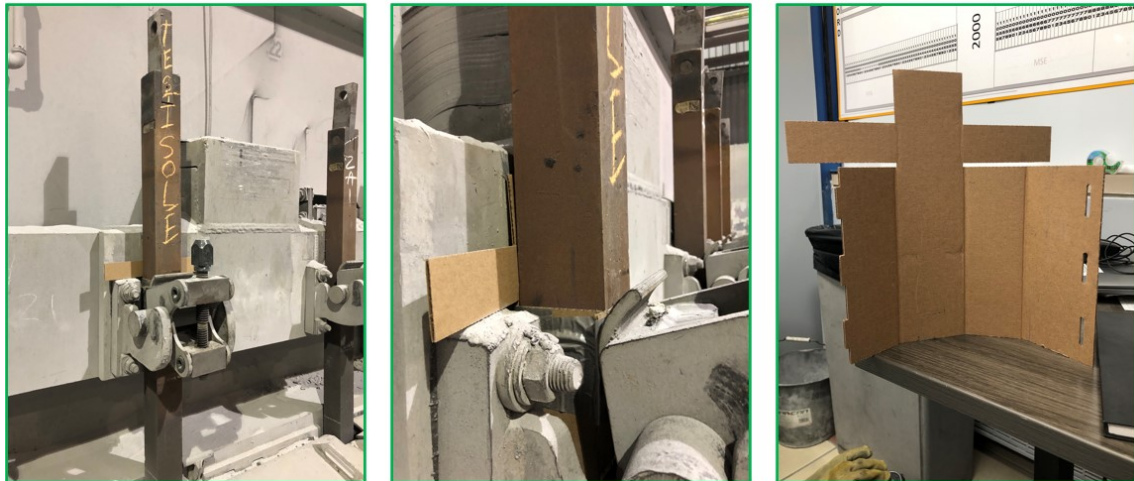
Figure 16. Anode isolation system.

This helps to lower the heat dissipation and generate heat by 20 to 35 kW (equivalent to 1.5 to 2.5 kA). To do this, many test were done with different materials and shapes. The use of a cardboard electrical insulator collar between the anode rod and the anode beam (Figure 16) was chosen.

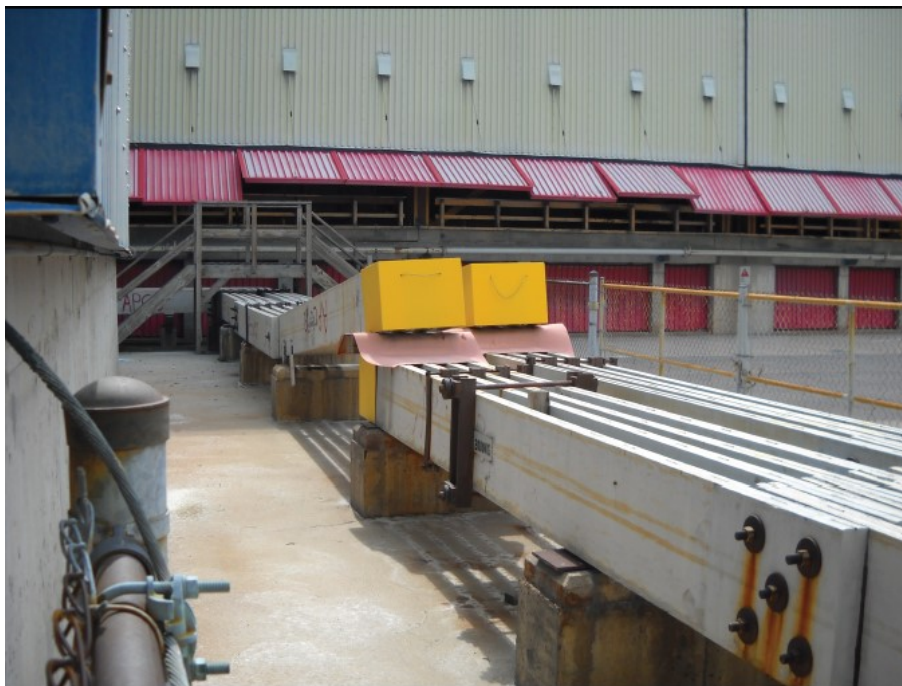
Due to the apparent fragility of the electrical substation for failures, another asset refurbished was the half-potline by-pass bridge (Figure 18).

Figure 18. Half-potline by-pass bridge.

- A complete review of the procedures; some flaws were identified for the electrical safety of the people working to install the bridge.
- A complete review of the maintenance plan and its execution as the bridge was not maintained for many years.
- Procurement of missing parts of the bridge and equipment; a special cabinet was dedicated to store the bridge parts and equipment.
- Development of a document explaining the roles and responsibilities of each employee involved.
- Testing of the motion of the moving bridge part to ensure the correct motion and the correct grabbing point for the crane to manipulate it.
- SMED (Single Minute Exchange of Dye) activity to reduce as much as possible the installation time.

The maintenance of the by-pass bridge was put back in the plant maintenance calendar and the emergency response plan was modified with all of the changes.
