## Alba Reduction Line 1 Outage and Recovery

Aluminium Bahrain, Manama, Kingdom of Bahrain

### Abstract

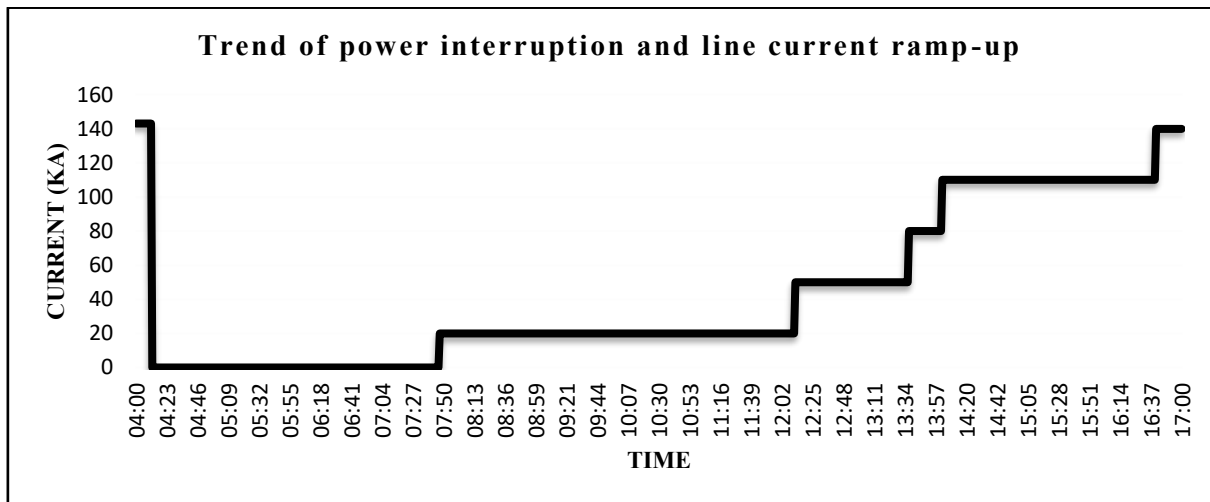
On the 13th of November 2024 at 04:12 a.m., Line-1 which is almost 55-year-old, experienced a complete power trip due to the failure of rectifier R16 which is responsible of feeding Line-1 and therefore the current has dropped from 144 to 0 kA. This marked the beginning of a prolonged power outage that lasted nearly 8 h, during which the line remained inactive.

Current restoration efforts began at 12:12 p.m., with an initial ramp-up to 50 kA. The line current was then gradually increased in a controlled, stepwise manner to avoid thermal shock and to protect the integrity of the pots. By 1:29 p.m., the current reached approximately 70 kA, followed by progressive increments throughout the afternoon. At 2:30 p.m., it reached 90 kA, and by 3:10 p.m., 100 kA. Continued ramp-up brought the current to 120 kA by 3:40PM and 130 kA by 4:15 p.m.. Full restoration to 140 kA was achieved by 4:41 p.m., successfully completing the recovery process of the line electrical current within 12.5 hours of the initial trip (Figure 1).

Figure 1. Trend of power interruption and line current ramp-up.

Figure 1. Line current profile for alba line 1 on 13 November 2024, showing the sudden outage (zero current) and the subsequent controlled ramp-up of current once power was restored. the potline remained without power for ~8 hours (04:12–12:12), after which current was gradually increased from 50 to ~134 kA over a 4-h span.

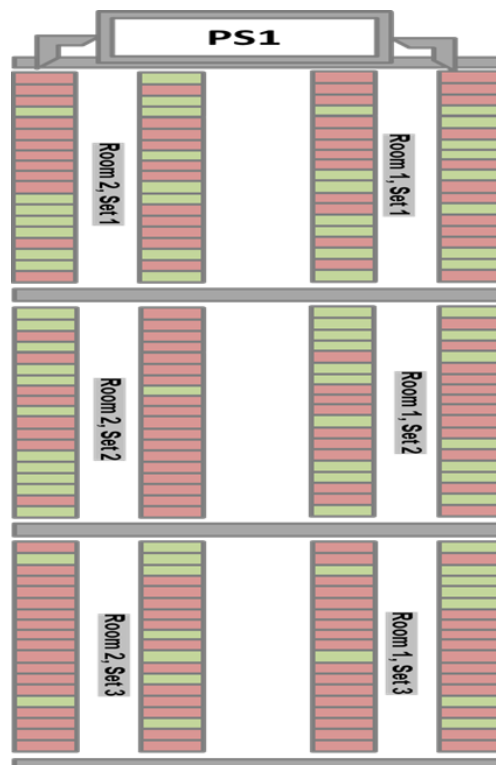
Field inspections confirmed that around 60 % of the pots in Line 1 as shown Figure 2 mapping of potline 1 had frozen due to the prolonged 8-h outage and allowed the remaining 40 % of pots to continue operational.

Figure 2. Mapping of pot line 1 (green are live and red stopped pots).

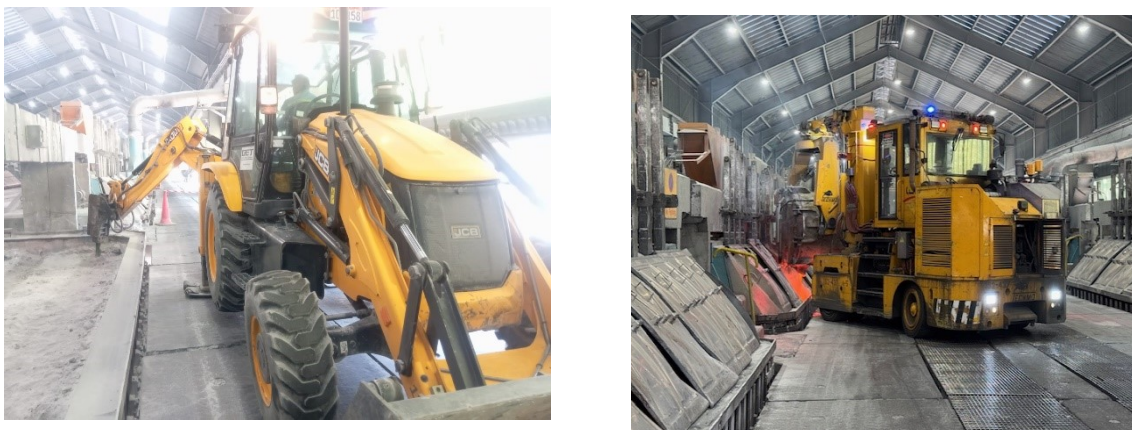
**Figure 3. Special equipment, JCB & BTV, were used to assist and contribute towards a faster recovery for dry scaling, removing anode butts.**

As a part of the quick recovery plan special equipment had to be used for removing solid bath and the immersed anodes. JCB (Figure 3) was introduced in order to ensure a faster recovery process. Moreover, specialized contractors were deployed for cathode cleaning and relining on working simultaneously in separate areas to speed up the recovery process.

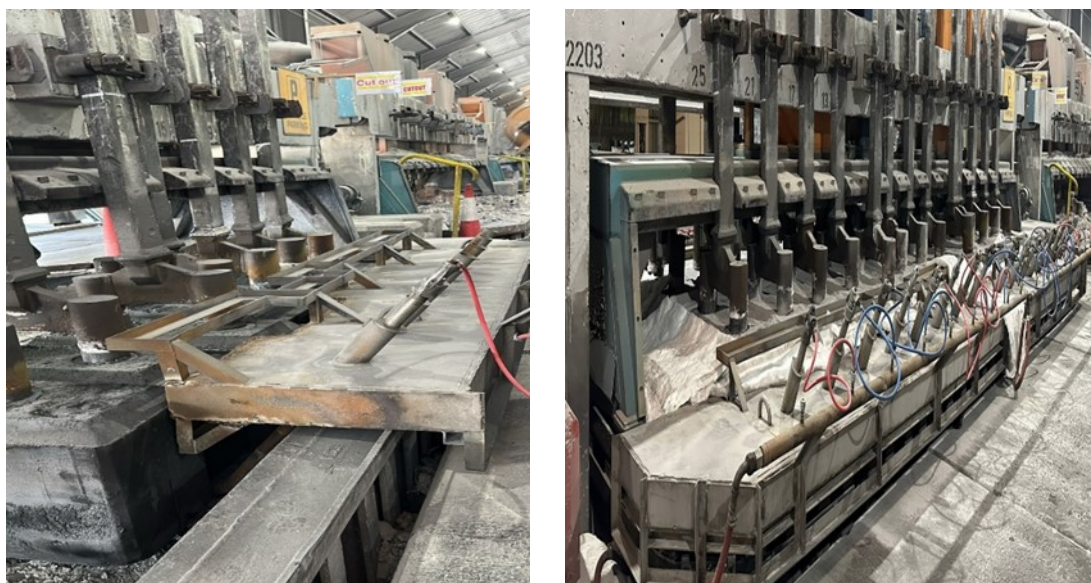
Figure 4. Introduction of gas burner for crash start method.

Prior to bath-up, the pot lining is gradually preheated over approximately 48 hours to a temperature of  $910 \pm 30$  °C using gas baking. Due to the risk of bath freezing immediately after bath pouring, it is critical to maintain the pot voltage between 7–10 V (10–12 V if the bath temperature drops below 970 °C within 2–4 h) to keep the bath in a molten state and elevate its temperature to around 985 °C. Insufficient preheating, inadequate bath quantity, or improper distribution can cause the pot voltage to spike to 25–30 V, often indicated by bright cathode or anode effects. Therefore, achieving consistent and thorough pot lining preheating, along with the addition of approximately 6 t of bath (equivalent to 2 crucibles), is essential for stable bath-up and start-up conditions. Following bath pouring, the pot voltage typically reduces automatically within 3 hours as the pot continues to heat and the frozen bath begins to melt. After covering the anodes and crust area with pure crushed bath, and then a 50:50 mixture of crushed bath and alumina, the pot voltage should be maintained at  $\geq 6.5$  V, ensuring that the bath temperature does not exceed 995 °C. Over the next two operational shifts, voltage should be gradually reduced to the range of 5.5–6.0 V, while maintaining the bath temperature within the optimal range of  $985 \pm 10$  °C. Careful voltage adjustment during this period is crucial to stabilize bath temperature within the 970–985 °C target range and to minimize thermal shock to the lining, as per pot normalization procedures. This method enhanced the recovery during this critical situation which has led to an increase in the number of pots back into operation per day.

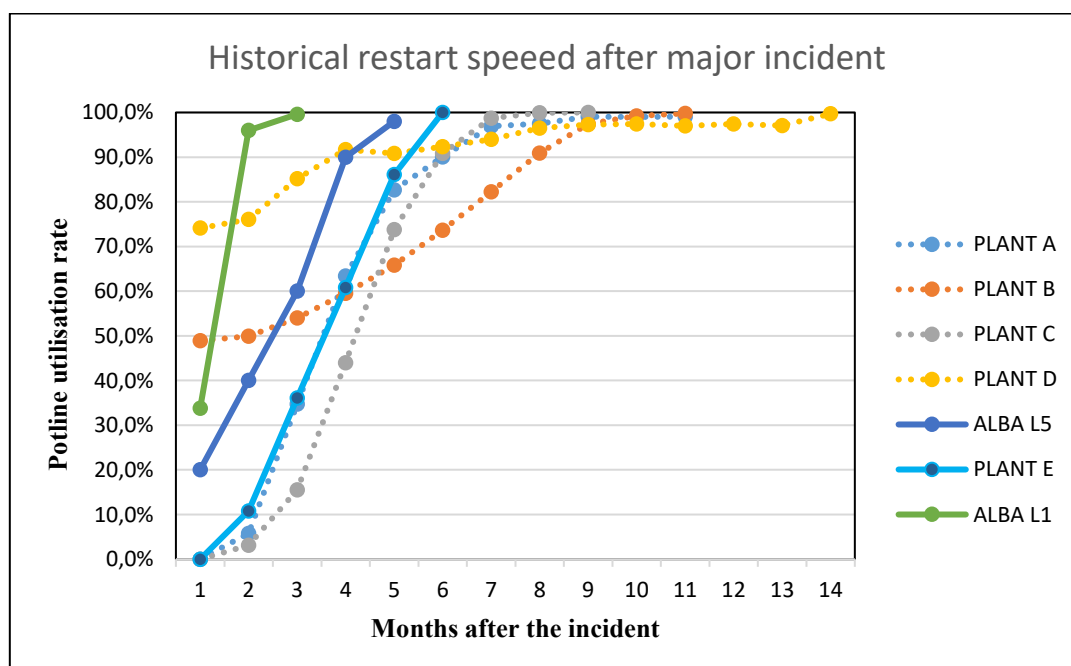
Initially, the target was to recover the full potline recovery within 120 days. However, following a strategic re-evaluation, the target was revised to 100 days. Through the implementation of enhanced start-up methodologies and process optimizations, the recovery period was further reduced to 69 days, and ultimately to 44 days – achieving full restoration of 100 % of the pots back into operation as shown in Figure 5. This remarkable performance established a new benchmark, with an average start-up rate of 3.43 pots per day, peaking at 6 pots back into operation in a single day. To ensure the stability of the restarted pots, a dedicated normalisation team was formed to focus on managing voltage stability and bath chemistry control during the critical post-start-up phase.

Figure 5. Pace of recovery speed in comparison to other smelters [1].

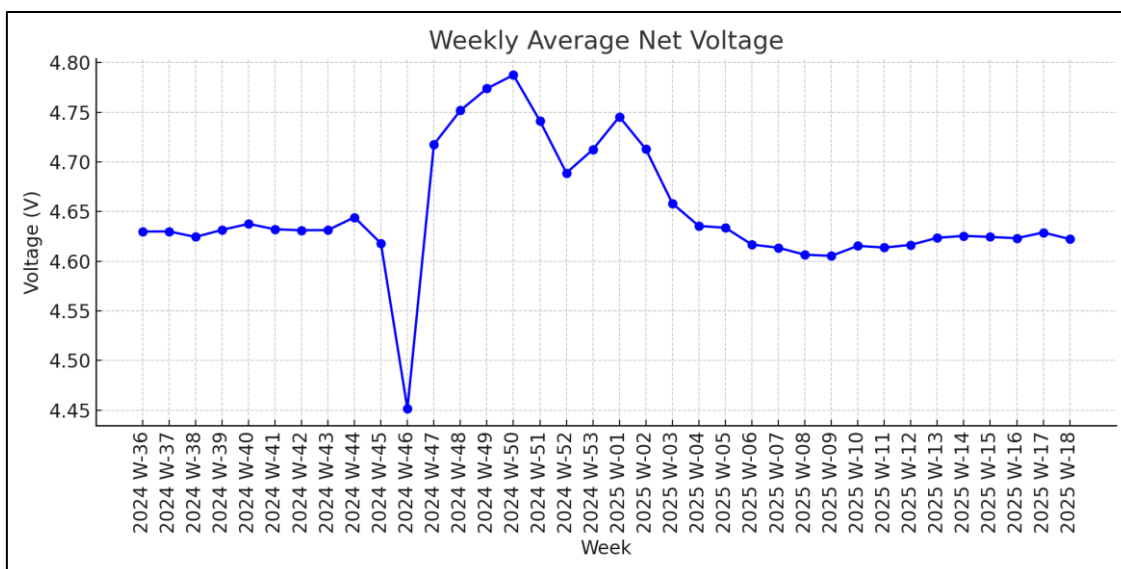
Voltage: Net voltage initially increased due to pot start-up, bath production pots and during normalization period, then gradually stabilized as pots normalized (Figure 6.)

Figure 6. Weekly average net voltage.

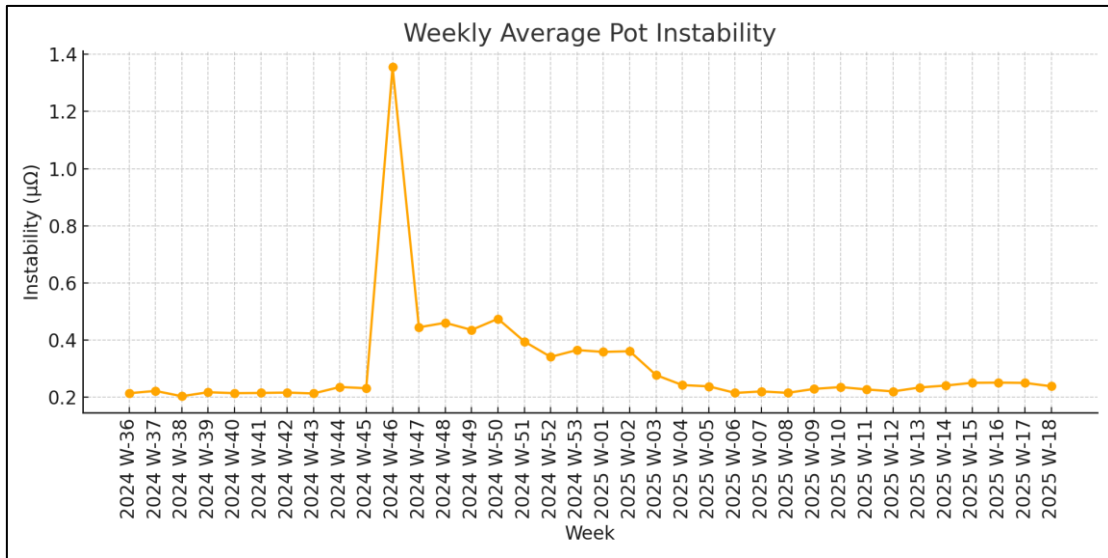
Instability: Pot instability rose sharply during the crisis and progressively decreased as pots were restarted and normalized (Figure 7).

Figure 7. Weekly average pot instability.

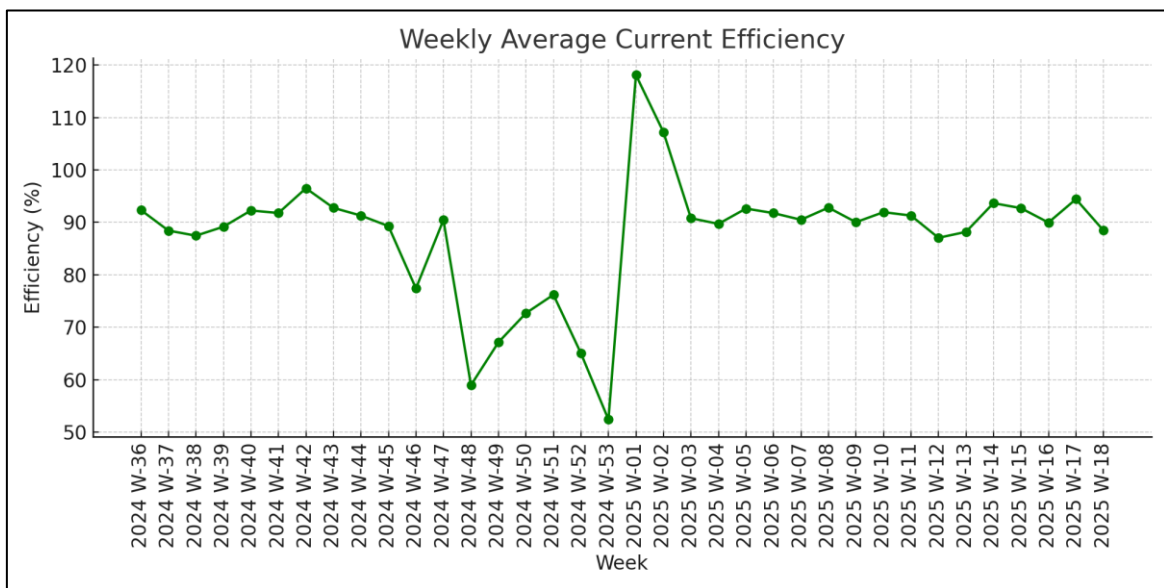
Current efficiency: Dropped during the outage, then improved steadily during the recovery phase with stabilized operations (Figure 8).

Figure 8. Weekly average current efficiency during outage.

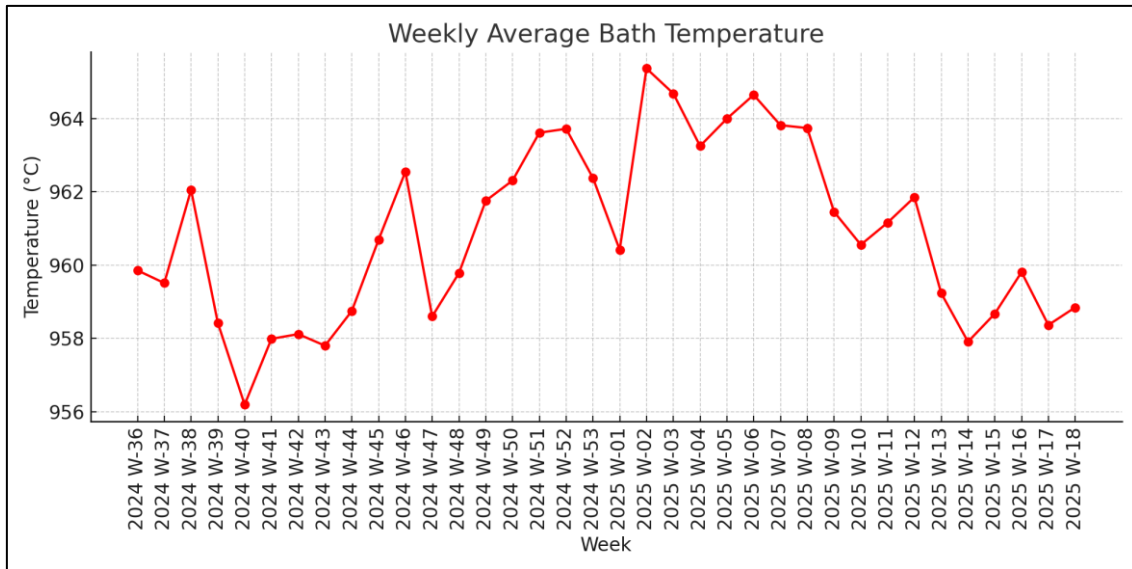
Bath Temperature: Fluctuated during the crisis but returned to target range during recovery operations (Figure 9).

Figure 9. Weekly average bath temperature.

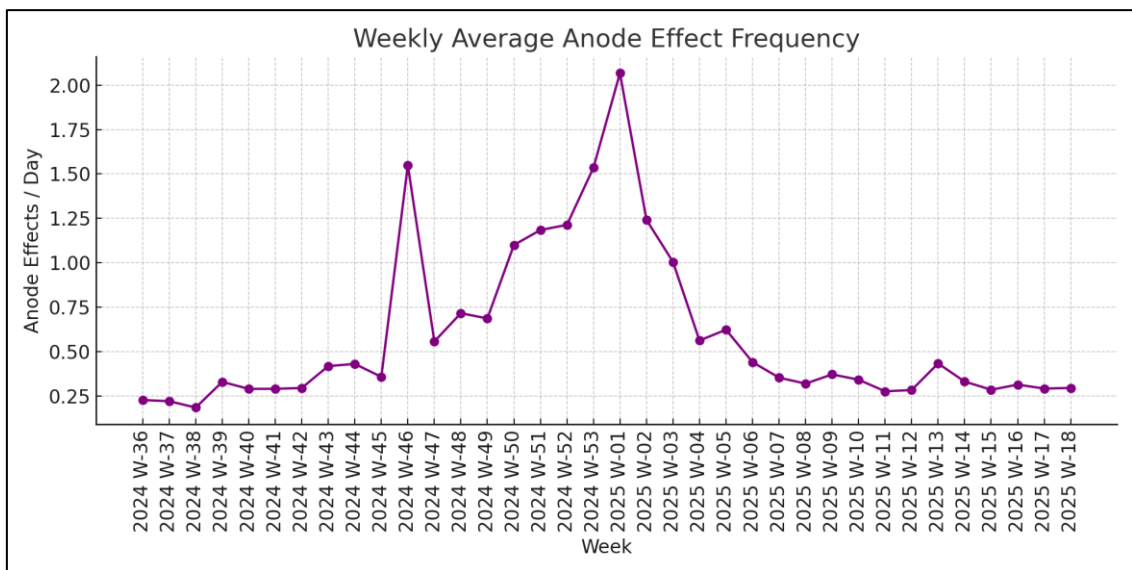
Anode effects: Increased sharply during unstable periods, then declined as line current and alumina feeding stabilized (Figure 10).

Figure 10. Weekly average anode effect.

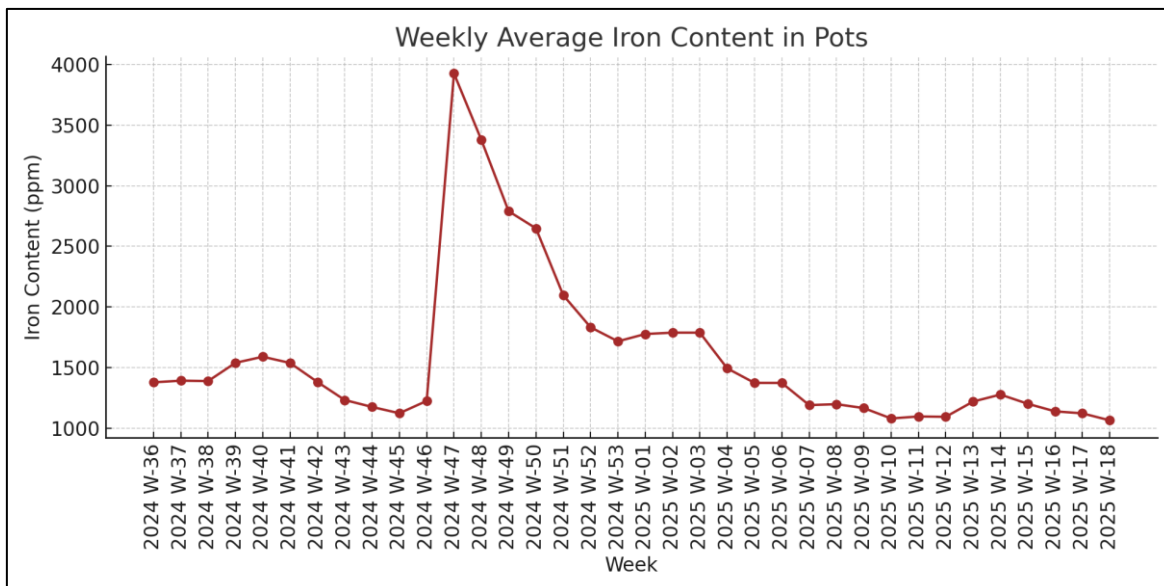
Iron content: Showed temporary fluctuations due to bath level disturbance and anodic incidents, then normalized after stable operation resumed (Figure 11).

Figure 11. Weekly average iron content in pots.

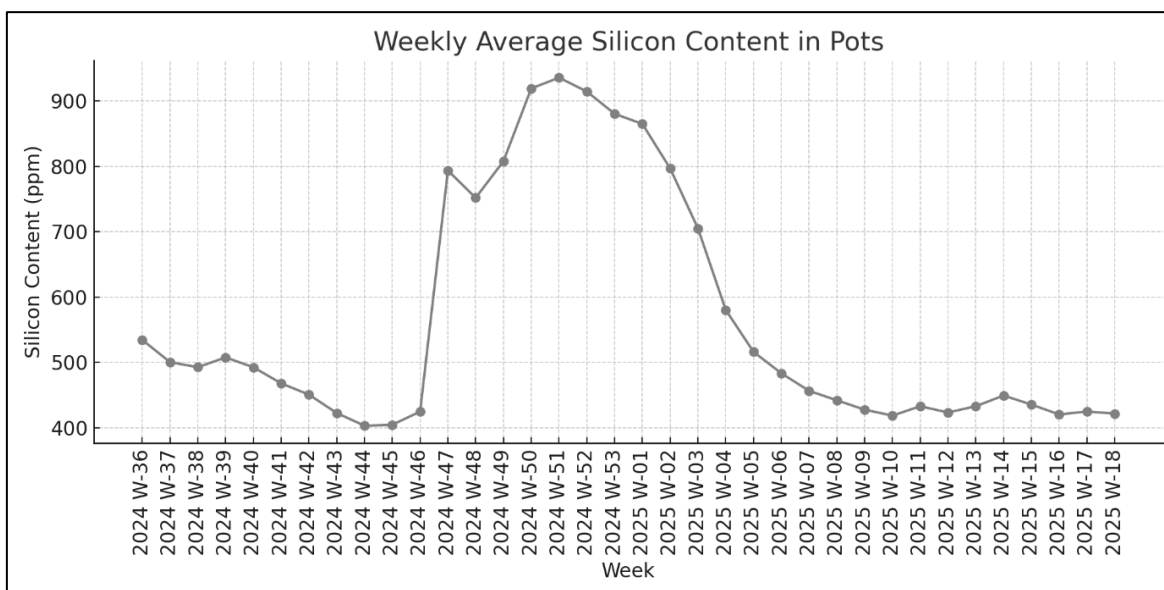
Silicon: showed an increase due to pot restart and back to normal after the recovery, showing no major contamination during the recovery process (Figure 12).

Figure 12. Weekly average silicon content in pots.
