Why Do Some Casthouses Have Catastrophic Explosions While Others Do Not?

Alex W. Lowery¹ and Liu Jin²

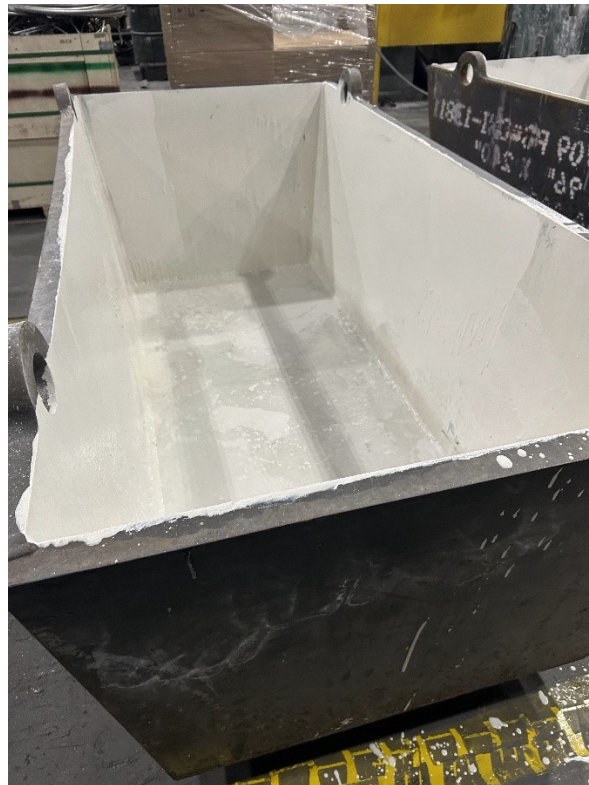
Figure 3: Wise Chem E-212-F coated drain pan.

Some companies have applied Wise Chem E-212-F or E-115 to their emergency drain pans ensuring they will be ready for use and eliminates the need to be oiled.

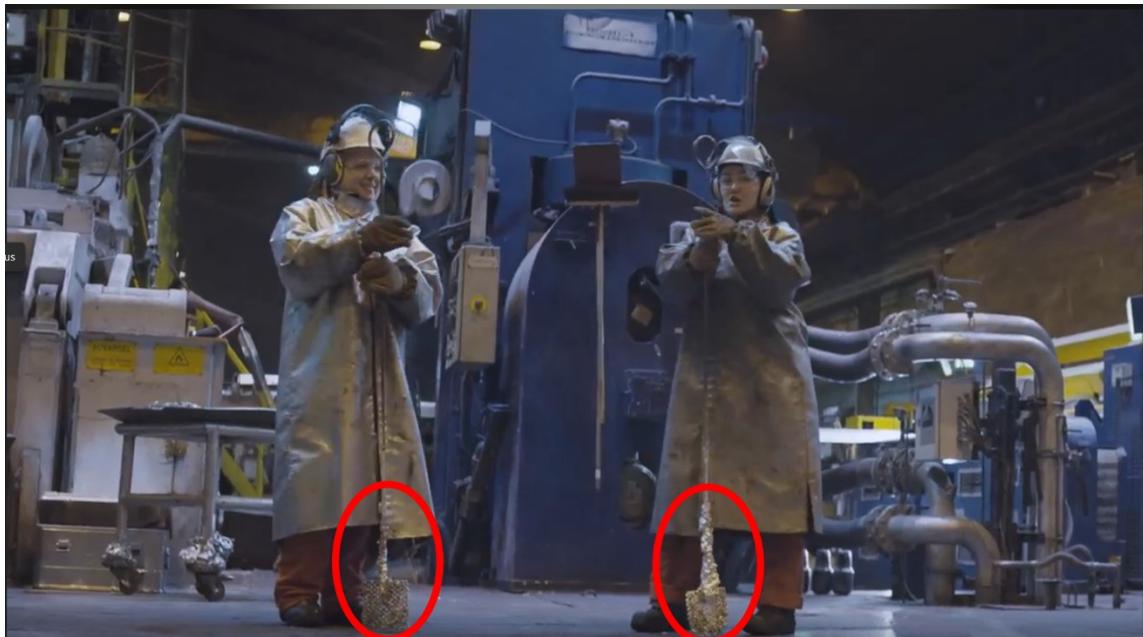
The maintenance and reapplication of approved safety coatings is required because the coating wears away after repeated molten metal contact. The bare substrate beneath the coating eventually becomes exposed with repeated exposure to molten metal. Industry backed scientific studies proved that the minimum bare area to generate an explosion on a steel or concrete substrate is 5 cm x 5 cm. Periodic maintenance of the safety coating should be completed and recoat of the casting pit every 16-20 months, and tooling every 12-16 months. These times can be reduced due to frequency and volume of molten metal contact. It is a good idea to inspect the casting pit walls after a large bleedout and repaint if necessary.

Figure 4. Hand tools covered with solidified aluminium.

Hand or furnace tools also needs to be applied and maintained regularly with specific coatings. There are a variety of coatings that can be applied to hand and furnace tools. They prevent rust from occurring or provide a physical barrier from the rust and molten metal. George Stavnes,

Global Products Manager of Pyrotek states “we only recommend alkaline or neutral pH coatings which will not create flash rusting (although neutral may create some cosmetic flash rust spots).” Please note that all tools regardless of have been coated or not need to be preheated before being used in molten metal to drive off any surface moisture.

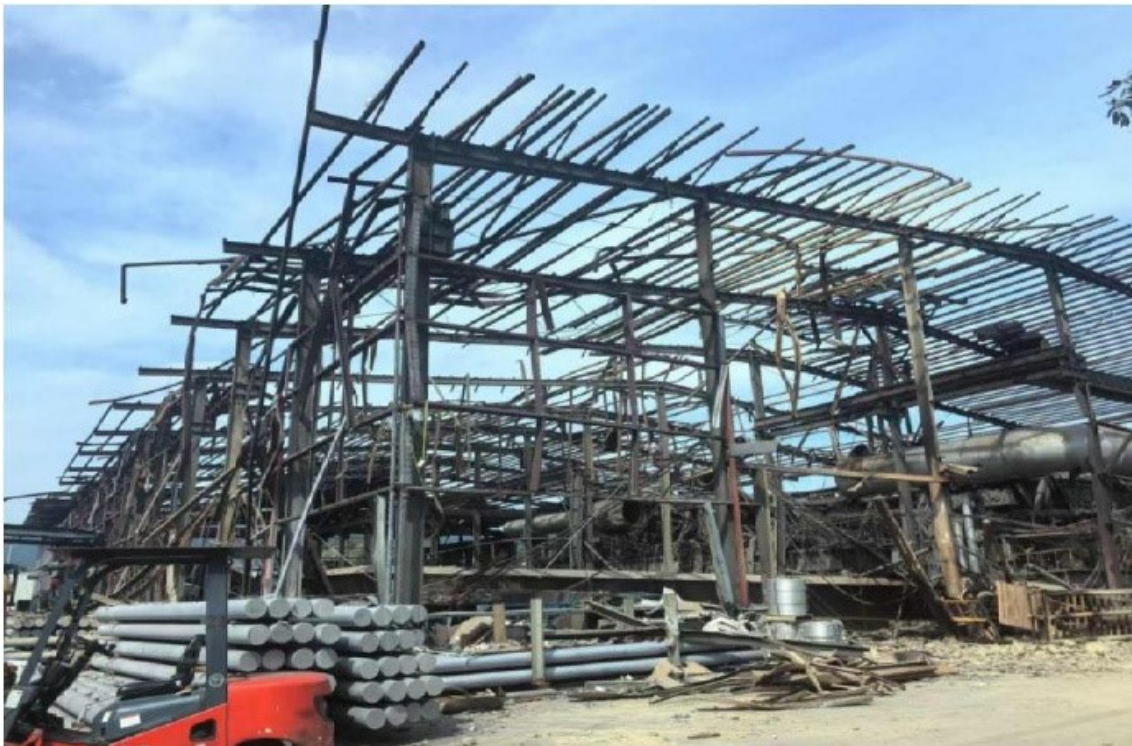
Figure 5. July 9, 2024 Fujian Province explosion.

An explosion occurred in Fujian Province at a 30 000-tonne aluminium company. Two workers were killed, and one was injured (Hongwei, 2024 [7]). The explosion occurred around 16:00 on the afternoon of July 9. The No. 2 deep well with 32 billets with a diameter of 227 mm were being cast. The subsequent investigation aided by video camera was able to determine what occurred just prior to the explosion.

The report cites one deceased workers’ actions as the main reason for the explosion occurring. The worker “adjusted the flow rate of the aluminum liquid through the flow channel gate three times, causing the liquid level to fluctuate and the cooling intensity to be uneven. As a result, the aluminum liquid in the crystallizer was pulled out before it was completely crystallized, resulting in aluminum leakage.” The longest ingot length is 6570 mm and the shortest is 6480 mm, with a length difference of 90 mm.

Though the investigative report states clearly the actions and inactions of the workers that resulted in a bleed out, the report fails to discuss why the explosion occurred. The explosion resulted with molten metal pouring into the casting well for over one minute. The molten metal must have come into contact with bare steel, concrete, or stainless-steel substrate resulting in an explosion. The molten metal has also come into contact with a coating that was not approved by the Aluminum Association (USA) for the prevention of molten metal explosions.

Though that statement may read controversial. It should be noted that bleedouts occur routinely without a molten metal explosion of severity. In this incident “all three casting wells were cracked and the equipment was completely damaged.” The difference between this workplace and other workplaces is the proper use and maintenance of Wise Chem safety coatings.

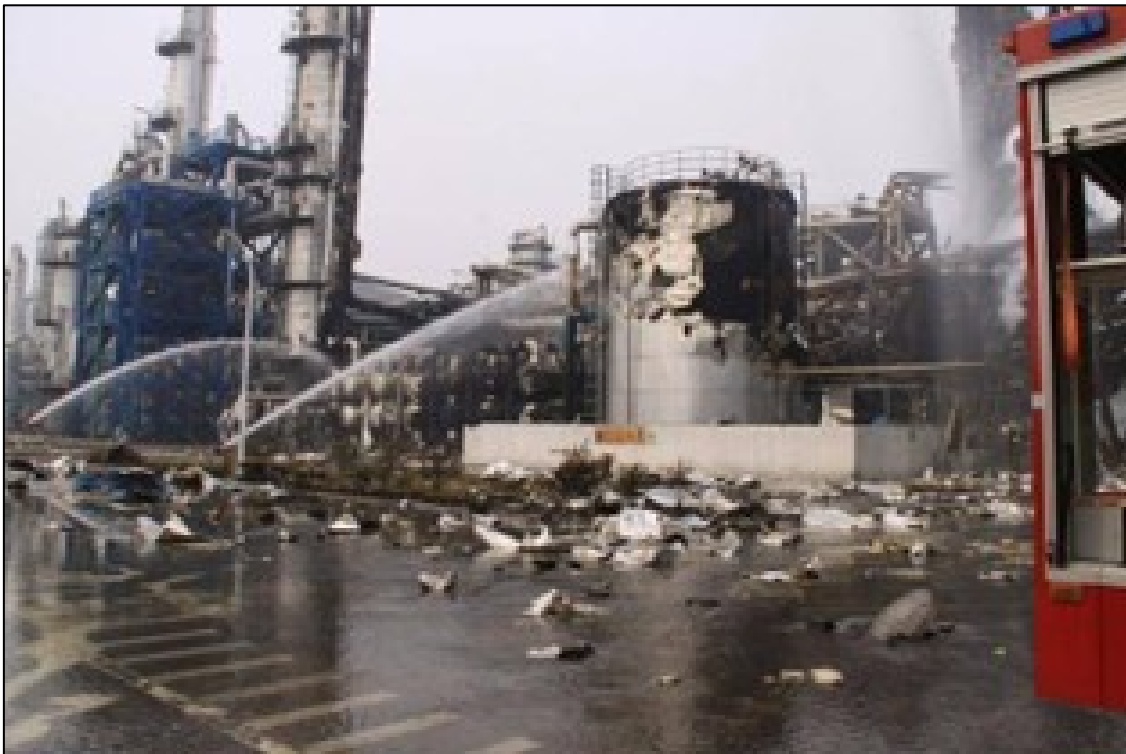
The explosion occurred around 16:30 on the afternoon of July 26, at the #B deep well 32 billets with a diameter of 203 mm were being cast. The subsequent investigation does not state if video camera footage was used to determine what occurred just prior to the explosion.

Figure 5. July 26, 2024 Henan Province explosion.

On August 8, 2024, samples of the broken wire rope were taken for inspection, and the results showed: “As the aluminum rod is cast, its length and weight increase, and the wire rope on the southwest side may (have been) stressed. Broken wires or strands appear at the concentrated point and eventually (broke). After the break, other wire ropes suddenly bear too much weight. The remaining three wire ropes broke while they were stretched straight. The weight exceeds the actual weight that the wire rope can bear but is lower than the breaking force of the wire rope.”

The investigative report concluded “The direct cause (of the explosion) is that the steel wire rope used in the accident casting well contains sulfide inclusions, which reduces the steel wire rope (capacity). An energy spectrum analysis showed “the sulfur content in the inclusions of the steel wire matrix as 2.2%”.

Regardless, the investigative report incorrectly lists the failure of the southwest corner rope as the “direct cause” of the explosion. The failure of the steel wire rope did not cause the explosion. It was a contributing factor in the explosion. The investigative report fails to explain and explore why the explosion occurred. The report states when the steel wire rope failed it caused “the aluminum rod to separate from the crystallizer and a large amount of aluminum liquid on the mold plate instantly poured into the casting. In the well, a large amount of hydrogen and heat were generated in the narrow and limited space of the casting well, causing an explosion.” Though the statement “hydrogen and heat were generated...causing an explosion” is correct and represented in the chemical equation below. The statement fails to address why the chemical Equation (1) occurred.

As previously explained, explosions occur when molten aluminium and water interact on a bare substrate of steel, concrete or stainless steel. Explosions can also occur when molten metal interacts with water on nonapproved Aluminum Association (USA) safety pit coating. That is the direct cause of this explosion when molten metal interacted with water on a bare substrate or with a non- approved safety pit coating. It was not the failure of the steel wire rope.
