Operational Excellence in Rodding Plant - A Path to Control Sodium in Anode Butts

Mohammad AlShaibani¹ and Zobida Farzanah²

2. General Superintendent - Process Control, Carbon and Port
Emirates Global Aluminium, Abu Dhabi, United Arab Emirates

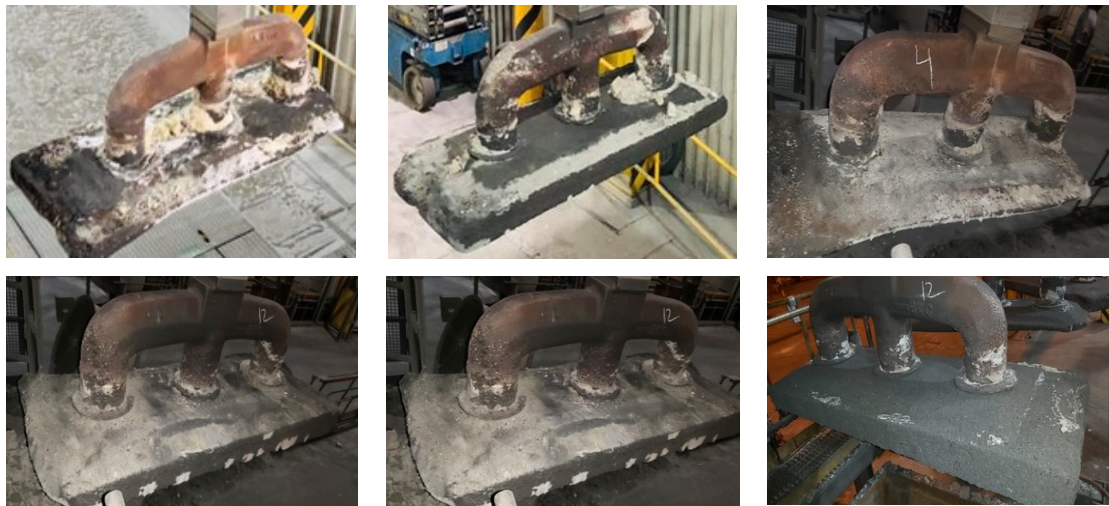
The images in Figure 2 illustrate the condition of the 50 % of butts that failed to meet quality standards despite undergoing cleaning process. These butts retained excessive bath residues, with sodium (Na) content exceeding the 600 ppm limit which indicate the inconsistencies in the current cleaning process and the need for operational improvements to enhance cleaning efficiency and product quality.

Figure 2. Images of butts with bath presence after cleaning.

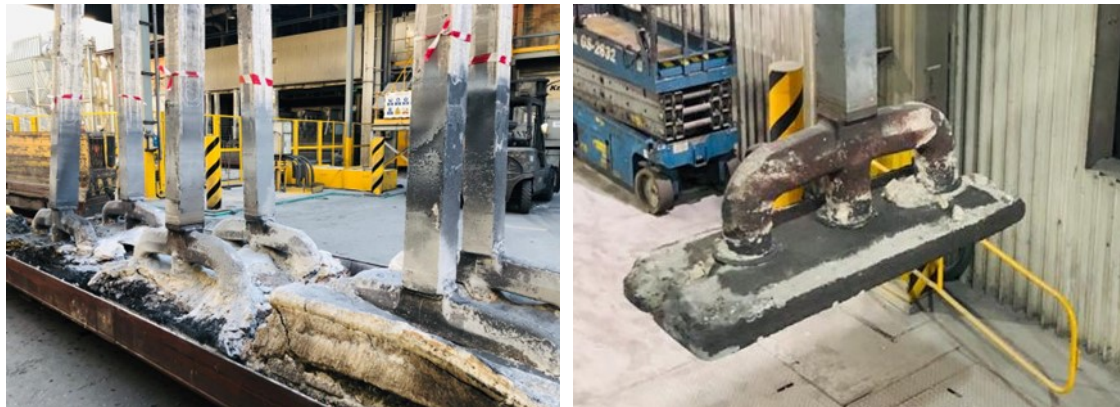
Prior to the primary cleaning stage at the Hot Bath Removal (HBR) facility, as shown in Figure 5, butts were inspected to assess their initial condition. The HBR process consists of three sequential cleaning steps: hammering, chain flailing, and air blowing. Observations revealed that significant bath residue remained adhered to the butt surfaces following this stage, as presented in Figure 6.

Butt condition before HBR

Butt condition after HBR

Figure 6. Butt condition before and after HBR.

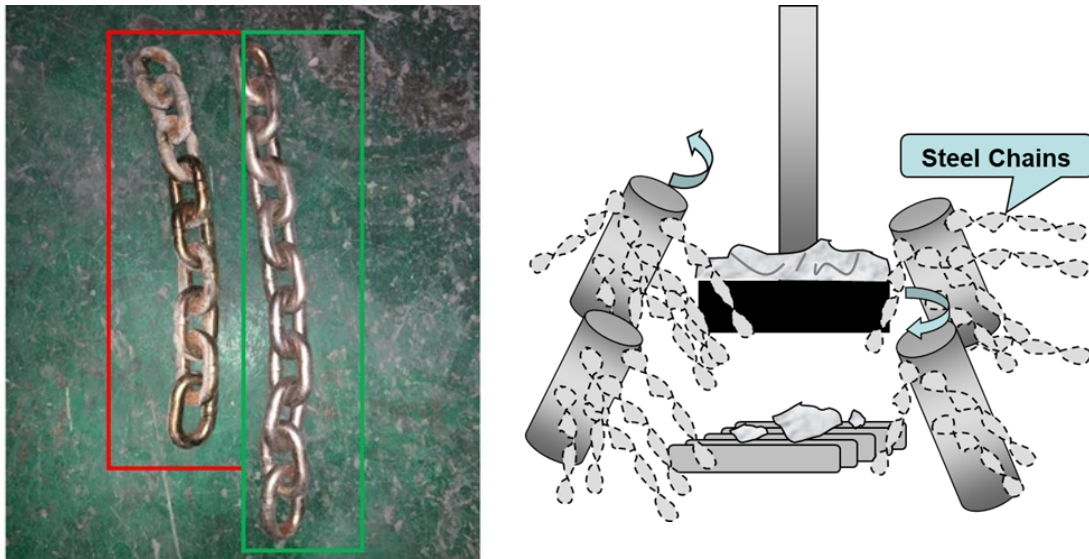
The persistence of fine, thin bath residues on the butt surfaces at the exit of the HBR facility indicated that the chain flail process (Figure 7) may not have been functioning at optimal effectiveness. This observation necessitated a comprehensive assessment of the chain flail mechanical condition and operational performance. To validate this hypothesis, an experimental trial was conducted in which a butt was fully coated with paint and processed through the HBR system. This method allowed for the identification of areas where the chain flails failed to make effective contact with the butt surface. The results confirmed that certain surface regions remained untouched, and it was determined that increasing the chain link length was required to improve coverage and enhance the overall cleaning efficiency as presented in Figure 8.

Figure 7. Chain flail process.

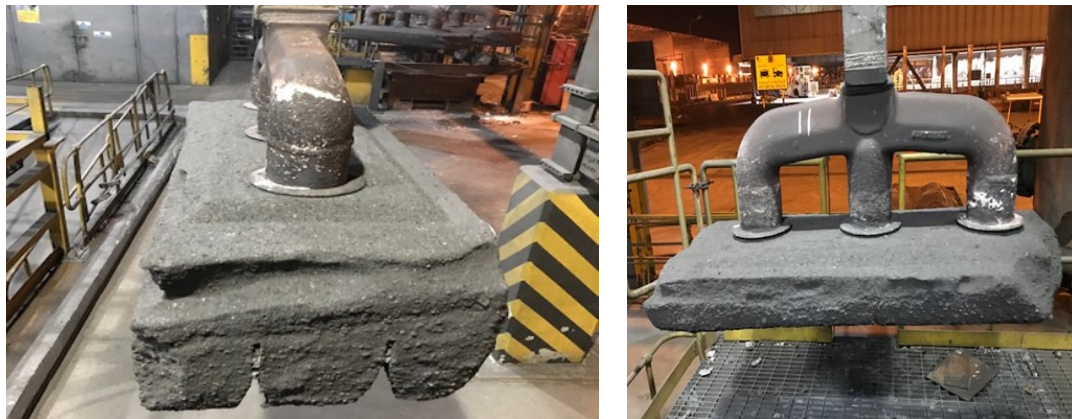
Figure 8. Butt condition after chain flail modification.

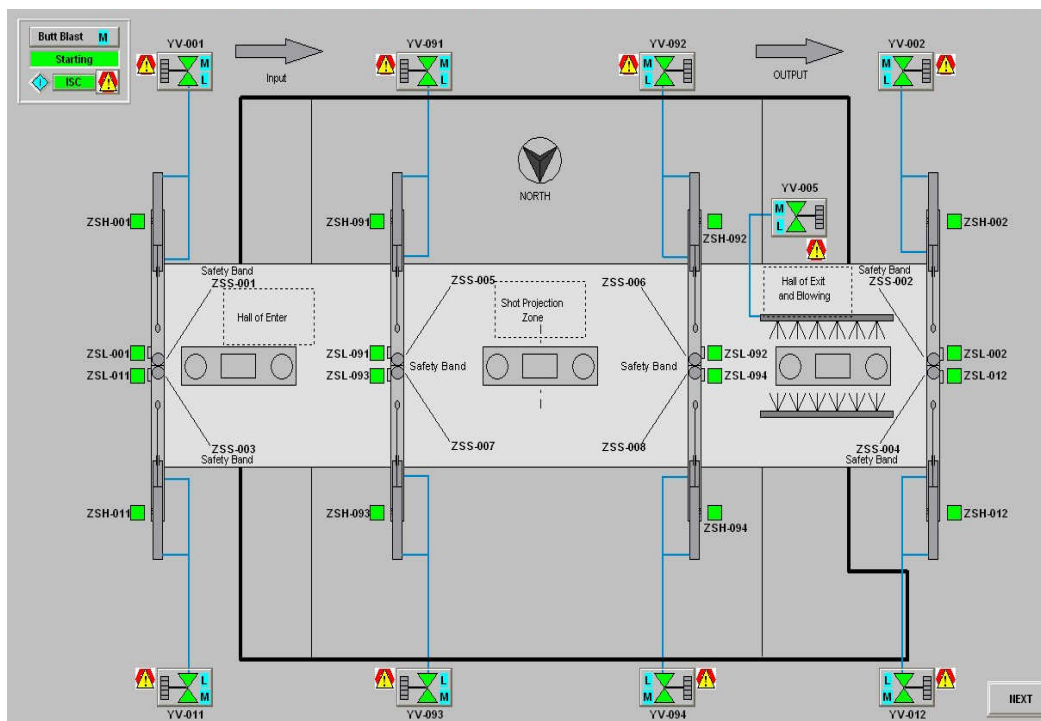
- As the level of steel shots in the hopper decreased, the system lacked an automatic alarm mechanism to alert the shopfloor team. This oversight resulted in suboptimal blasting performance and poor butt surface cleaning at the machine's exit stage.
- It was also observed that, during operation, some of the six blasting wheels were not consistently operating under the required load, further affecting cleaning effectiveness.
- Additionally, a fine layer of bath dust continued to adhere to the butt surfaces even after passing through the blower stage.

Figure 10. A steel-shot low-level alarm interlock was integrated into the system.

1. A **steel shot low-level alarm interlock** was integrated into the system. This interlock notifies the shopfloor team when the hopper level falls below the defined minimum threshold (refer to Figure 10).
2. The **indexer cycle time** was increased from 45 seconds to 53 seconds per cycle to enhance the cleaning exposure and effectiveness (refer to Figure 11).
3. **Additional air blowing nozzles** were installed within the exit chamber of the Butt Shot Blasting Machine to improve the removal of residual bath dust from the butt surfaces (refer to Figure 12).

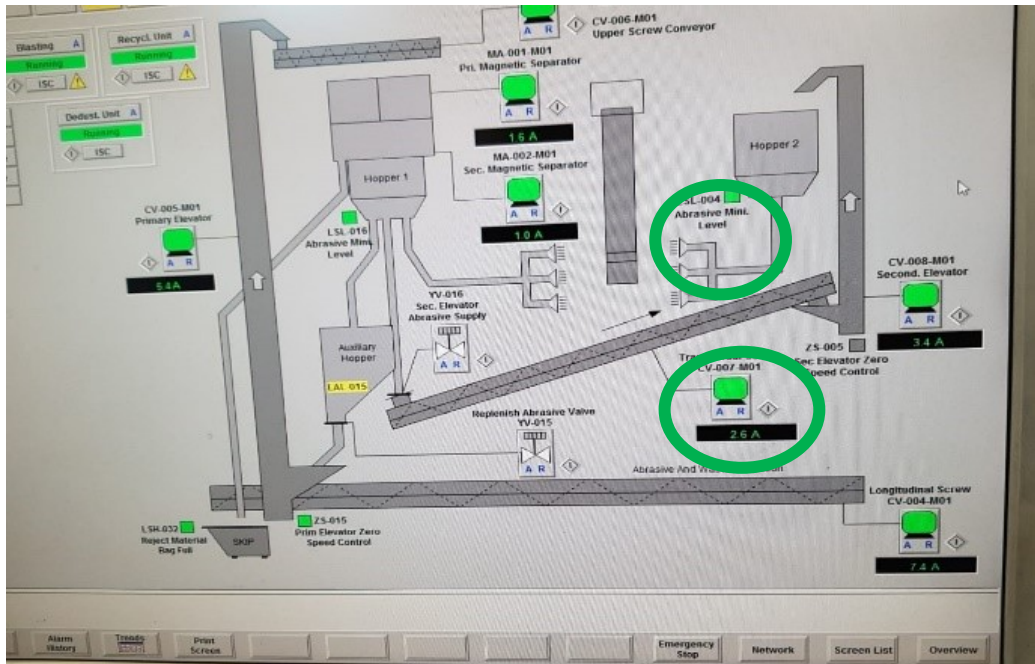
Figure 11. The indexer cycle time was increased.

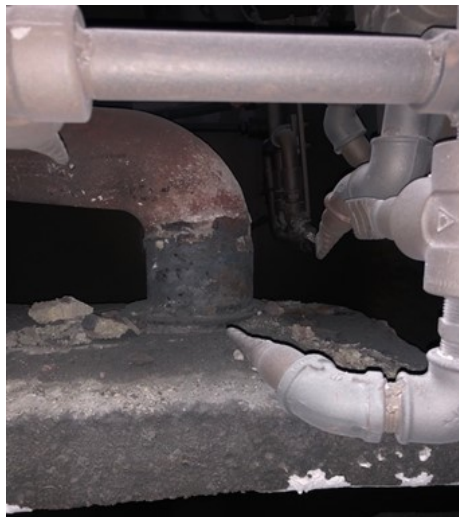
Figure 12. Additional air-blowing nozzles for removal of residuals.

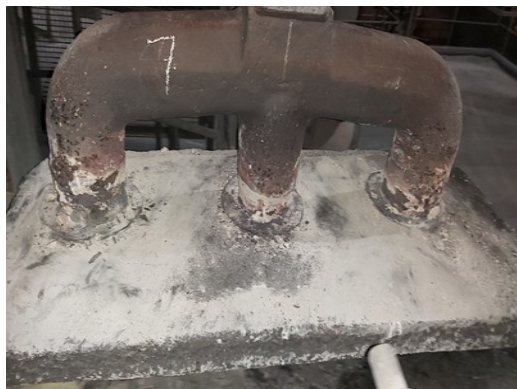
Before

Figure 13. Removing of residuals by additional air-blowing nozzles.
