Laterrière Smelter Experience During Low Amperage Operation Due to Rectifier Problems

Patrice Desrosiers¹, Patricia Gagnon², Kathlyn Bouchard³ and Jean-François Bilodeau⁴

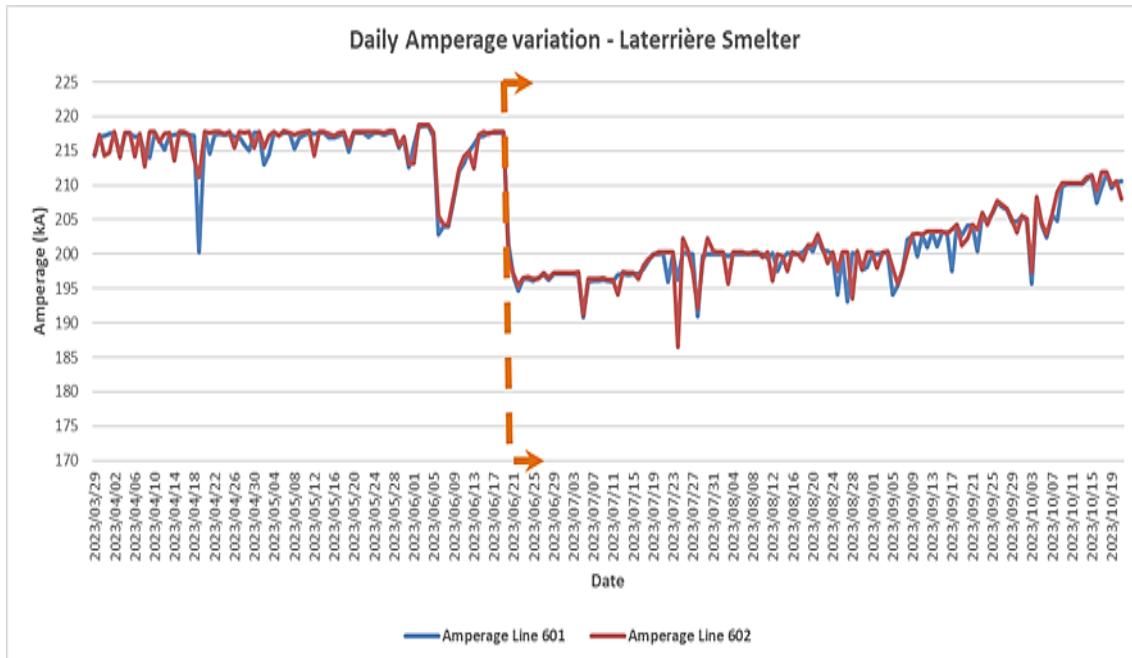
increased slowly (Figure 1) by controlling the internal temperature inside the rectifiers - which is strongly dependent on the external ambient temperature that was cooling down during that period.

Figure 1. Daily amperage of the two potlines.
