## Enhancement of Filter Bag Life in EGA's GTC

**Abdulrahman Flamarzi<sup>1</sup>, Mohamad Abdulghafor<sup>2</sup>, Auhood Al Jasmi<sup>3</sup>  
and Bharat Gadilkar<sup>4</sup>**

Emirates Global Aluminium, Abu Dhabi, United Arab Emirates

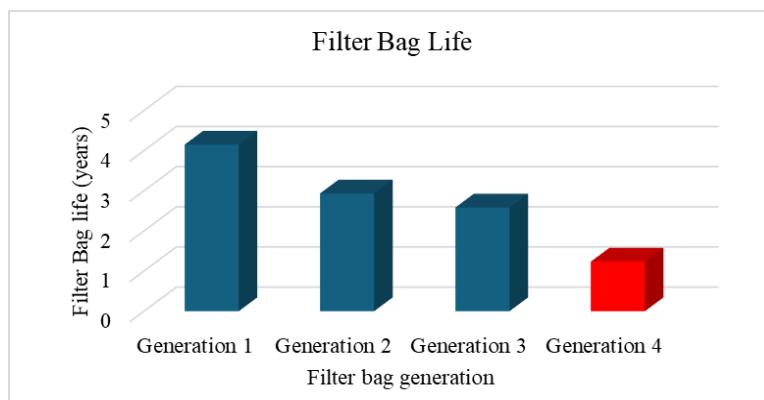
The filtration bags within a Gas Treatment Centre (GTC) are crucial for the abatement of particulate matter and HF emissions derived from aluminium reduction processes. At Al Taweelah, six GTC units equipped with 116 000 filter bags, with a filtration surface of 283 000  $\text{m}^2$ , have recently encountered premature degradation, reducing their operational lifespan from an anticipated 2.5–3 years to less than one year as shown in Figure 1. This increased maintenance expenditures and operational interruptions, thereby posing significant challenges to operational efficiency, financial stewardship and adherence to environmental regulations.

**Figure 1. Graphs representing bag lifespan deterioration.**

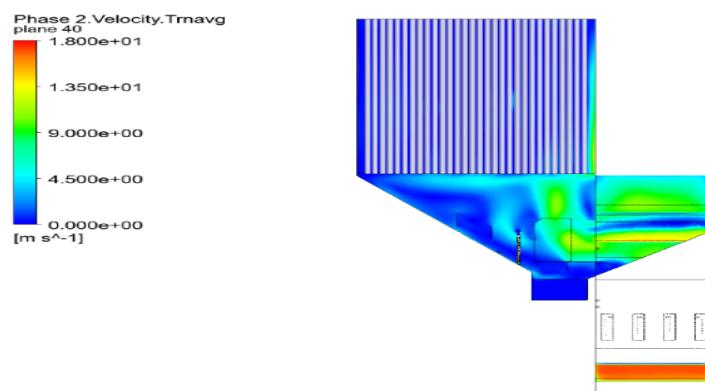
Due to localised damage observed in the filter compartment, EGA validated the gas flow patterns in both the design and current condition (Figure 2). To investigate the causes of uneven gas flow, factors such as scale formation, alumina and gas deflector conditions, alumina distribution and gas flow behaviour were reviewed. The finding was that there was a lot of scaling on the gas deflector which could contribute to interrupt the gas flow profile and cause uneven gas distribution, causing localised stress on certain filter bags and reducing their lifespan. Moreover, it was investigated if the OEM designed the compartments have some zones with higher velocity compared to other zones.

Figure 2. Simulated gas flow velocity.
