INTERNATIONAL COMMITTEE FOR STUDY OF BAUXITE, ALUMINA AND ALUMINIUM ICSOBA NEWSLETTER

Volume 7 – June 2012

1. Introduction

The red mud pond dam failure at Ajka (Hungary) and subsequent developments

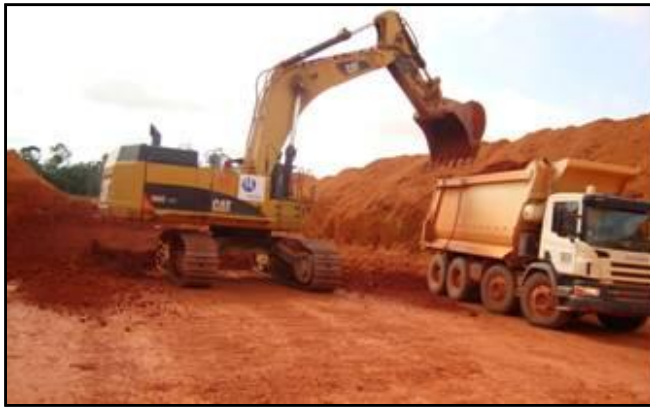
Fig 2 –Loading of ore by a hydraulic excavator

In MPSA, ore mining is carried out by the open pit method, in accordance with the strip mining method, determined by the long-term planning team in the design phase of the project, mainly based on the morphology of the mineral body. The mined ore loading is accomplished by hydraulic excavators.

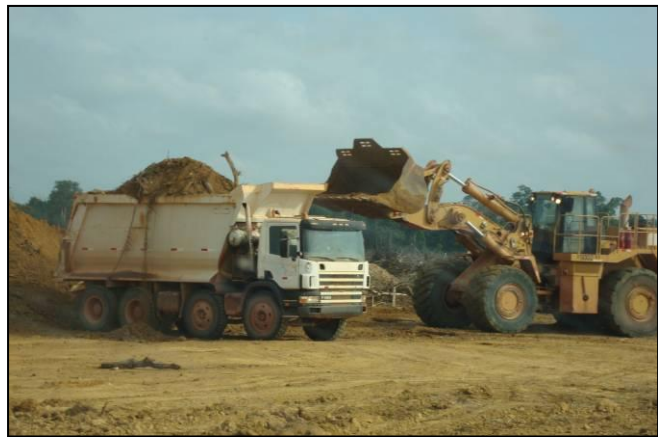
Fig 3 – Detail of the loading of ore by CAT 988H wheel loader

CAT 988H wheel loaders were used essentially as support equipment for mining infrastructure activities – moving stacks of ore and topsoil supplies, formation of protection plots, etc.

Changes in the mining operational scenario, caused by the world economic crisis of 2009 with market downturn and related lower production levels, and also a series of corrective maintenance occurrences caused a decline in the DF (Physical Availability) of mining hydraulic excavators and hence the CAT 988H fleet started to be used as production equipment.

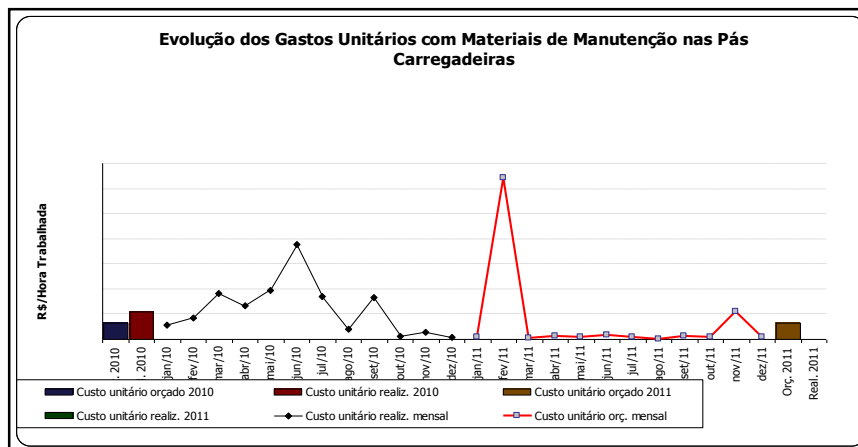
Fig 7 – Chart of costs with Maintenance Materials over time

The overall goal was to obtain adherence to the 2011 budget. So, the goal would be to reduce costs of maintenance materials of wheel loaders up to December 2011.

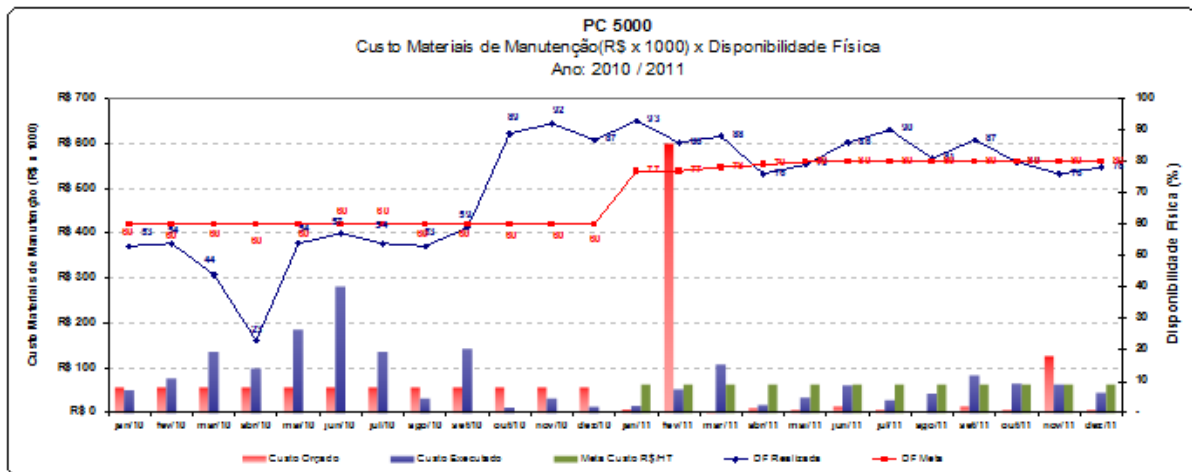
Fig 17 – Chart of Maintenance Materials Cost x Physical Availability

Although several actions taken by the maintenance personnel were effective (preventive maintenance routine itself, for example), the cost cutting project has contributed to the increased physical availability (DF) of the fleet of loaders. The graph of Fig. 17 illustrated the effect on the fleet DF.

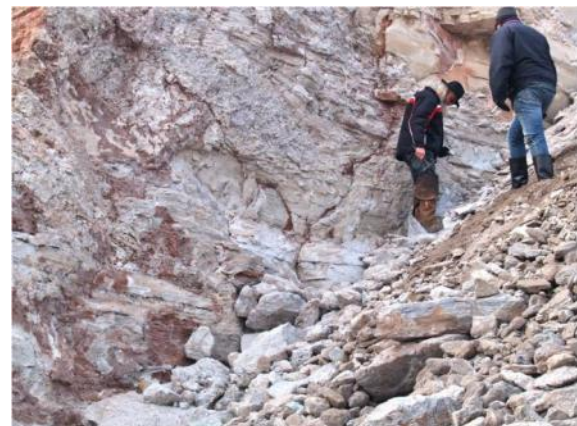
Fig. 6 Western wall having removed the fresh surface of the break. Open fissures with dislocations of a size of dm [10]

It can be concluded that the material of the dam is highly variable, with sacks of sand and clay. The clay can react with the caustic content of the liquid phase being stored in the red mud pond, however this reaction is slow [11]. Debris from an earlier construction stage can also be detected. All of these negatively affect the integrity of the dam material.

- The material of the dam is largely heterogeneous both in horizontal and vertical directions and this facilitated the formation of fractures.
- The dam was not properly sealed, an inner water sealing wall was not applied

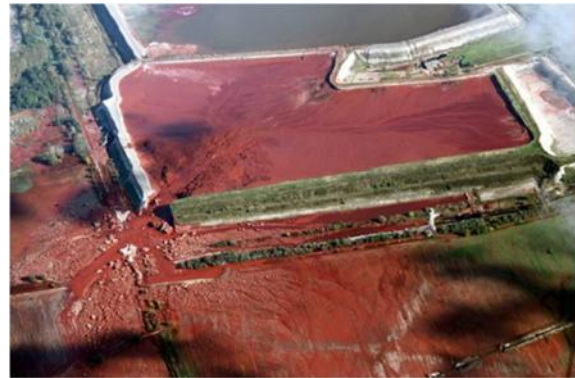
Fig. 9 Aerial photo of the Reservoir No. 10 after the dam failure in October 2010 [25]

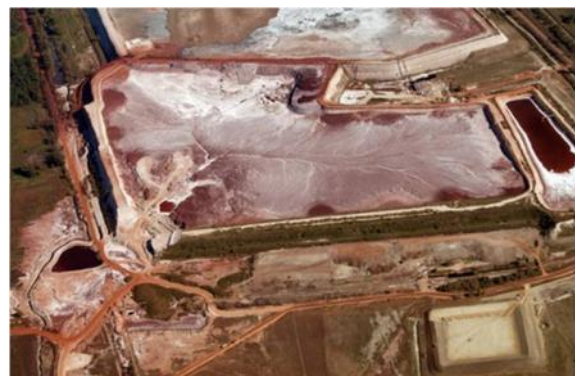
Filter presses were implemented in the Ajka refinery early 2011. The moisture content of the bauxite residue filter cake thereby is believed to be 30-35%. Some gypsum is added to the washed press-filtered bauxite residue to adjust its pH between 10 and 11. New phenomena is the dusting of the dry mud stacking during windy weather, this has not been kept under control as yet [24].

Fig. 10 One year later. Dry mud stacking of press filtered bauxite residue.
