Role of Pitting in the Formation of Potholes in Carbon Cathodes - A Review

The formation of potholes on carbon cathodes is one of the main causes of pot failure in the aluminium industry. A single pothole deep enough to cause the molten metal pad to come in contact with the collector bar is enough to fail a pot. Based on current theories, the cathode wear mechanisms, industrial experiences in formation of potholes and their characteristics and the role of pitting in the formation of potholes, are discussed. Pitting, a highly localized form of cathode erosion that produces relatively small pits on the cathode surface is a phenomenon observed in potholes of the cathode block during autopsies of spent pot linings. The presence of pitting within these potholes shows that pitting plays an important role in their formation.

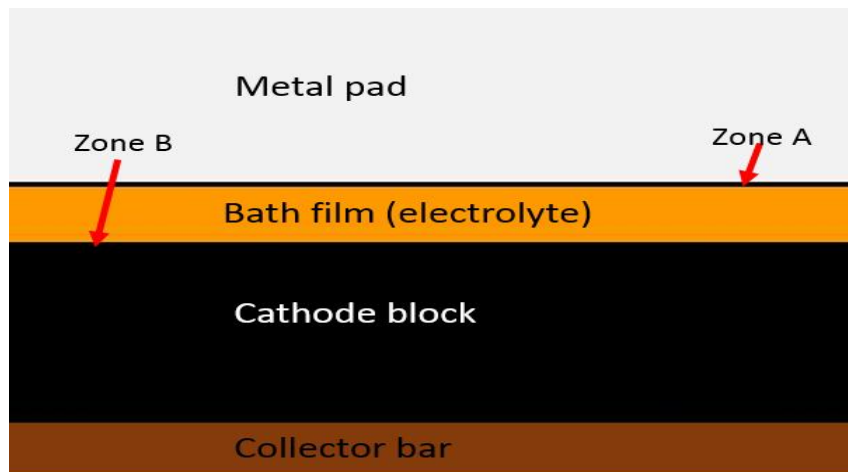
Figure 2.2. Sketch of the interfaces and zones at the carbon cathode from [2].

It is proposed that Reaction 4 relies on a constant supply of Al^{3+} ions, which is formed by the anodic dissolution of molten aluminium at the metal/electrolyte interface (zone A). Increasing the current within the system will increase the driving force for the anodic dissolution of Al^{3+} and will increase the driving force for the transport of Al^{3+} ions to and into the cathode material (zone B), thus increasing the chance of aluminium carbide formation [2, 12]. Figure 2.2 is a sketch showing the interfaces and zones as explained by Rafiei et al. [2].

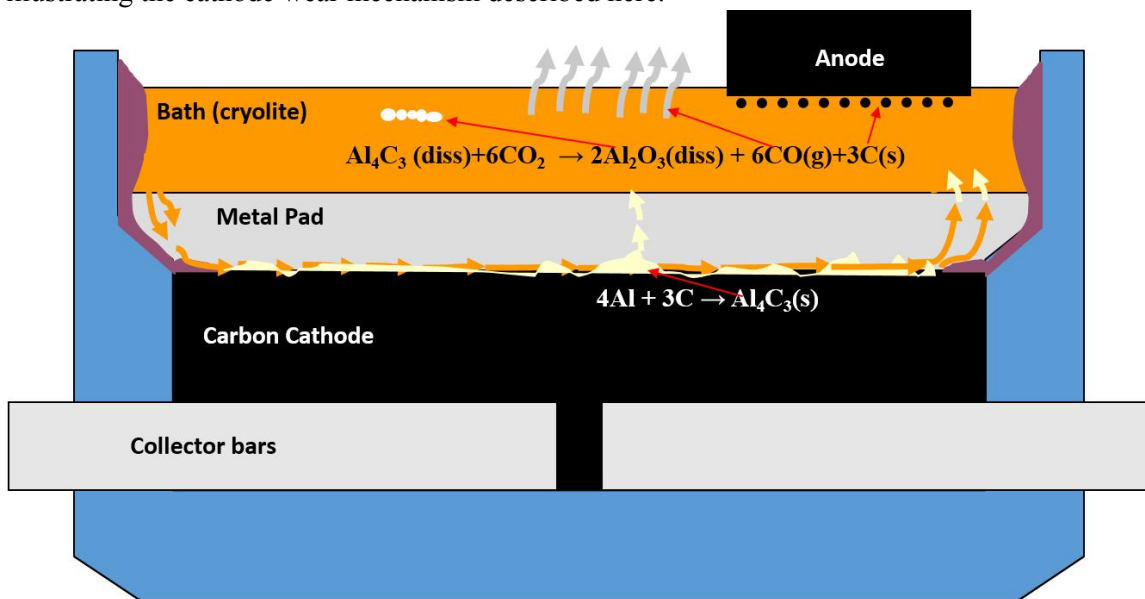
Figure 2.4. A sketch illustrating the cathode wear mechanism.

As the dissolution of carbide in the metal is known to be low compared to the solubility in the cryolite melt, it is proposed that the presence of a bath film at the carbon-metal pad interface is very important in the erosion of carbon cathodes [1]. The continuous presence of cryolite at the carbon-metal interface is enhanced by the convective patterns set up by the magnetic field within the metal pad [20]. K. Tschöpe et al. [23] observed that by increasing the speed of rotation of a cathode sample with slots, the wear rate increased. This was attributed to mass transport of carbide to the electrolyte bath above the aluminium pad. Figure 2.4 is a sketch illustrating the cathode wear mechanism described here.

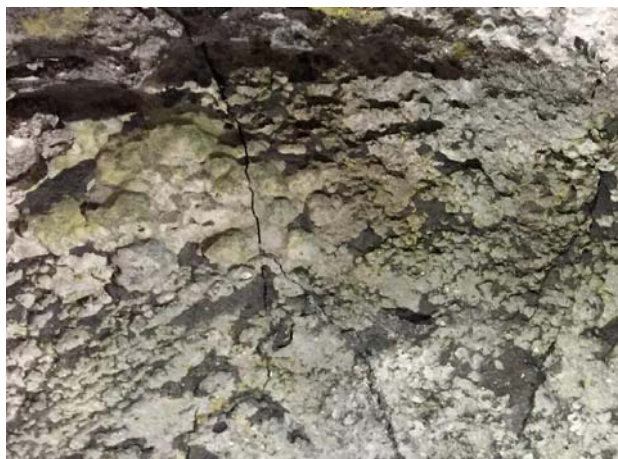
Figure 2.7. Pitting on the carbon cathode surface.

Pitting is a terminology used mainly under the subject of corrosion where it represents a highly localized form of corrosion that produces sharply defined cavities [28]. Its usage in connection with cathode erosion is therefore reasonable since the cathode erosion is mainly a chemical or electrochemical corrosion of the carbon cathode involving the formation and dissolution of aluminium carbide [1]. Pitting is observed on the carbon cathode surface at locations with the highest current densities [5]. Figure 2.7 is a picture showing pitting on a cathode surface.
