PITTING ON CARBON CATHODES IN ALUMINIUM ELECTROLYSIS CELLS

Samuel Senanu¹, Tor Grande¹ and Arne Petter Ratvik²

Belem, 29 October – 1 November 2018

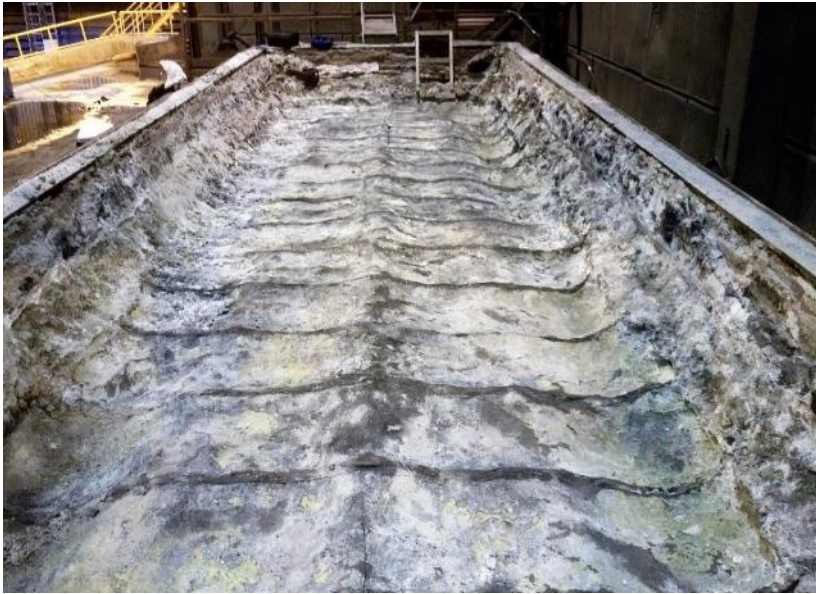
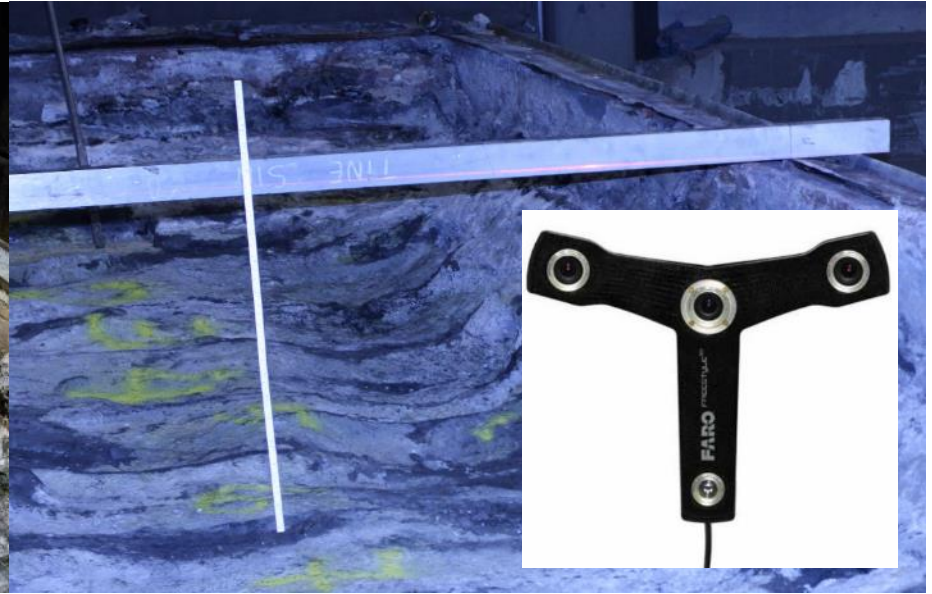
Size of the Spent potlining = 4 m X 15 m

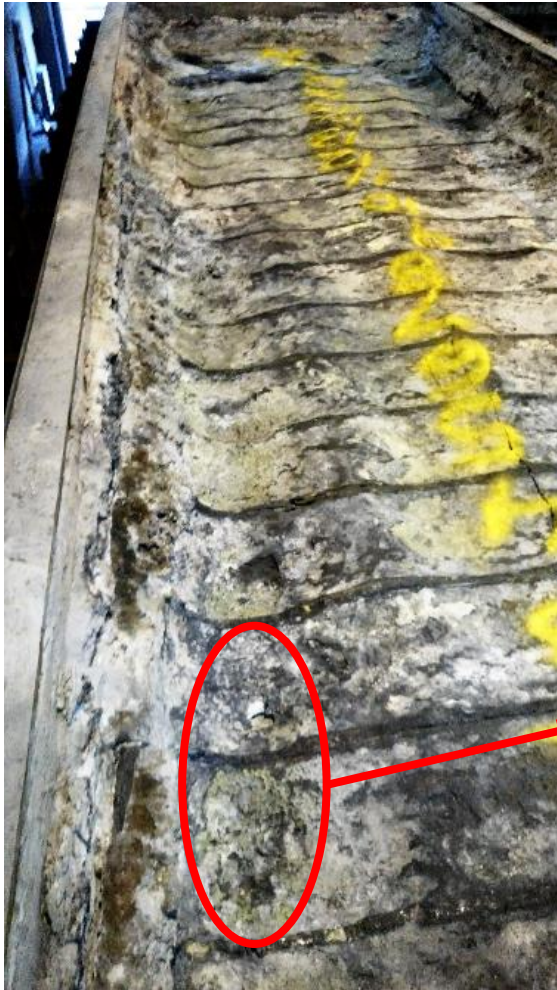
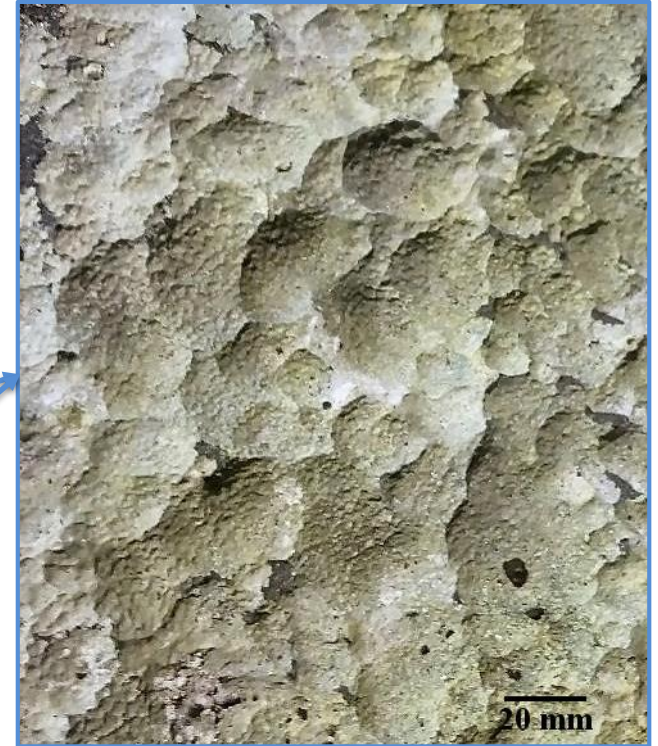
Pitting on Spent Potlining

**Pothole location
characterized
by pitting**

- **Highest wear at side ends of carbon cathode blocks**
- **Locations with highest wear characterized by high degree of distinct pitting**
- **Graphitized cathode blocks with very low degree of pitting at centre canal**
- **Pitting observed all over graphitic cathode block surface**
- **Variations in size of pitting from centre canal to side end of cathode blocks**
- **Remains of worn out coke aggregate observed in carbon matrix**

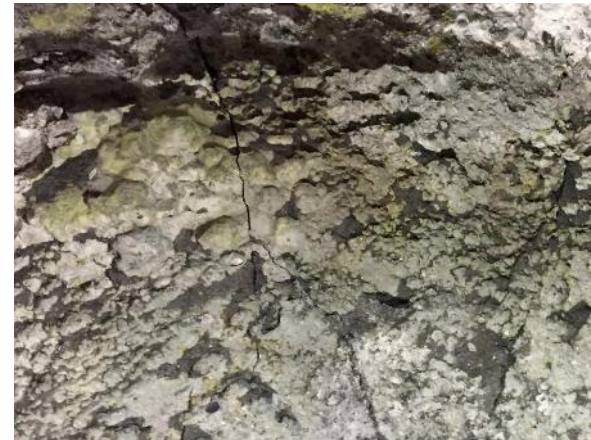
Pitting is a term adopted from pitting corrosion of steel which is a highly localized form of corrosion that produces sharply defined cavities
