## Thermal Behavior of Cathode Bottom Lining at CBA

Companhia Brasileira de Alumínio (CBA), Alumínio, SP, Brazil

### Abstract

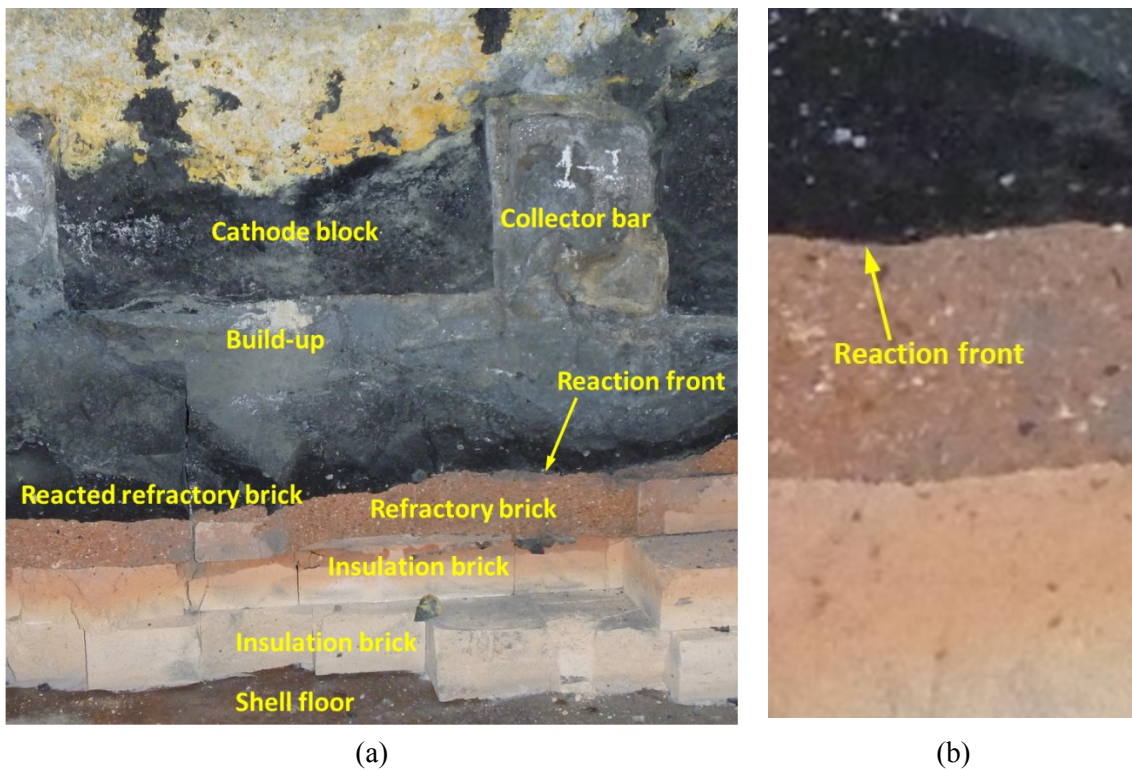
A typical cross section of a used lining, as shown in Figure 1, presents a layer called “build-up” of white grey colour consisting of cryolite, sodium fluoride, aluminium, alumina, silicon,  $Al_4C_3$ , Fe-Si and Fe-Al alloys. Below this layer there is a dense black layer consisting of reacted refractory where nepheline ( $NaAlSiO_4$ ) and a glassy phase close to albite ( $NaAlSi_3O_8$ ) were found [1]. This layer acts as a diffusion barrier slowing down further sodium and bath penetration. The sharp interface between the intact refractory brick and this layer is what is called “reaction front”. The solidus temperature of this front, if albite is present in addition of sodium fluorite and cryolite, is around 865 °C [1]. By design, this isotherm should be located within the refractory brick, not in the insulation layer.

**Figure 1. Cell cross section bottom lining (a) and reaction front in detail (b).**

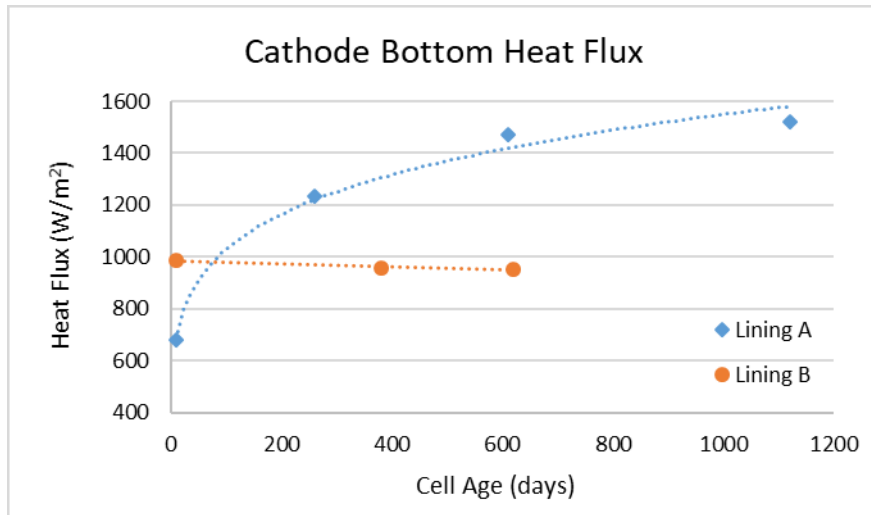
In a bottom with a thermal resistance designed to have the solidification isotherm inside the refractory bricks, the heat flux is a little higher but stable over time and it is not necessary to increase cell voltage to compensate extra heat losses. Figure 2 shows the heat flux measurements for two different lining designs of the same technology that relies only on high silica refractories as diffusion barrier. Lining A is the old design with theoretical thermal resistance of  $1.24 \text{ m}^2\text{K/W}$ , which results in an initial heat flux of  $680 \text{ W/m}^2$ . However, the insulation hot face temperature is  $877 \text{ }^\circ\text{C}$  leading to its deterioration over time. Lining B was designed to have a thermal resistance of  $0.84 \text{ m}^2\text{K/W}$ , having an initial heat flux of  $980 \text{ W/m}^2$ , but in this case the insulation hot face temperature is  $810 \text{ }^\circ\text{C}$ . The heat flux remains stable over the period of 600 days when the Lining A was already having more than twice the designed heat flux.

**Figure 2. Cathode bottom heat flux against cell age.**

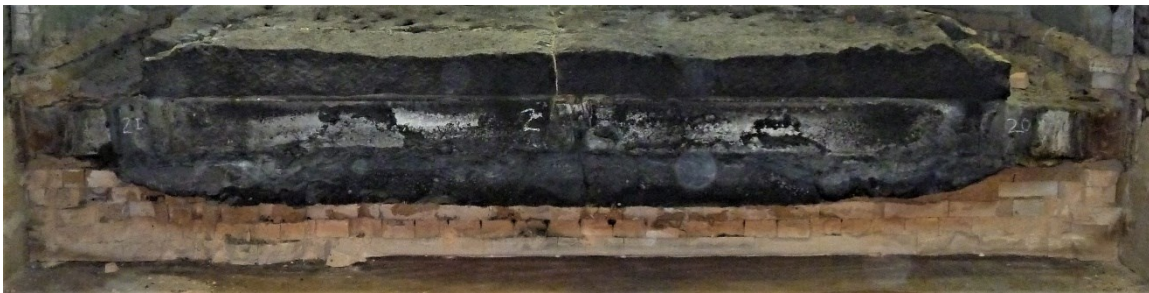
Figure 3 shows the sub-cathodic lining autopsy of a Lining B cell design at the age of 1300 days which failed due to sidewall problems. It can be noted that the two insulation brick layers were not contaminated. Also, one of the 3 refractory layers is still intact.

**Figure 3. Cell lining cross section of Lining B design.**

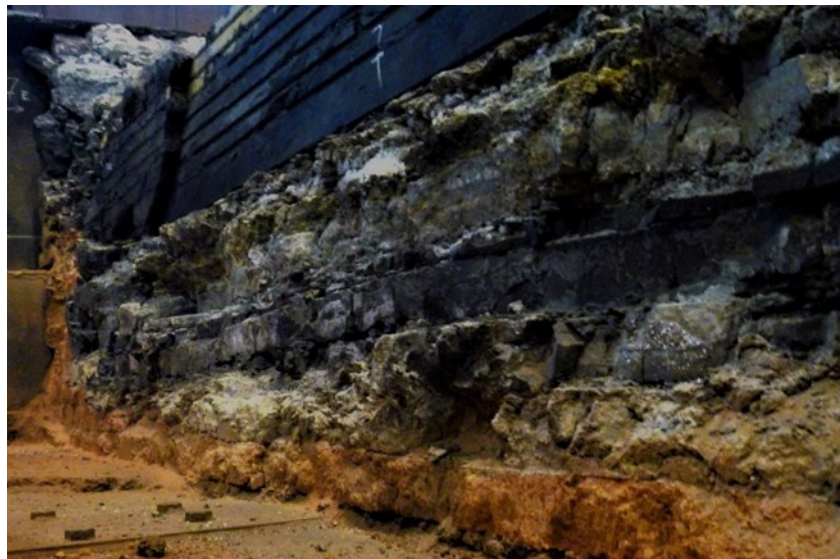
In February 2013, an autopsy was made in the cell 1639 with 3065 days of life. A cross section in the middle of the cell, at cathode 7 position, is shown in Figure 5.

**Figure 5. CBA cell lining cross section – Cell 1639 autopsy.**

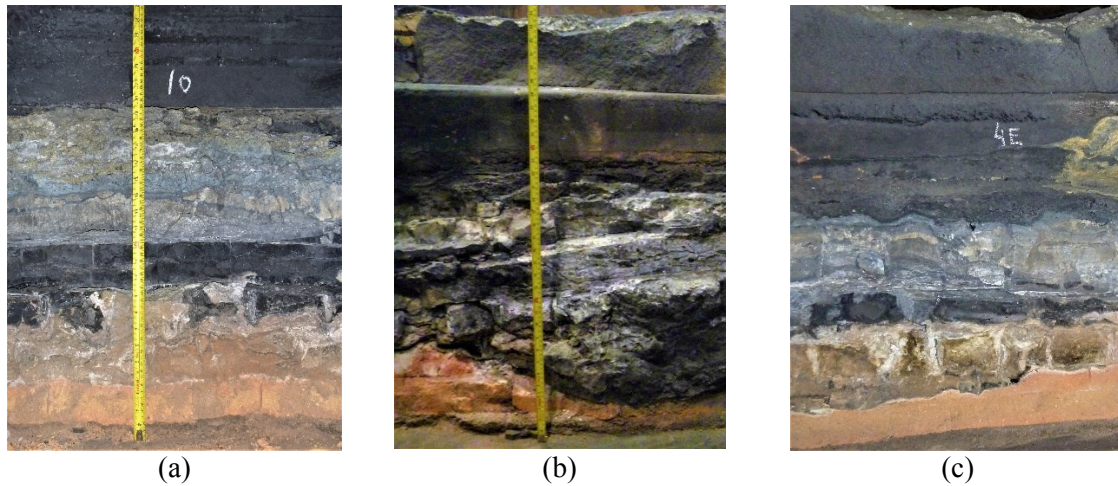
Figure 6 shows other cathode positions for the same cell. We can see the affected refractories (black glassy), but the reaction front is not sharp. Also, below the front we can see that the insulation bricks are contaminated in a non-uniform way. Since the cell is very old we can see a lot of build-up just below the cathode (white grey). The cathode block bottom position was measured during the autopsy and there was 150 mm of build-up thickness in average. The insulation bricks were not compressed.

Figure 6. CBA cell bottom lining details – Cell 1639 autopsy.

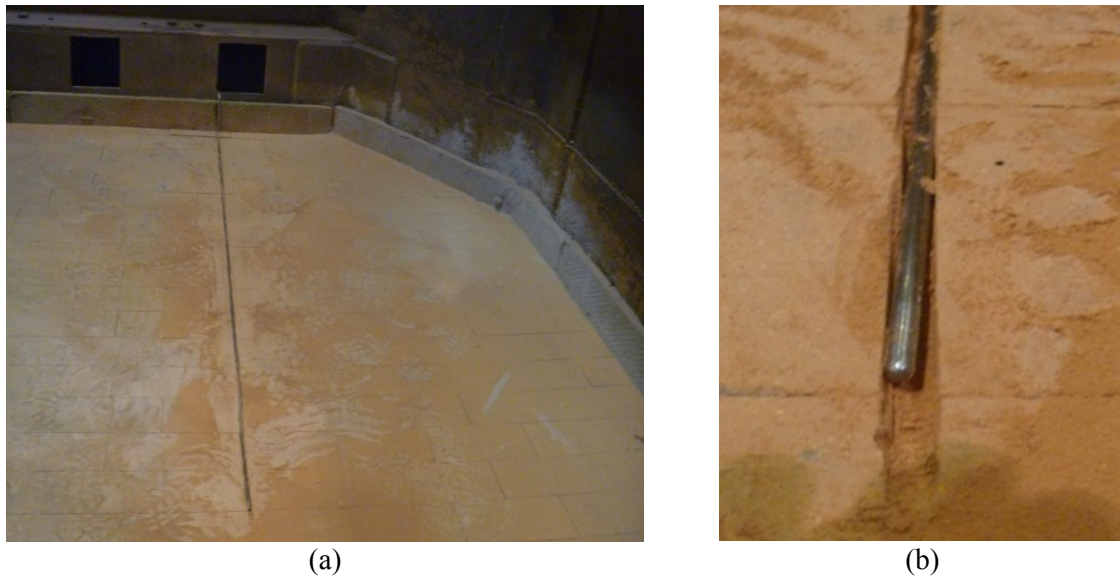
In order to check the temperature at the insulation hot face during operation, thermocouples were installed just below the steel plates, as shown in Figure 8. Different cathode positions were chosen and 2 to 3 thermocouples were installed in each one of the 10 test cells.

**Figure 8. Thermocouple installed in the hot face of the insulation (a) and detail (b).**

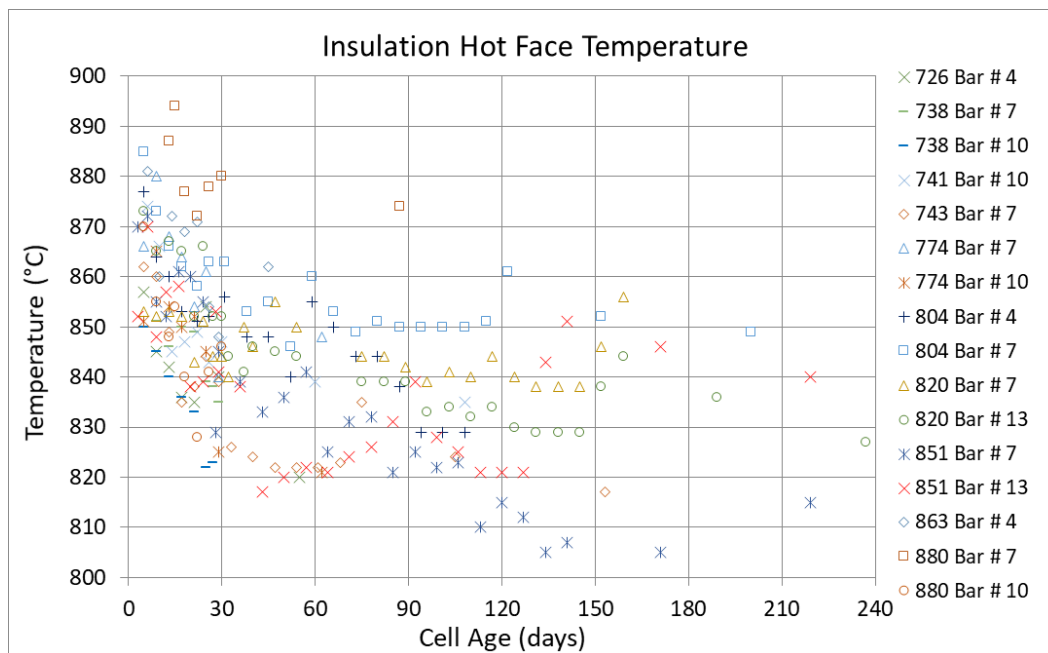
The Figure 9 shows the results of these measurements in the first 8 months of cell life. It is possible to notice some dispersion in the obtained values. In the beginning, the values range from 850 – 885 °C, reducing to around 820 – 865 °C within 30 days and stabilizing in 820 – 850 °C within around 90 days.

**Figure 9. Insulation bricks hot face temperature in the test cells. The numbers on the right are test cell numbers.**

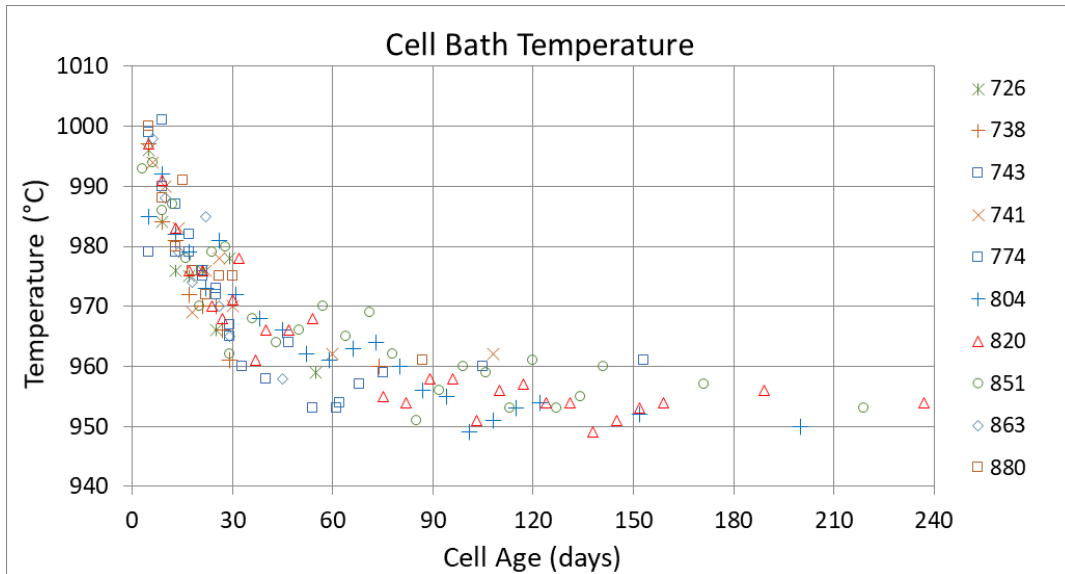
Figure 10 shows the bath temperature measurements taken at the same time as the lining thermocouples. We can see that the temperature remains high over the initial 30 days of the cell life, reflecting in the insulation temperature.

Figure 10. Bath temperature in the test cells.

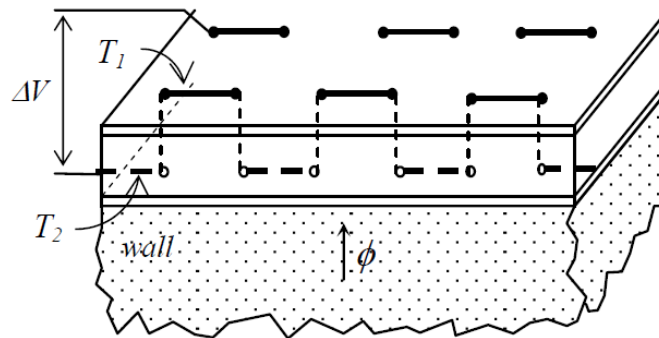
The heat flux sensor is a thin plate made of a material with a known low thermal conductivity having differential thermocouples over the sensor area – Figure 11 [5]. The temperature difference between the two faces is used to calculate the heat flux passing through the sensor by applying the Fourier law (Equation 1).

Figure 11. Typical heat flux sensor – reproduced from [5].

The heat flux is measured by attaching the sensor to the surface of interest. A good contact between sensor and surface should be guaranteed with no air pockets between them. Also, surface finishing and planarity are important to consider. The installation of the sensor itself on the surface disturbs the heat flux crossing it. The main difficulty is found when the local condition is windy. This is because the wind locally cools down the sensor which shows larger fluctuations than the real one to be measured. Even with steady wind, the sensor will show a higher value than the actual flow. This is due to the difference of the sensor transfer constant which was calibrated in no wind condition.

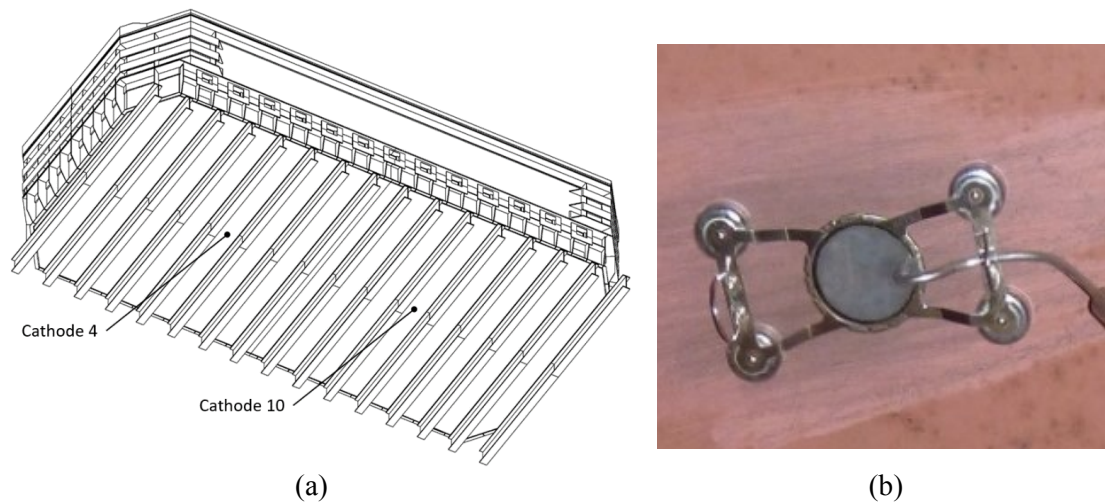
Heat flux and temperature were measured at the shell bottom between cradles as shown in Figure 12. The positions were just below cathodes 4 and 10. The goal was to assess the behaviour over the pot life. Figure 12 (b) shows the KEM (Kyoto Electronics Manufacturing) T500B sensor in use on the steel potshell. The existing bottom design cells were selected to have different ages.

**Figure 12. Heat flux sensor position (a) and view of the sensor used (b).**

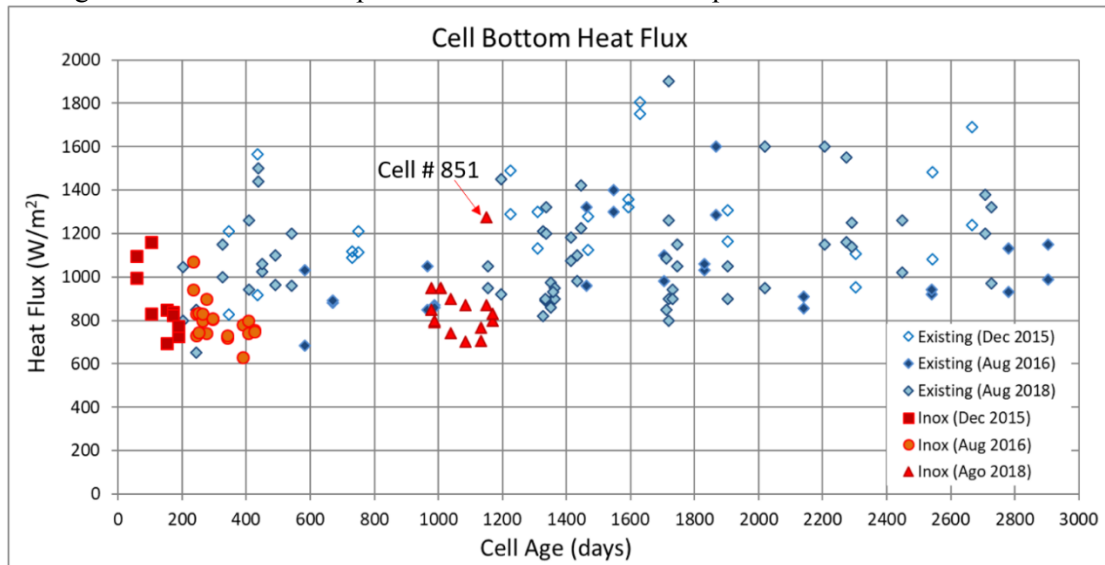
Figure 13 shows the measurements of heat flux on three occasions (2015, 2016 and 2018) for cells of the existing bottom lining design and the test cells using stainless steel (Inox) plates. We can see the somewhat high dispersion of the values measured in the existing bottom lining cells and there is no clear correlation between heat flux and age. Although some of the older cells give values close to the theoretical initial value of  $790 \text{ W/m}^2$ , most of them show higher values, including some younger cells. The test cells show a much more uniform behaviour and their heat flux did not increase until the age of 1100 days. The only exception was Cell 851, which had a metal tap-out through the collector bars on 12 and 13 in July 2018.

Figure 13. Cell bottom heat flux measurements.

The presence of liquid or solid sludge on the top of the cathode may explain the low heat flux values for the existing design older cells.

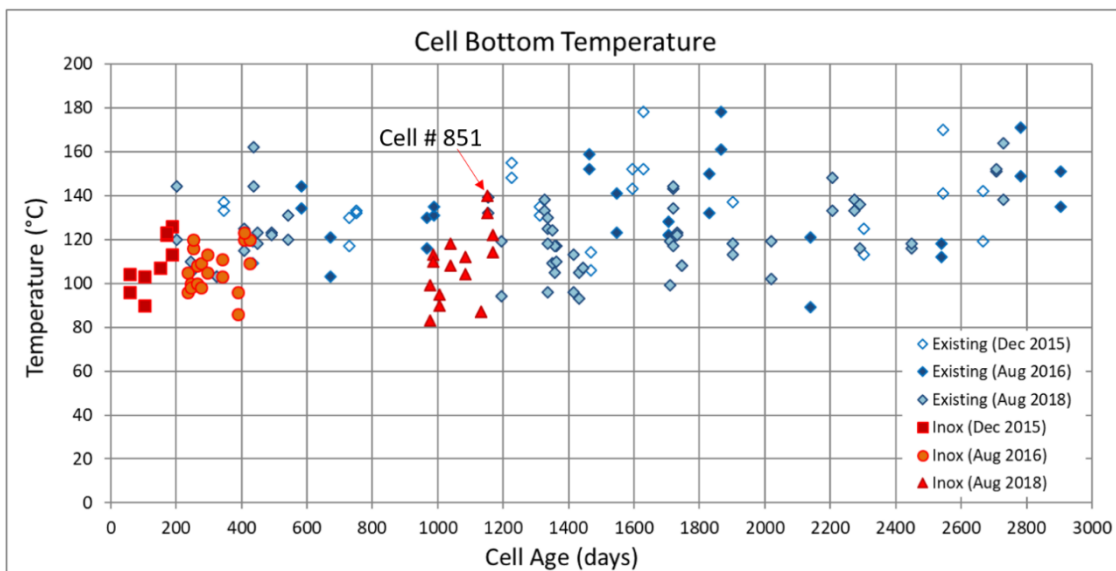
Figure 14 shows the cell bottom temperature measurements. The behaviour is very similar to the heat flux. Again, the hottest test cell in 2018 is the 851.

Figure 14. Bottom temperature measurements.

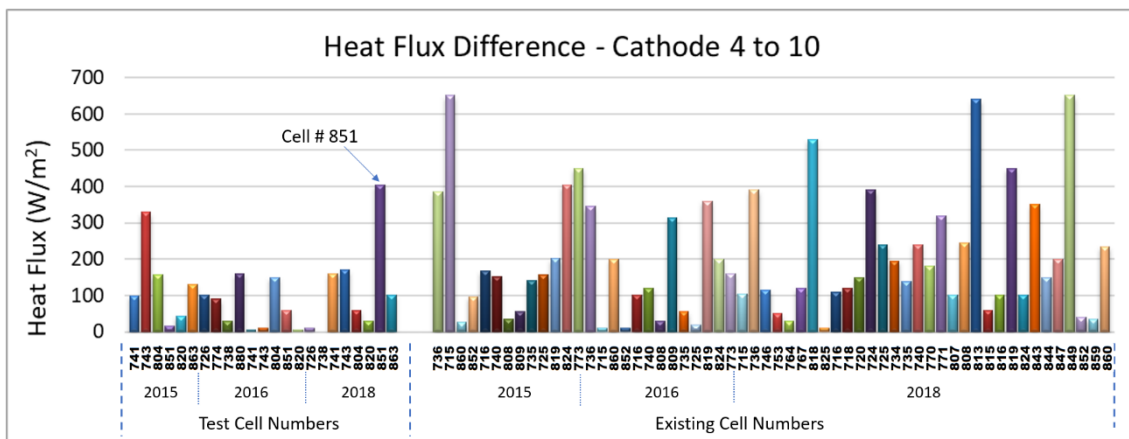
The bottom insulation is uniform by design and no difference should exist between cathode 4 and 10 positions. Figure 15 shows the absolute heat flux difference between the cathodes 4 and 10. The difference may be an indication that part of the lining has deteriorated. The test cells

present less variation except for the Cell 851 which had an episode of collector bar metal tap-out that might have resulted in the partial destruction of the steel plates.

**Figure 15. Bottom heat flux absolute difference between cathode 4 and 10 positions.****5. Cell Voltage**

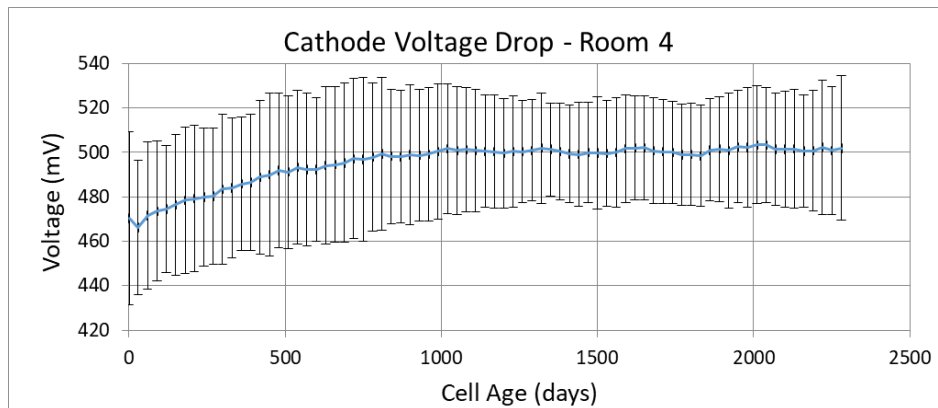
Cell voltage is a function of the electrical resistance of the circuit between identical positions in two adjacent cells. Busbar and anode resistances are almost constant. Cathode resistance is different from cell to cell and also is changing in time due to the increase in contact resistance, cracks and material properties. Figure 16 shows the measured cathode voltage drop (including 235 mV of busbar drop) over time for CBA Room 4. The value starts around 460 mV and becomes stable after 800 days at around 500 mV, with a standard deviation of around 25 mV.

**Figure 16. Cathode voltage drop over life for all cells in Room 4 (8 December 2015).**

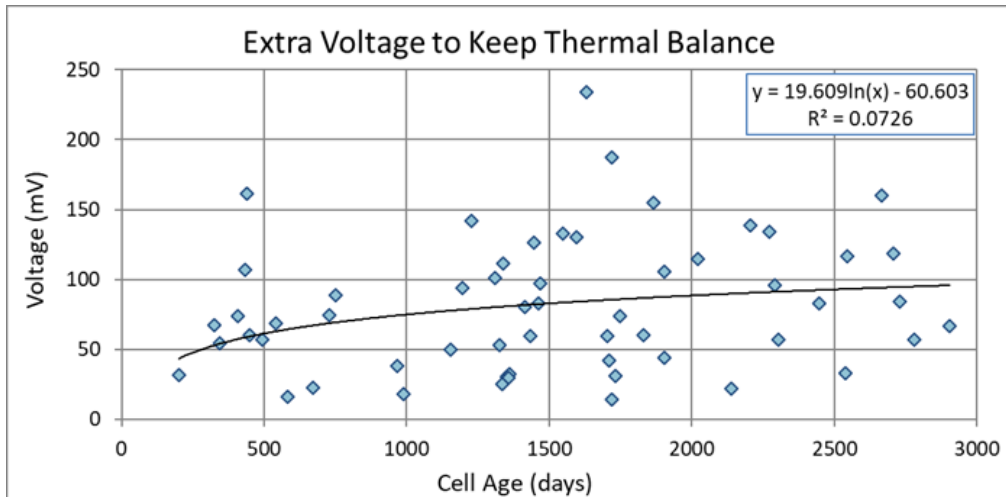
However, the required cell voltage should increase over cell life due to increased thermal losses by the lining as it deteriorates. The increase in thermal losses requires more heat generation through the ACD which results in more voltage to maintain the thermal balance. Figure 17 shows the theoretical extra voltage to be added to compensate for this increase and keep the cell in heat balance for the existing design cells measured. We considered  $790 \text{ W/m}^2$  as the reference bottom heat loss at the beginning of the cell life before the contamination of the insulation. There is 80 mV extra voltage in average, but the dispersion is high and, as for the heat flux, there is a weak correlation between extra voltage and cell life.

Figure 17. Extra cell voltage to compensate extra bottom heat losses for existing cells.

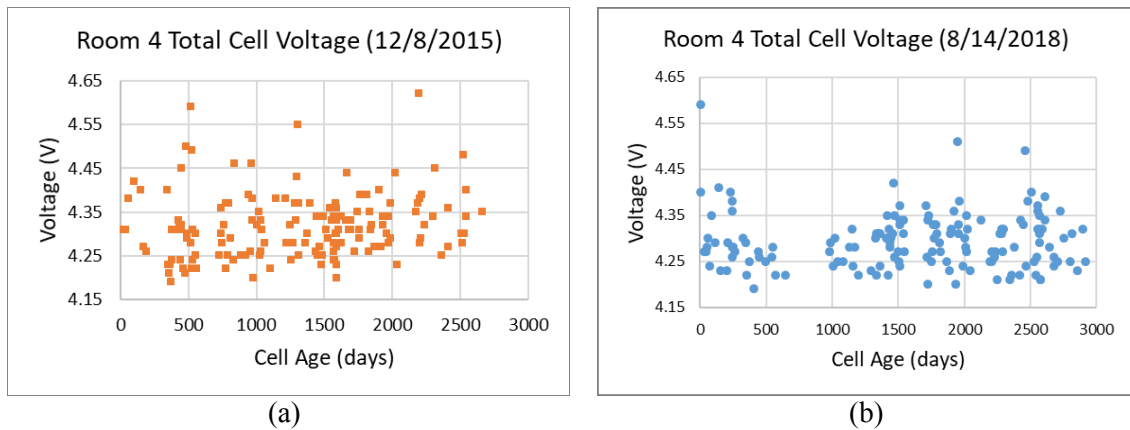
Figure 18 shows the total cell voltage as a function of cell life in two different days for all cells in Room 4. There is no correlation between cell life and voltage meaning that current efficiency and/or superheat are being affected in the old cells that have the bottom lining deteriorated and the cathode voltage drop increased. A decrease in superheat may affect alumina dissolution, increasing risk of sludge formation. The decrease in current efficiency may be compensating part of the heat deficit originating from bottom lining deterioration.

Figure 18. Room 4 cell voltage on 8 December 2015 (a) and 14 August 2018 (b).

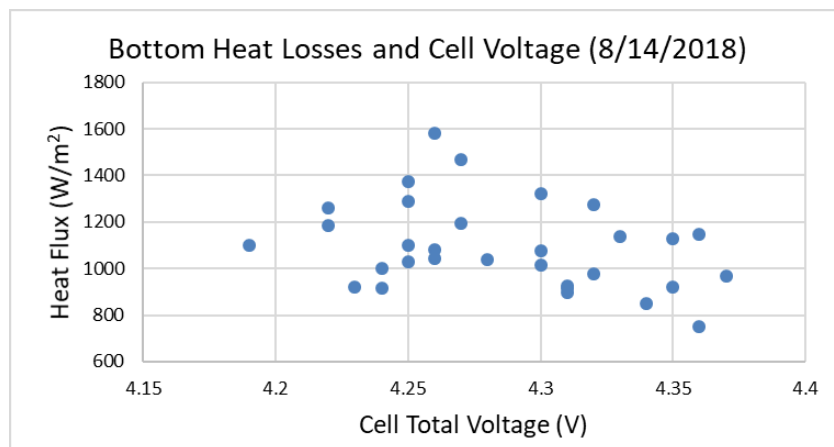
The cell voltage is related to transient factors, such as the need to reduce instability, to reduce sludge, increase or decrease temperature, etc. Figure 19 shows that there is no correlation between the measured heat flux and the total cell voltage in the same day of the measurements. This means that other factors had more impact on the total voltage at the time of the measurements.

Figure 19. Bottom heat losses and cell voltage on 14 August 2018.

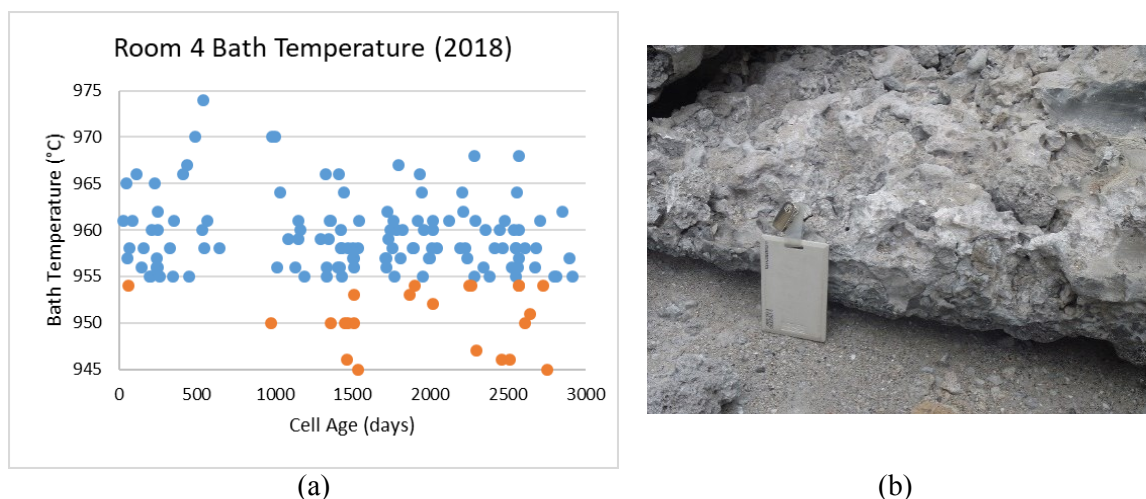
Some of the cells have the sub-cathodic lining damaged, which reduces its thermal resistance, increasing heat flux and the risk of the top of the cathode reaching temperature below 955 °C. Figure 20(a) shows the bath temperature of Room 4 in 2018. We can notice around 17 % of cells have bath temperature below 955 °C.

All these conditions together may explain why large volumes of solid sludge phase and alpha alumina (corundum) are found in CBA cells - Figure 20(b).

**Figure 20. Room 4 cell bath temperature on 15 August 2018 (a) and hard muck removed from the cathode top of the Cell 1639 (b).**
