## **Crane for Maintenance of Potroom Building Rails**

**Jasbant Pradhan, Krishnan S. Kumar**

Emirates Global Aluminum Jebel Ali, Dubai, United Arab Emirates

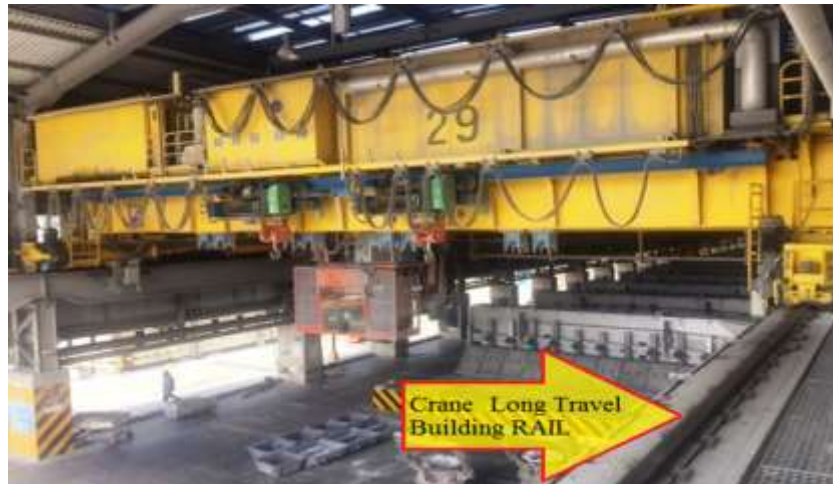
**Figure 1. One of the potroom cranes in operation, the picture shows building rail.**

The rail track (Figure 1 and Figure 2 left) is from 160 to 800 meters long and runs along several sections in a potroom. To carry out inspection and maintenance job on the two sided building rails, the power should be isolated in the section so as to avoid crane movement and electrocution from crane's power rails, mounted along the building beam above the rail. However, electrical hazards of bridging between pot potential and earth potential still exist as pot ducts up to the insulation sleeve and superstructure are at pot potential but the exhaust duct on the building side, the building and the crane rails are at earth potential (Figure 3). The difference between the pot and the earth potential can be as high as the potline voltage, depending on where the electrical 'null point' of the potline is [1].

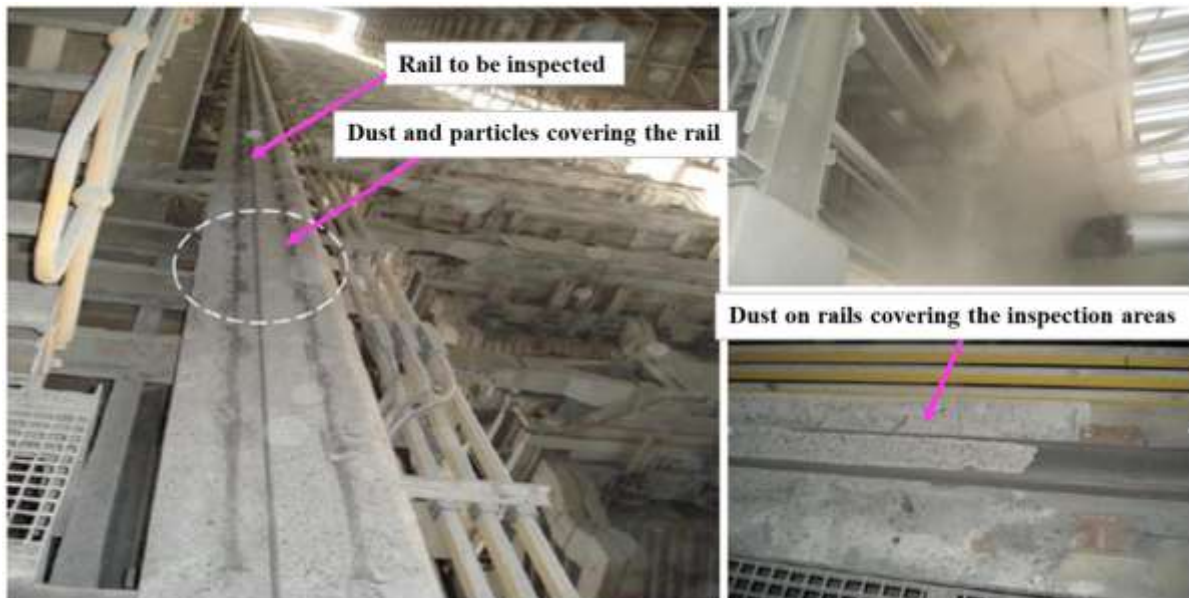
**Figure 2. Building rail and associated hazards (dust and fumes).**

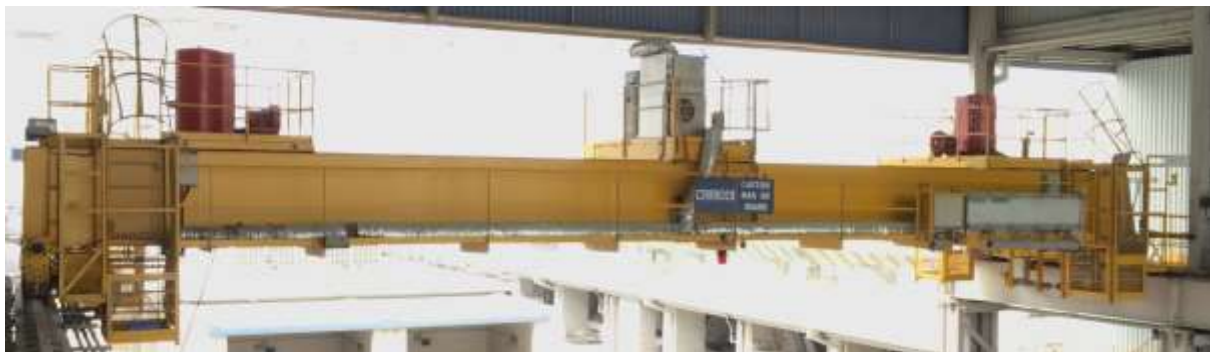
**Figure 4. Building rail inspection car parked in crane maintenance bay.**

A decommissioned potline construction crane was sitting in the courtyard and we had the idea that this crane could be modified and dedicated for the potroom crane rail maintenance work. The crane was modified with all the inventions, described below and certified by Carl Stahl, who still certifies the crane periodically. Figure 4 shows the modified crane.

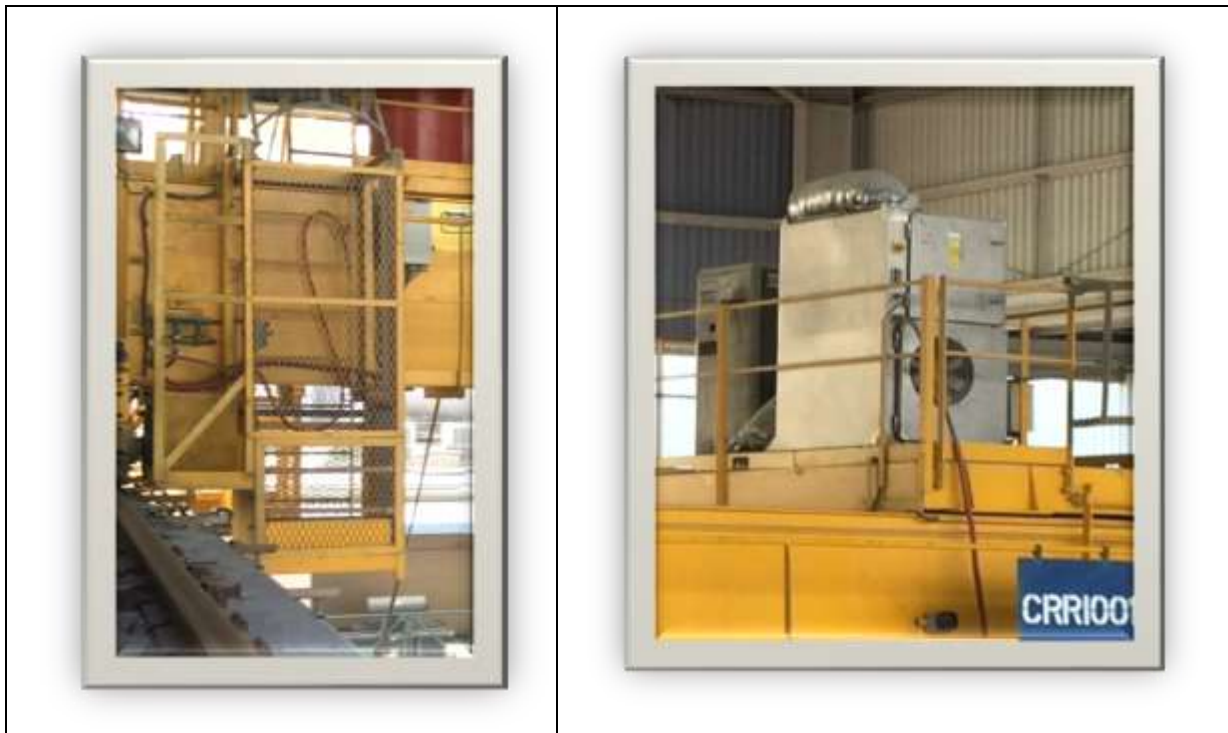
**Figure 5. Left: man-carrying baskets, Right: air conditioning system.**

- Four-sided man carrying baskets with safety harness hook points for maintenance personnel (Figure 5, left),
- Tool box and storing boxes for clamps and bolts,
- Anti-collision sensors,
- Air compressor for pneumatic tools used in maintenance jobs, such as pneumatic wrench tools,
- Vacuum machine installed on the rail inspection car to clean the alumina/dust deposited over the rails (Figure 6, left),

- Air conditioned unit installed and cooling ducts laid up to man-carrying basket (Figure 5, right),
- Rail cleaning brushes installed on the car,
- One pendent with festoon cable arrangement to operate the inspection car for both A and B room,
- Emergency stop push button installed in each man-carrying basket,
- Audio alarm installed for communication between operator and the maintenance personnel on the car (Figure 6 right),
- Separate audio alarm to indicate crane movement,
- Variable frequency drive installed for smooth acceleration (Start) and de-acceleration (Stop) of the car,
- Certified and used in multiple projects, minimizing the cost and time.

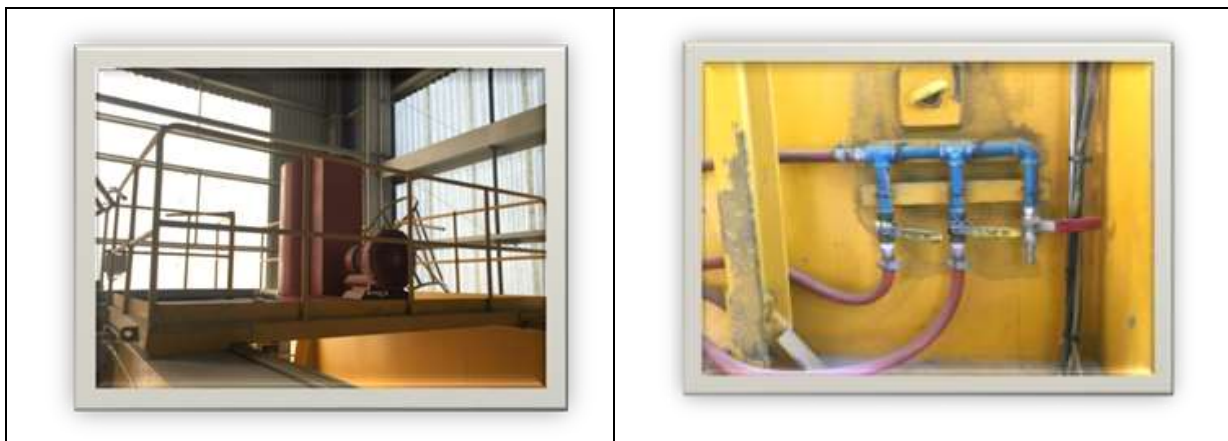
**Figure 6. Left: vacuum system, Right: power tool air outlets.**

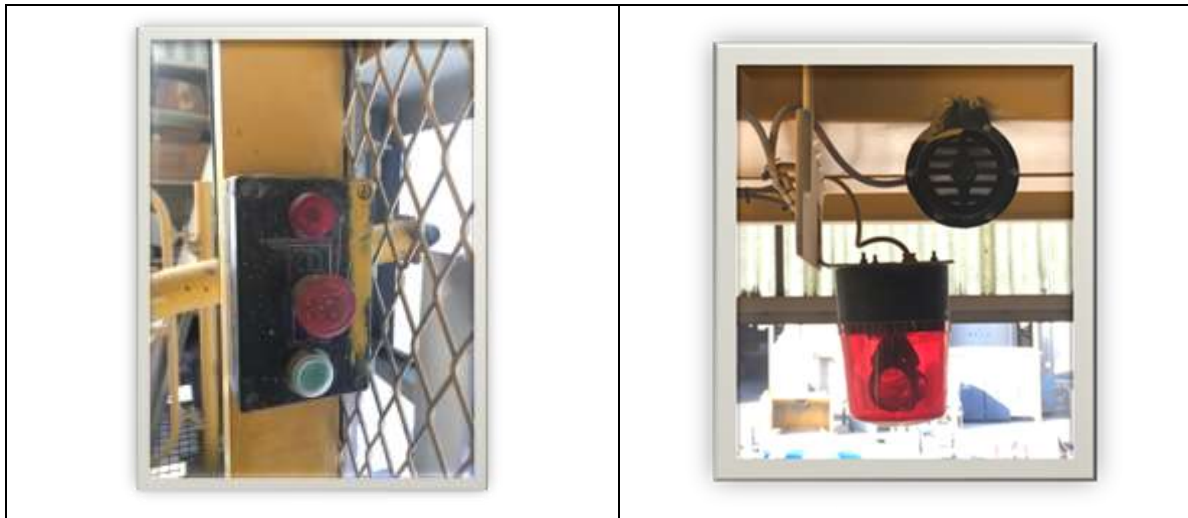
**Figure 7. Left: safety stop and horn, Right: visual and audio alarm.**

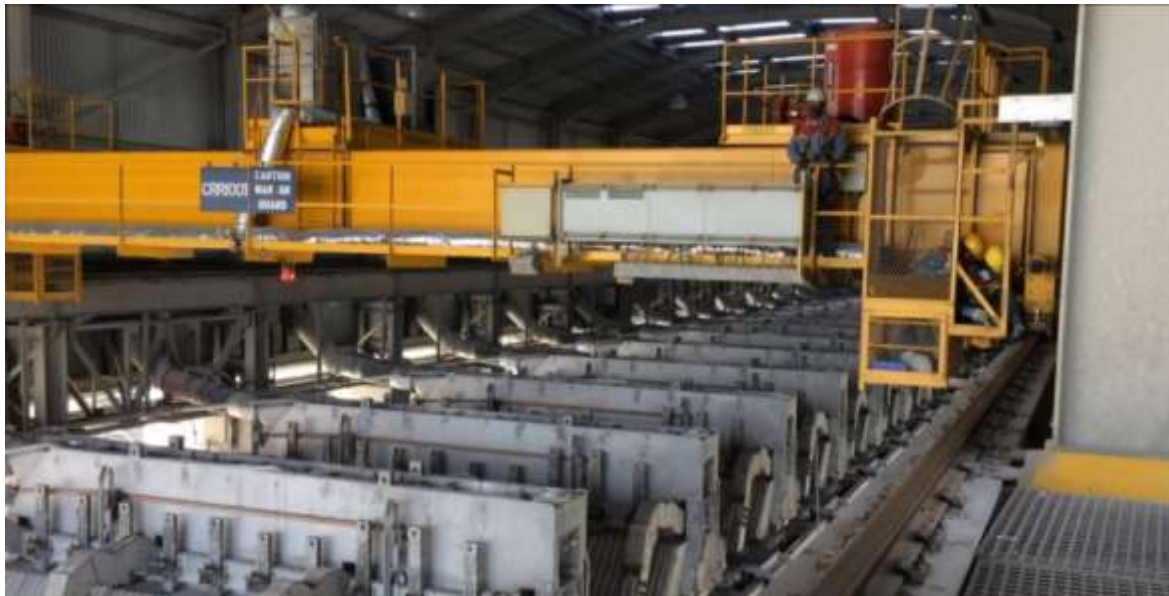
**Figure 8. Rail inspection car being used in one of the section for rail inspection.**

The new crane in use for the potroom rail inspection and repair is shown in Figures 8 and 9. Beside the usage of the crane by EGA maintenance teams, it has been also used by Fives ECL and Rapid Rail for some potroom projects.

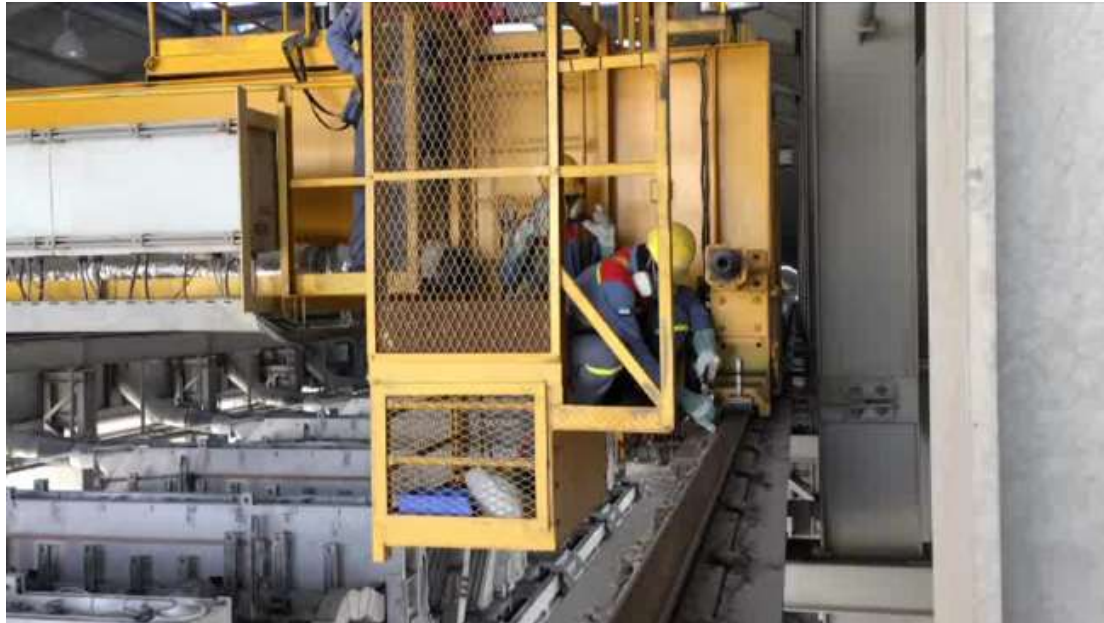
**Figure 9. Picture shows maintenance crew using pneumatic torque wrench for tightening and replacement of rail clamps.**
