Improving Reliability and Reducing Electric Energy Losses in the 'Rod–Yoke' Connections

This article proposes using a new approach of mounting the yoke to the anode rod through several Fe-Al bimetallic couplings of various configurations and designs.

Key words: RA-400 pot, RA-550 pot, Fe-Al bimetallic coupling, anode rod assembly, energy efficiency.

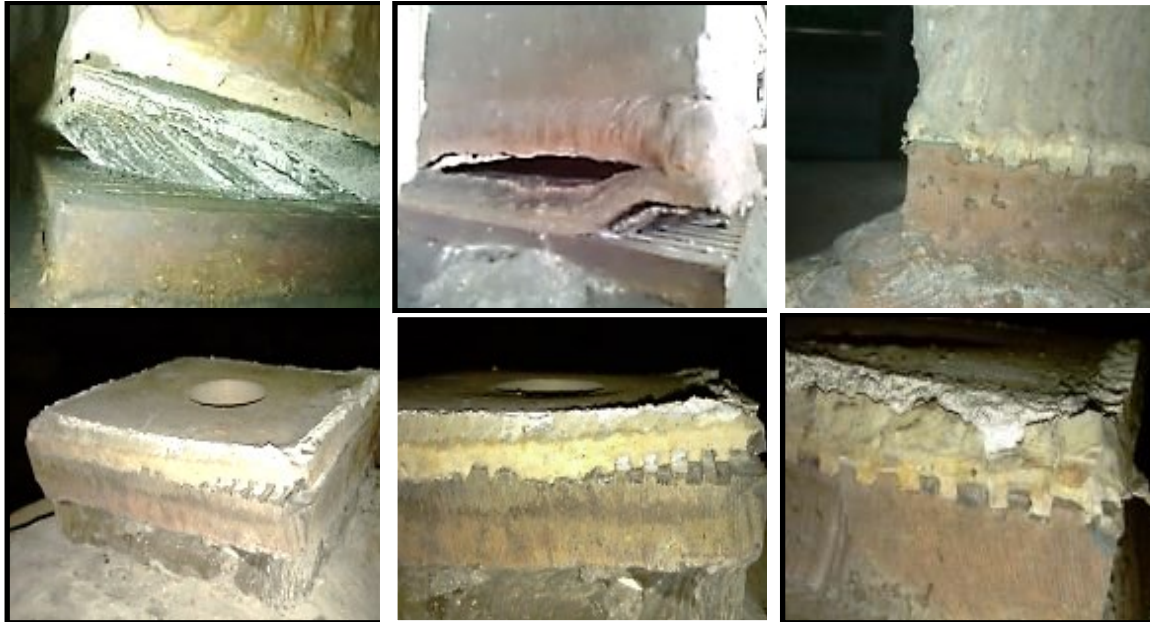
Figure 3. Examples of breakdown of the Fe-Al bimetallic joint of the RA-400 pot.

Starting from 2010, at the RA-400 pilot site located in the pilot potroom of the Sayanogorsk Aluminium Smelter, an increased failure of the anode rod assemblies was observed due to the breakdown failure of Fe-Al bimetallic plates. At the end of 2011, up to 50 % of the RA-400 anode rod assemblies in circulation were in repair (Figure 3).

The main reason for the failure of the Fe-Al bimetallic plates was their overheating due to problems with the removal of gases from the pot (failure of the Gas Cleaning Unit equipment). This incident triggered the initiation of the development of technical solutions in the design and manufacturing technology of bimetallic plates for RA-400 pots, aimed at improving the connection reliability and increasing the service life of these plates (determining the life cycle, monitoring the bi-metal state at all stages of the technological cycle).

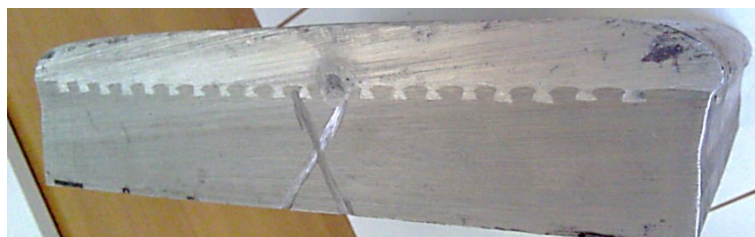
Figure 4. Bimetallic plate, type 1.

- Type 1 (Figure 4) — to eliminate the lower strength of a dovetail welded joint along the edges of bimetallic plates, large-size casting blocks are produced, with subsequent cutting into plates of the required size; along the edges of the bimetallic plate, 2 additional grooves are milled in the direction perpendicular to the main grooves (1 groove from each edge of the plate at a distance of 10 – 20 mm from the edge); to identify the cause of the failure, a zinc 'cartridge' is installed in the Fe-Al joint.

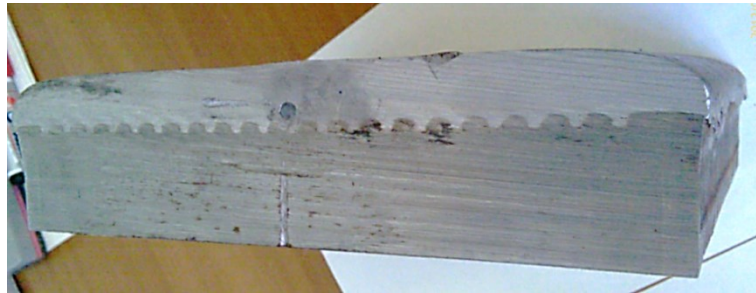
Figure 5. Bimetallic plate, type 2 with titanium interlayer.

- Type 2 (Figure 5) — to eliminate the lower strength of the dovetail welded joint along the edges of bimetallic plates, large-size casting blocks are produced, with subsequent cutting into plates of the required size; an additional titanium sublayer is used between the aluminium and steel parts.

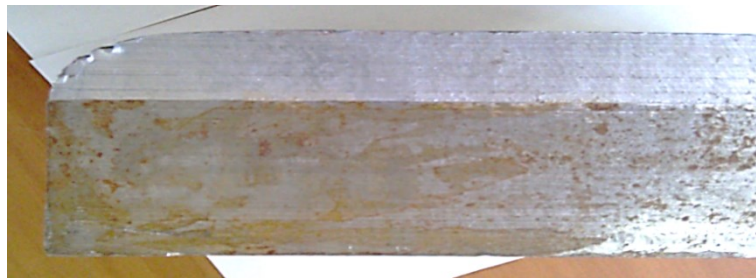
Figure 6. Bimetallic plate, type 3.

- Type 3 (Figure 6) — large-size casting block with subsequent cutting into plates of the required size, the aluminium plate is overlap-welded to the flat surface of the iron plate.

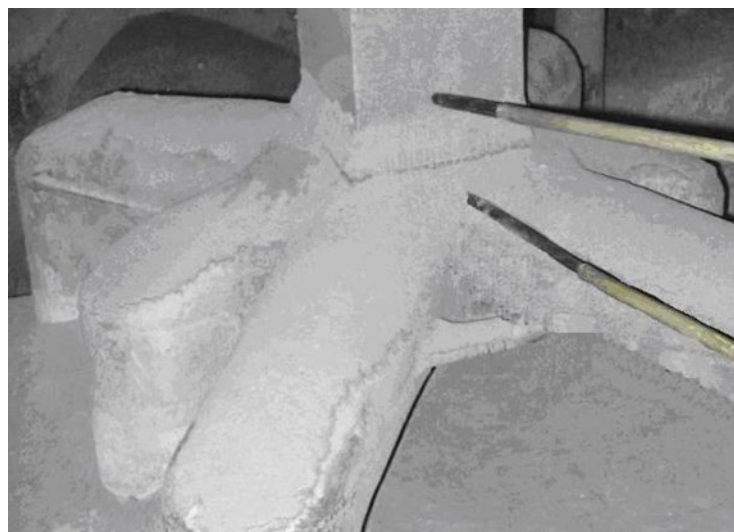
Figure 7. Position of probes while measuring the 'rod–yoke' voltage drop.

To measure the voltage drop, the oxide film on the anode yoke was pierced at the rod–yoke contact by lightly striking the probe tip installed visually 10 – 20 mm below the weld on the yoke, the tip of the second probe was at a distance of visually 10 – 20 mm above the weld on the yoke (Figure 7).

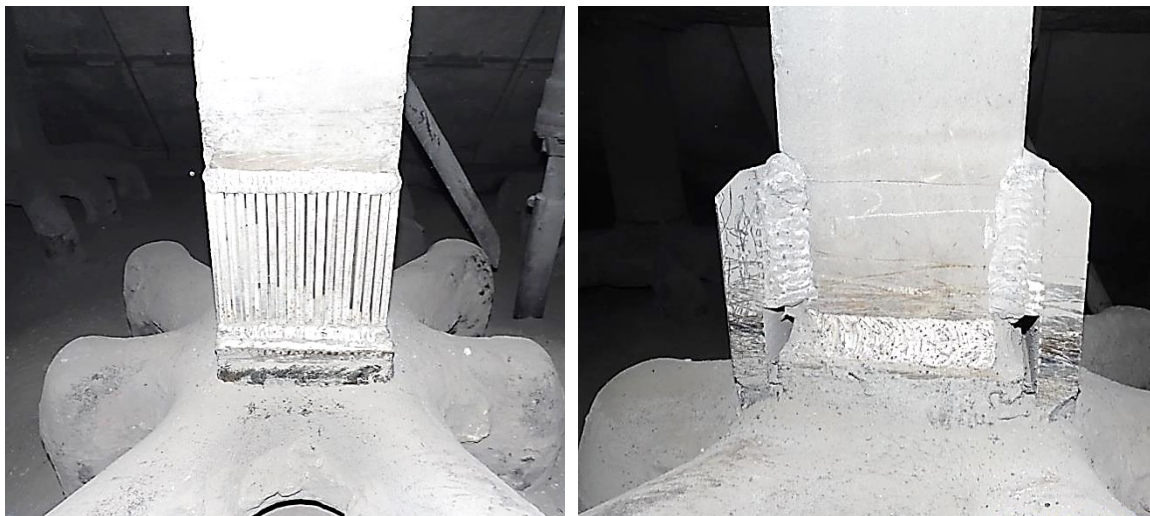
Figure 9. Technical solution to improve the connection reliability.

In 2016, it was decided at RUSAL Sayanogorsk JSC to continue testing the modified technology of welding the rod to the bimetallic plate (Figure 9) in order to further improve the reliability of the welding of bimetallic plates to the anode rod of the anode rod assemblies of OU RA-400 pots.

- Type 4 — type 2 or 3 bimetallic plate is welded to the yoke according to current technology, and the rod is welded through transitional 10 mm thick Al plates.
- Type 5 — type 1, 2 or 3 bimetallic plate is welded to the yoke according to current technology, type 2 or 3 bimetallic plates are welded from the sides in the same way.

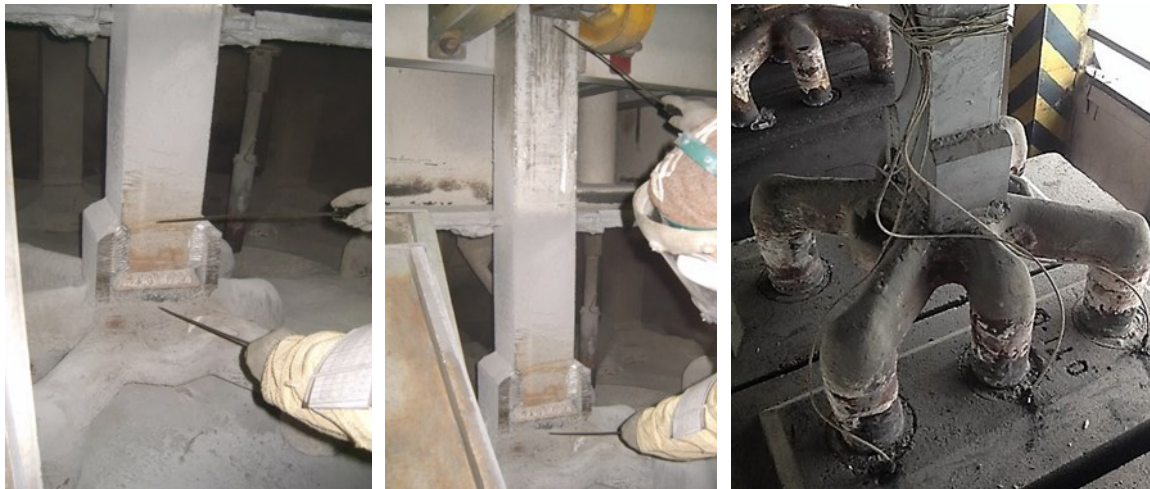
Figure 12. Monitoring of the voltage drop in the 'rod–yoke' contact of bimetallic plates mounted according to type 5.

- The technical solution has the lowest voltage drop (12.8 mV, which is 15 mV lower for typical connections), as well as the lowest temperature at the end of the anode changing cycle (180 ° C, which is lower by ~ 25 - 27 ° C for typical connections).
- The connection is more reliable and allows increasing the energy efficiency of the RA-400 technology (reduction of specific energy consumption ~ 47 kWh/t Al).
