Cathode Wear – Autopsy Findings Related to Degradation Mechanisms

Abstract

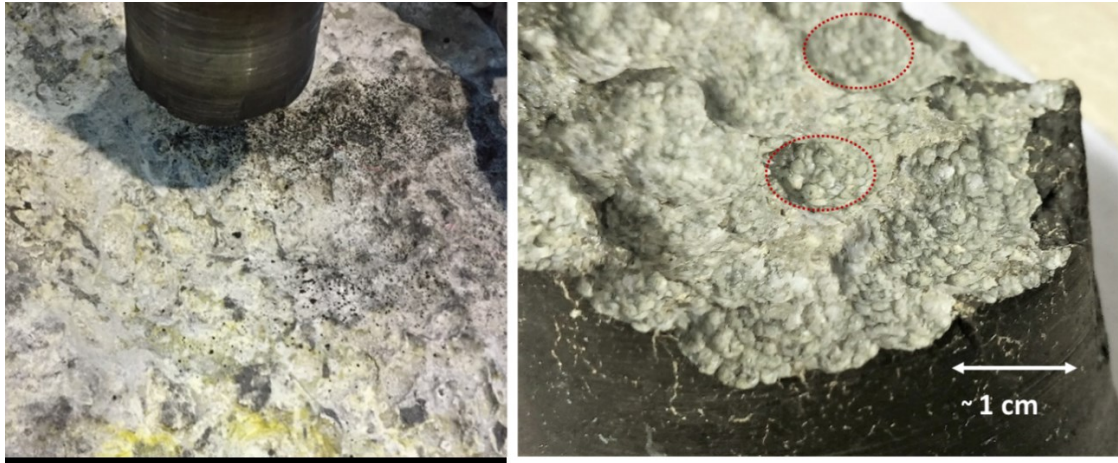
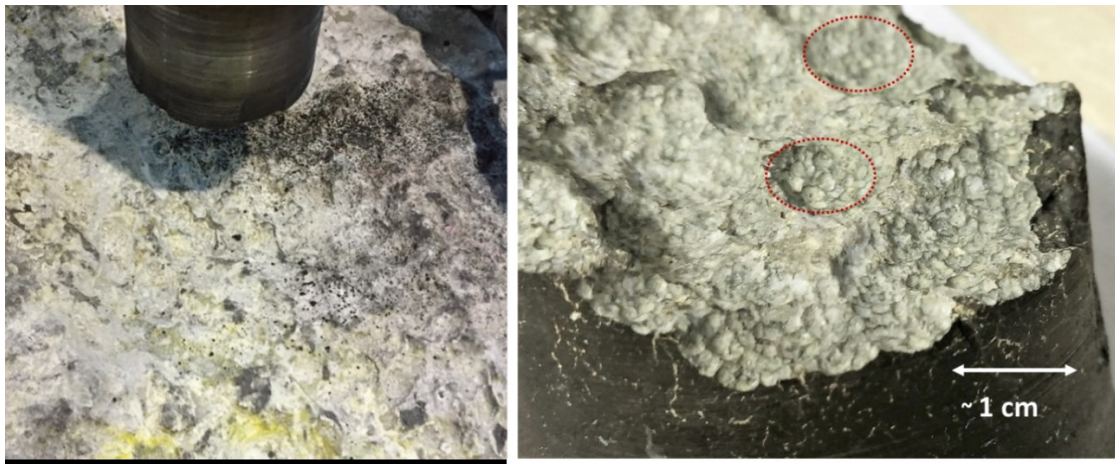
Figure 42. Pitting on the cathode surface of a spent potlining.
Left picture includes part of the 5 cm diameter drill used to take core samples.
Right picture shows more details of the micro wear pattern.

Figure 42 shows pictures of the cathode surface with pitting corrosion in one of the potholes located towards the outer ends of a cathode block.

Typical for all cells were that the pitting cavities were larger in areas with high wear, i.e., more coarse cavities towards the cathode block sides and gradually smaller towards the centre of the cells where the overall wear was lower. The average size of the pitting observed on the cathode surface (Figure 1) was measured to be approximately 7 mm.
