Cathode Wear – Autopsy Findings Related to Degradation Mechanisms

Arne Petter Ratvik¹ and Samuel Senanu²

SINTEF Industry, Trondheim, Norway

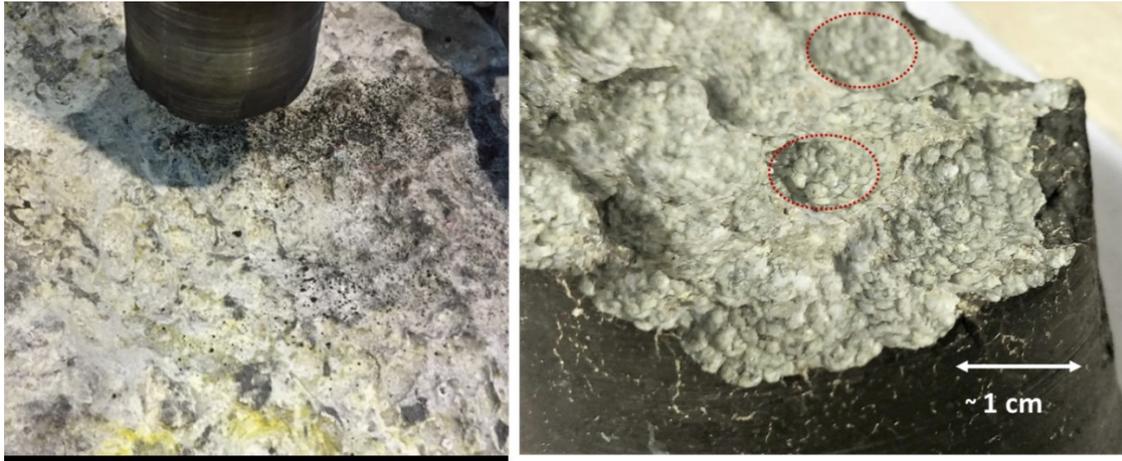
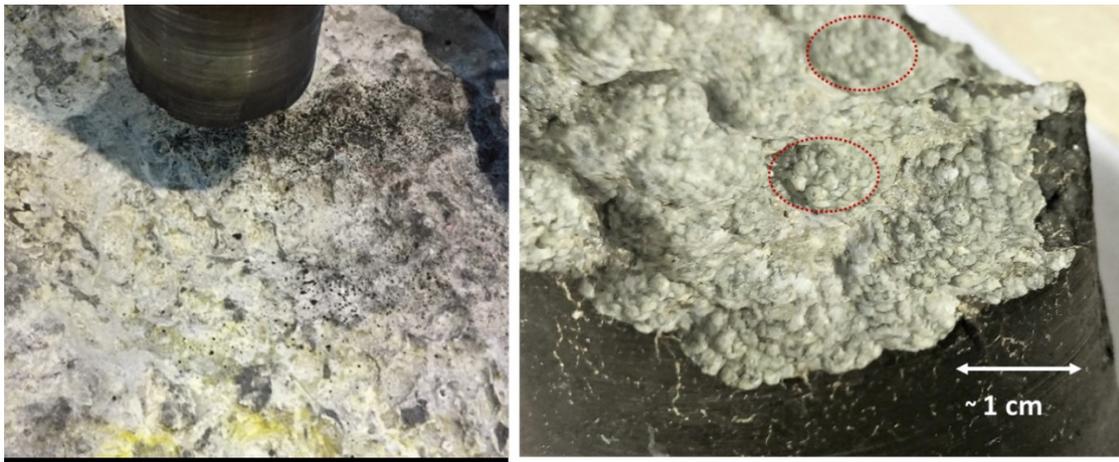
Figure 42 shows pictures of the cathode surface with pitting corrosion in one of the potholes located towards the outer ends of a cathode block.

Figure 42. Pitting on the cathode surface of a spent potlining.
Left picture includes part of the 5 cm diameter drill used to take core samples.
Right picture shows more details of the micro wear pattern.

Typical for all cells were that the pitting cavities were larger in areas with high wear, i.e., more coarse cavities towards the cathode block sides and gradually smaller towards the centre of the cells where the overall wear was lower. The average size of the pitting observed on the cathode surface (Figure 1) was measured to be approximately 7 mm.

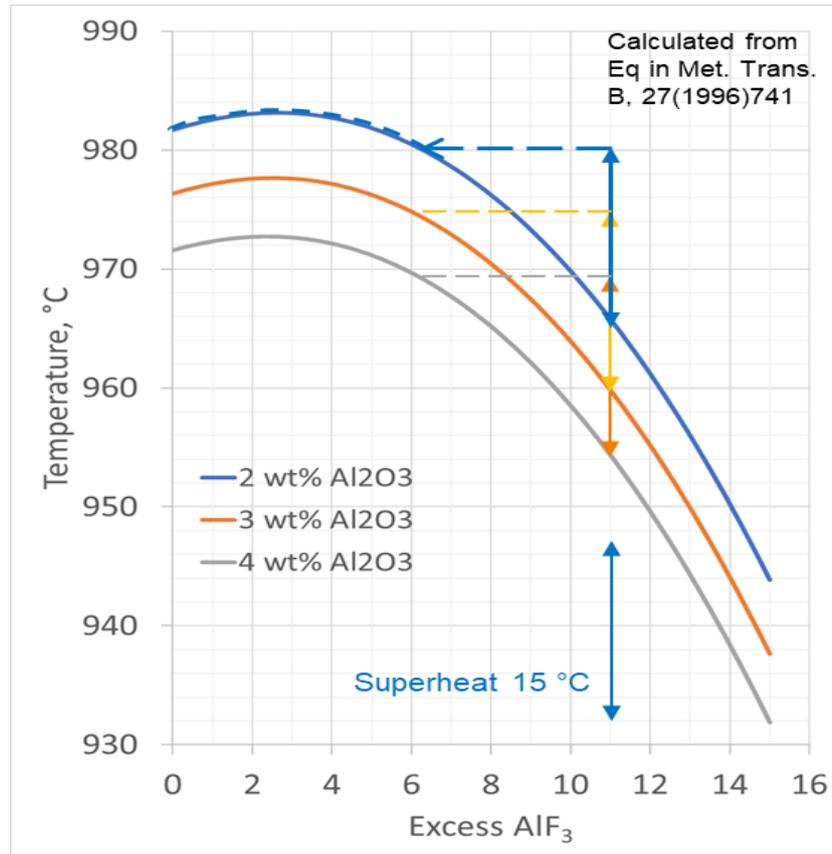
Figure 43. The liquidus curve for normal bath compositions with 5 wt% CaF₂ as function of excess AlF₃ and various Al₂O₃ contents.

X-ray diffraction analysis was used to study differences between regular bath samples above the metal pad with bath samples collected from carbon cathode surface. The regular bath samples had normal excess AlF_3 in line with normal bath compositions, while those collected at the
