## Analysis of Cathode Lining Failure Modes in High Current Density Cells at EGA

Emirates Global Aluminium (EGA), Al Taweelah and Jebel Ali, United Arab Emirates

### Abstract

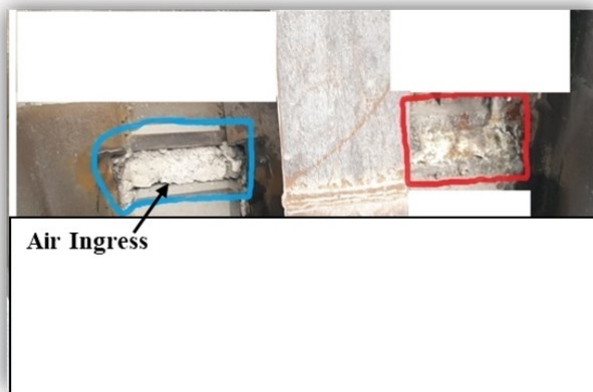
**Figure 3. Potential area of air penetration through collector bar window.**

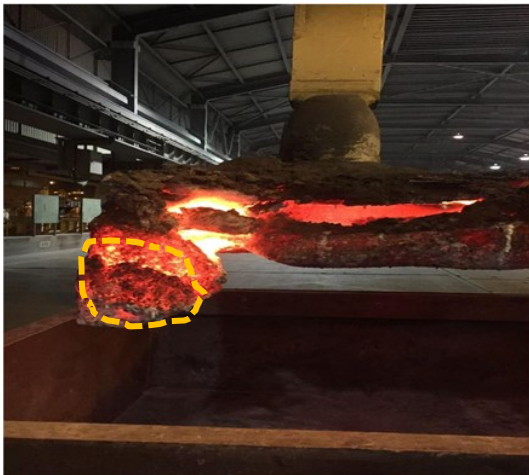
High operating temperature such as during an anode spike can lead to local decarburization through excessive heat generation. The situation can be worse in the case the total height of the spike (see Figure 4) meets the cathode surface. The local current density of the active area can reach more than 200 – 300 % of the nominal levels. This active area would be short-circuited, leading to hot spot, high temperature gradients, thermal stress, and cathode fractures. The larger the temperature difference the higher the stress in the cathode block. Theory shows that the total

Figure 4. Extended anode spike.

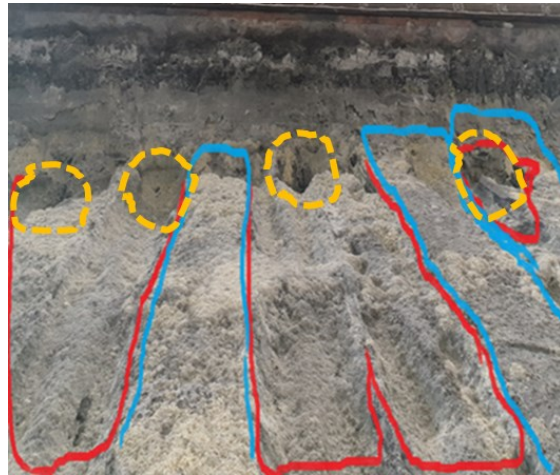
Figure 5 shows a carbon surface with deep-seated potholes (outlined in yellow) about 25 - 30 cm deep near the end of the carbon blocks under the shadow of a spike. It was established statistically that 90 % of the anode spikes occurred at the backside (towards the end of the blocks) and that is where the deep-seated potholes were located. In summary, there is coincidence (correlation) not causation between the deep potholes and anode spikes. Ideally, the anode spike should not reach the cathode level; its formation should be discovered earlier and the current through the spike disperses in the metal pad before it reaches the cathode block.

Figure 5. Deep-seated potholes in a graphitized cathode.

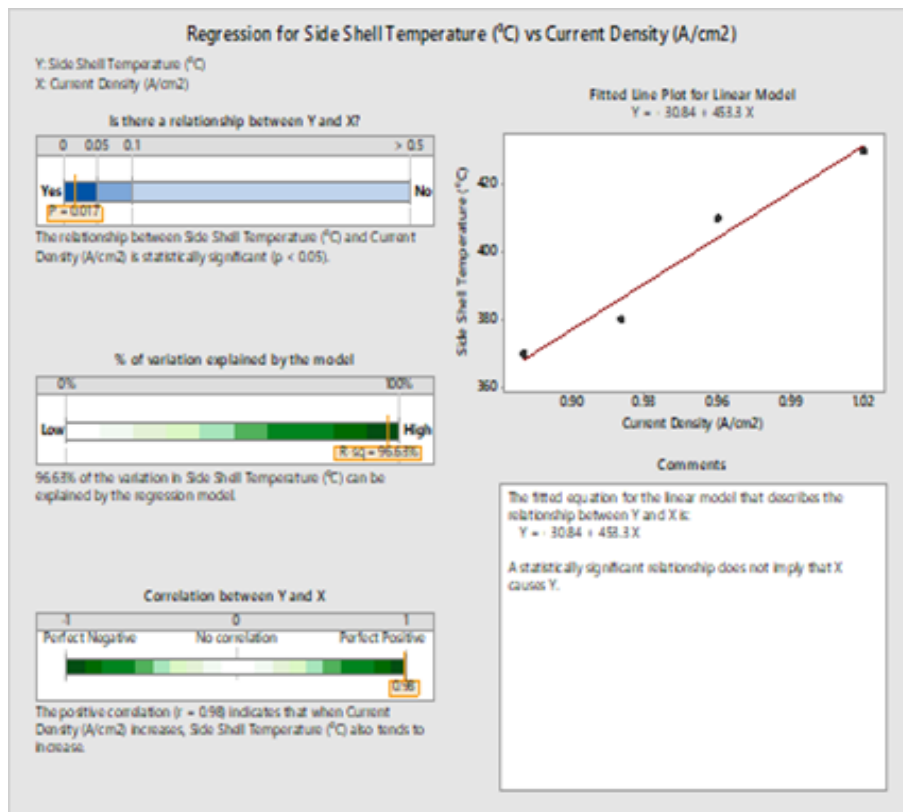
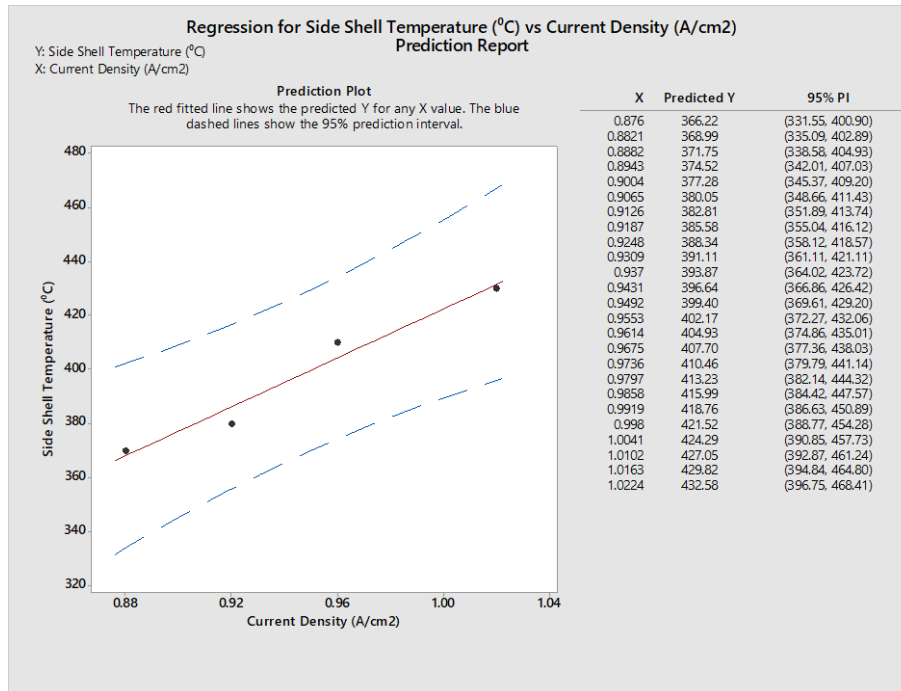
erosion or pothole formation. Figure 6 shows the regression of the sidewall temperature as a predictor of internal heat or current density shift during different phases of the amperage increase. The average sidewall temperature rose to 430 °C (standard deviation (SD) = 15 °C) when the current density increased to 1 A/cm<sup>2</sup>. Below 0.9 A/cm<sup>2</sup>, the average sidewall temperature ranged from 370 - 375 °C (SD= 10 °C), about 50 °C upward shift for additional 0.1 A/cm<sup>2</sup>. Premature lining failure was noticed a few months later after the electrical current density was 1 A/cm<sup>2</sup> and above. Figure 6 also shows the correlation between the current density (heat flux) and sidewall temperatures.

Figure 6. Regression of the sidewall temperature vs. current density.

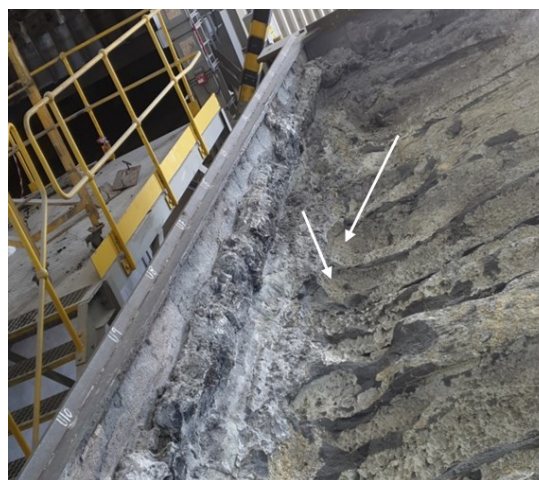
Figure 7 shows the shape of the flow in potholes. Observations of the shape of the potholes indicate that the fluid might have been turning around forming a vortex, which is driven by increased current flow into the pothole. These vortices increase erosion through slurry wear and through rapid removal of aluminium carbide that forms there. The location in the cell is an important factor of the vortex creation and slurry erosion; it has been observed that they are more frequently found opposite to anode risers (i.e., downstream).

Figure 7. Erosion pattern and indication of vortices.

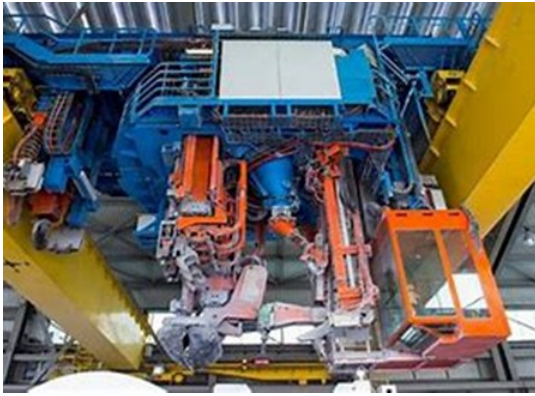
We measured the shovel stroke at the cathode-lining workshop in order to understand the possible influence of the shovel oscillatory frictions on the cathode deep-seated potholes. The stroke is the total vertical travelling when an operator decides to lower the shovel from top to the bottom of the anode cavity. The pot tending machine shovel (see Figure 8) has sharp edges and the two metallic buckets composing the shovel operate in a circular dynamic movement (CDM). The sharp edges, in addition to the CDM compared to a linear displacement of the buckets can create impingement of the fretted material. The magnitude of impingement depends on the load at the cathode surface and the hydraulic pressure exerted. The changing altitude and horizontal displacement of the shovel edges cause the CDM. A linear displacement potentially would allow smooth frictional results.

**Figure 8. Pot tending machine scoop.**

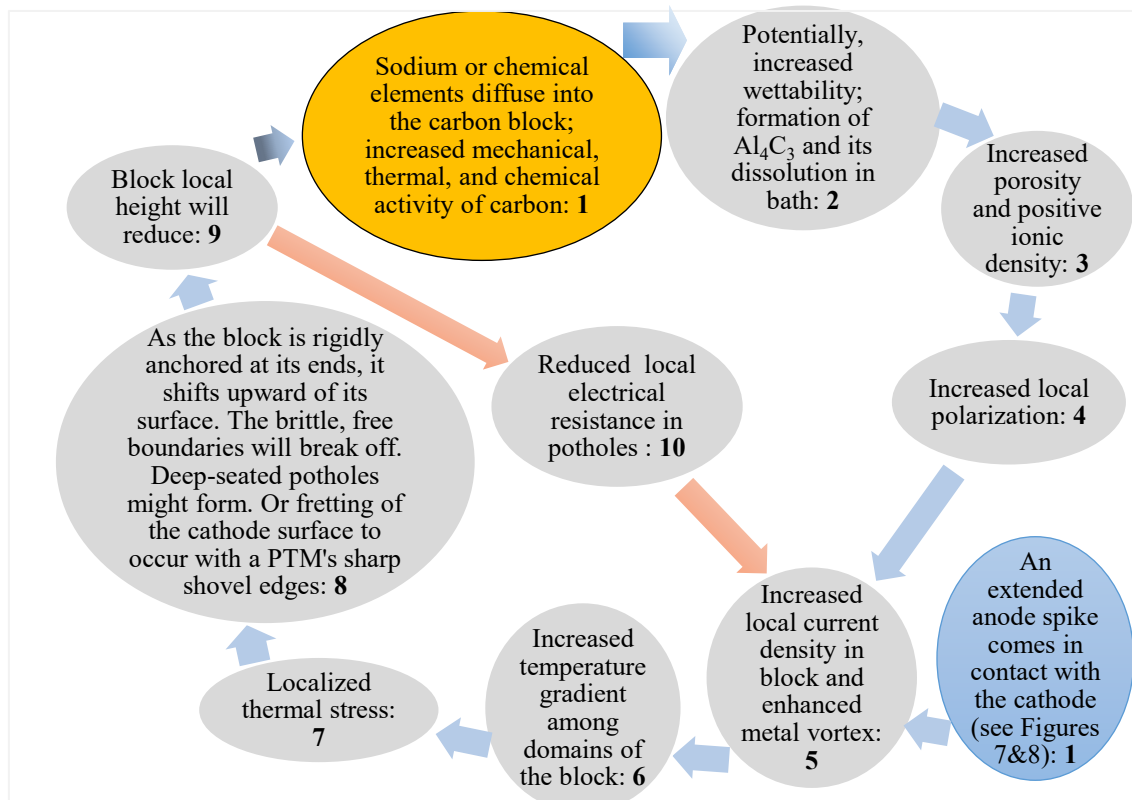
Conceptually, the deep-pothole formation in the cathode block can be summarized in the diagram outlined in Figure 10. The process steps are numbered from (1) to (10). The selected numbering order is, according to our view the most probable scientific explanations to describe the deep-seated pothole formation. Extended anode spike, even though it is rare, is pointed out as possible cause of deep-seated pothole formation through the mechanism of local overheating, thermal stress on the cathode, boundary busting, reduced block height, and increased current density and erosion.

Figure 10. Deep-seated potholes formation: Physical and electrochemical mechanisms.

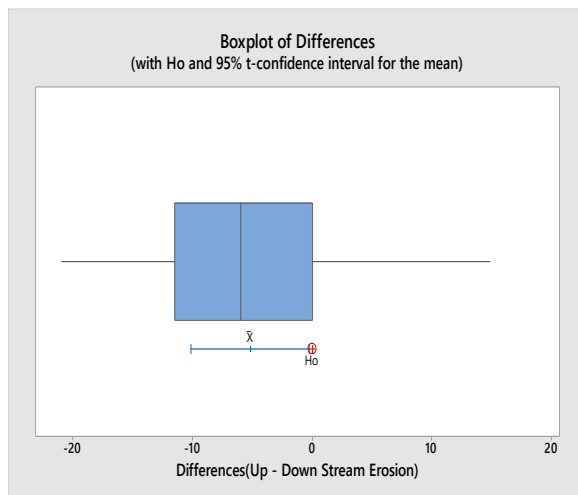
The test indicated that the means of the total erosion depth in up and downstream were statistically different (see Figure 11,  $\mu_d - \mu_u = 5$ , P-Value = 0.040). The standard deviation was 10 in the downstream and 9 in the upstream. The high standard deviation was revelatory of heterogeneous erosion among blocks. The outlier observed for the erosion rate was around 9.5 cm/year.

**Figure 11. CI for the erosions (Upstream – Downstream).**

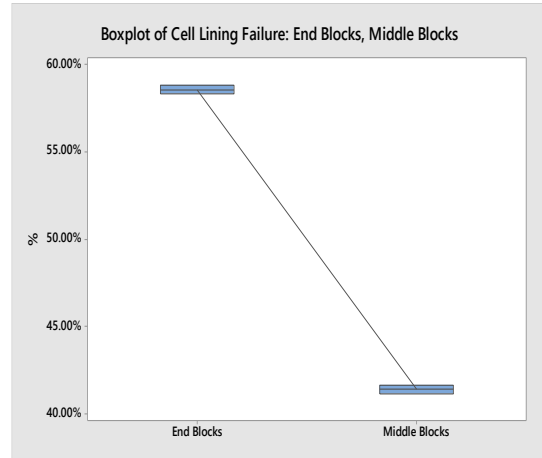
Similarly, 58.3 % of the failures occurred from the end blocks and 41.7 % from the middle blocks. End blocks are the last six of each end. The end blocks compose 42.8 % of the total number of blocks but contribute for 58.3 % of the cell lining premature failures (see Figure 19). The relative risk factor to failing from end blocks is 39 % (58.3/41.7) higher than the middle ones. The risk factor is any inherent attribute, characteristic, or exposure that increases the likelihood of developing abnormal erosion leading to cathode failure. Figure 18 shows actual failures as well as the near misses cases registered. Near misses are cases that had strong potentiality to fail, but which operation teams identified and neutralized before occurrence. The data showed similar findings.

Figure 18. Lining failure distribution: Middle vs end blocks.

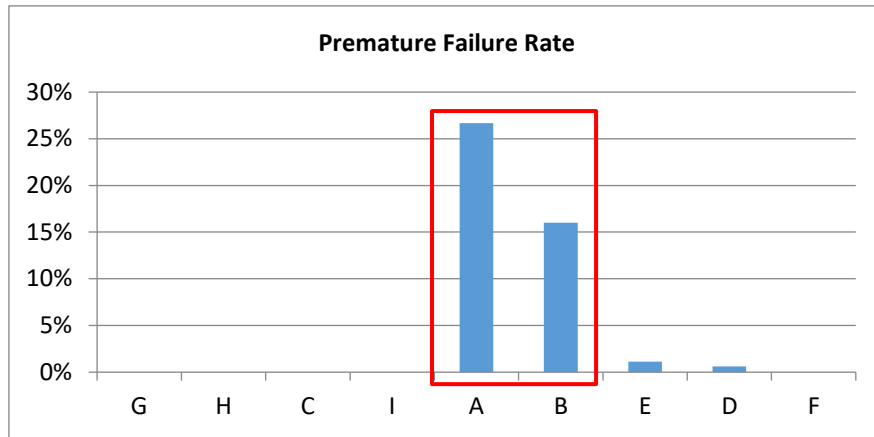
The particularity of these grades is that they have smaller resistivity, high thermal linear expansion and some are isotropic. For instance, the thermal linear expansion ratio of A to C was calculated at 1.8; notwithstanding, the sidelining configuration does not differentiate or consider such discrepancy. Typically, nine different grades are installed; only two are prone to high premature failure rate (see Figure 20).

Figure 20. Cathode grade-based premature failure rate.

We found that premature lining failure was high in cathode grades A and B, 26 and 15 % respectively. Statistical analysis indicated high correlation between current density and sidewall temperature. High current density increases electrochemical erosion, carbide formation, and thermal expansion. Side lining configuration should be adapted in accordance to each cathode grade thermal expansion coefficient. Companies operating high-current density reduction cells should avoid these cathode grade types.
