Laboratory Evaluations of Ceramic Sideline Materials

Egil Skybakmoen

Research Manager, SINTEF Industry, Trondheim, Norway

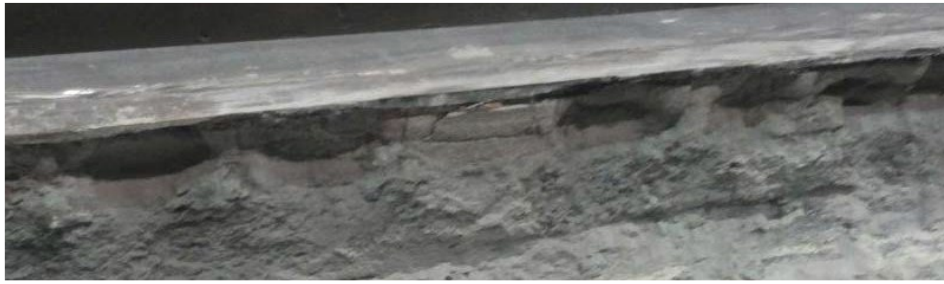
Figure 1. Example on severe degradation due to bad quality sidelining material. Plant A.

We do know from industrial autopsies that degradation occurs during the lifetime of the cells. The degradation mechanism and some properties of used sideline materials are reported earlier [7 - 9]. In some cases, severe degradation has been observed at the level above the bath, as shown in Figure 1 and Figure 2, also after short time of operation. The reason is bad quality sideline materials as explained later in the paper.

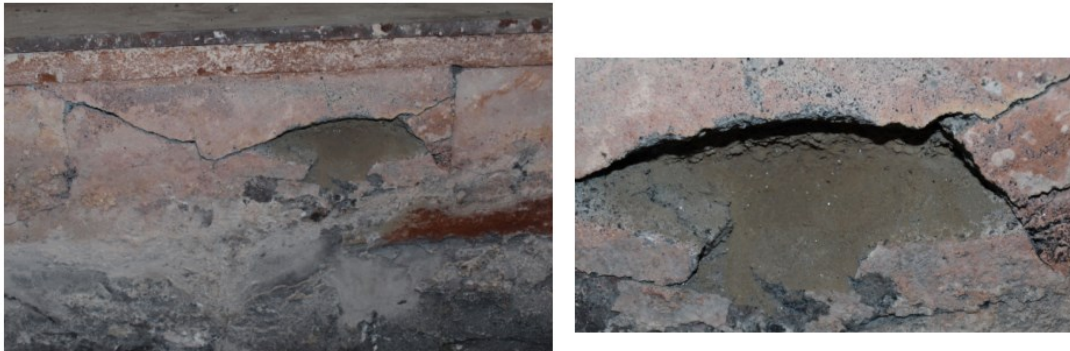
Figure 2. Example of severe degradation due to bad quality sidelining material. Plant B.

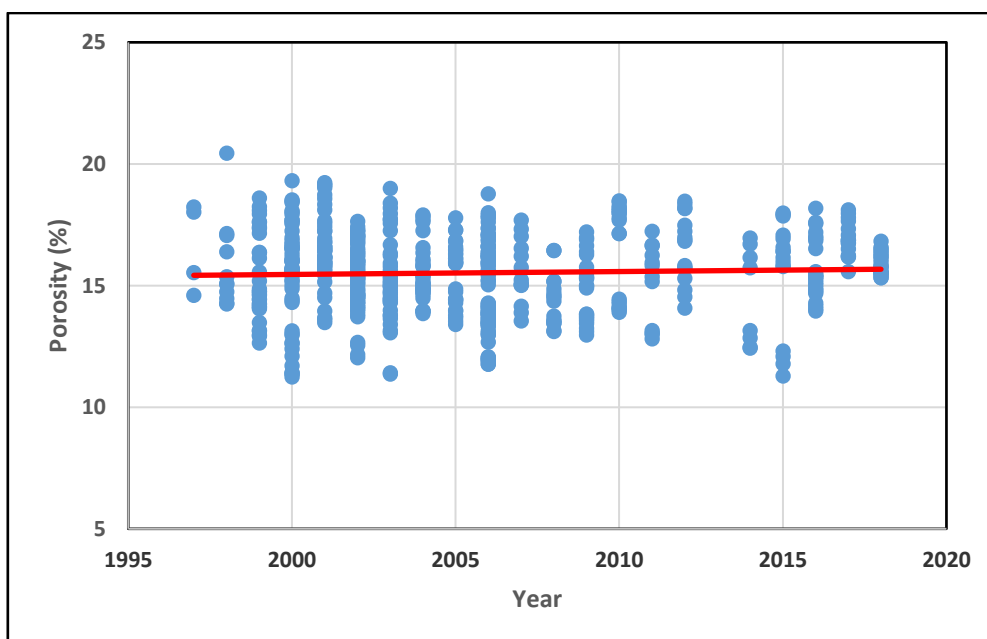
As stated above, the materials are not homogenous. As an example, the porosity variations is shown for all samples tested in Figure 8. There are large variations within the positions in the blocks as well as between different types of materials. However, there is no specific time-dependent trend. The average porosity is $15.53 \pm 1.67\%$ varying from 11.24 to 20.45%. The average value of density is $2.68 \pm 0.05 \text{ g/cm}^3$ varying from 2.51 to 2.86 g/cm^3 , see Figure 9.

Figure 8. Porosity variations in tested samples as function of time.

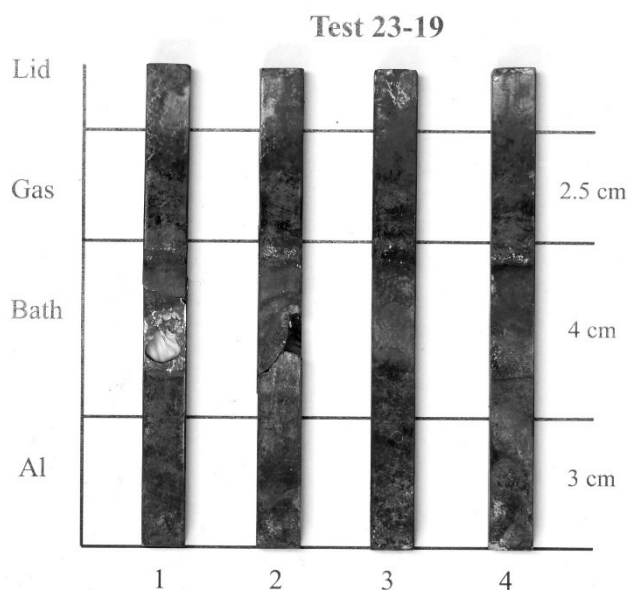
In order to evaluate alternative ceramic sidelining materials, pure and dense SiC was tested. The samples tested had low porosity ($< 0.1\%$) and high density (3.15 g/cm^3). Pictures of the samples after the test is shown in Figure 13. As seen the degradation is almost not visible and the degree of degradation was nearby between 0 - 1.

Figure 13. Dense SiC after the 50-h test.
