Cathode Life and Failure in a High Amperage CWPB Potline

Liu Zheng¹ and Yi Xiaobing²

CHALIECO GAMI, Guiyang, China

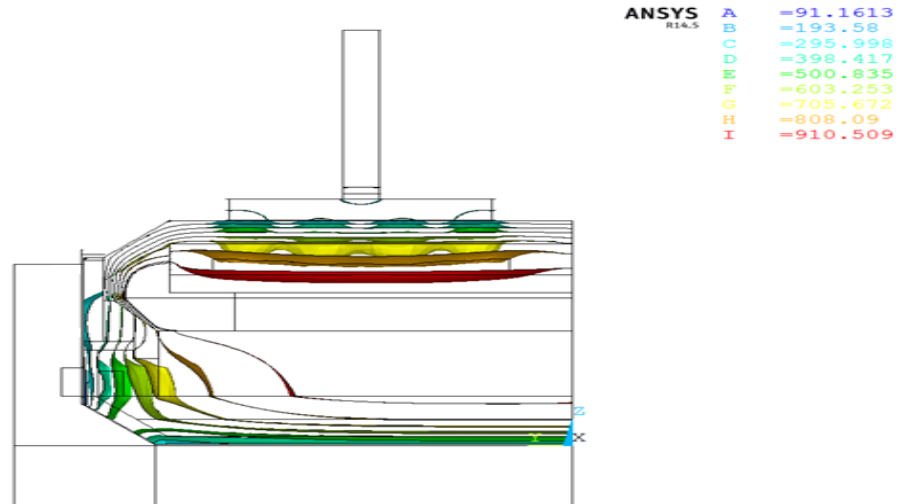
Fig. 1 presents the simulation of lining isotherm distribution for one kind of larger pots:

Fig. 1. Simulation of lining isotherm distribution for one kind of larger pots.

Lining engineering of larger pots consists of thermal equilibrium and mechanical stress engineering. The key principle of lining thermal equilibrium is that the bath solidification isotherm should be located within the refractory brick structure that is beneath cathode blocks, and 800 ~ 900 °C isotherm should be located in the impermeable structure above thermal

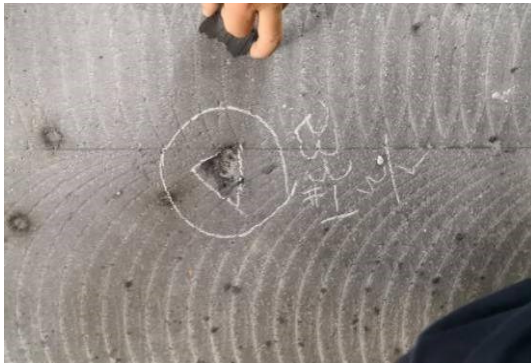
To find out the causes for pot lining failure and avoid such failure to happen again, expert team had an intensive study for cathodes of non-startup pots and finally found that there was one supplier who supplied cathode with obvious quality problem. After careful examination, experts found the surface of cathodes had holes and cracks, shown in figures 3 and 4.

Figure 3. Cracks in Pot #1540 A16.

After investigation, experts came to conclusion that the the reason for such phenomenon was that the manufacturer used different batches of aggregates, of which the technical parameters varied widely. Research showed that type and grain diameter of aggregates, temperature, heat-up time and vibration time had remarkable impact on the functions of chemisorption, surface wettability and capillary penetration between aggregates and the adhesive material. The impact was directly related to the infiltration effect to aggregates given by coal tar [6].

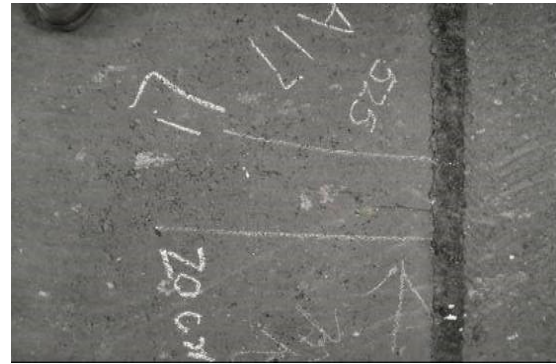
Figure 4. Cracks in Pot #1534 B18.
