## Welding Damaged Risers and Busbars without Potline Outage

Aluminium Dunkerque, Loon Plage, France

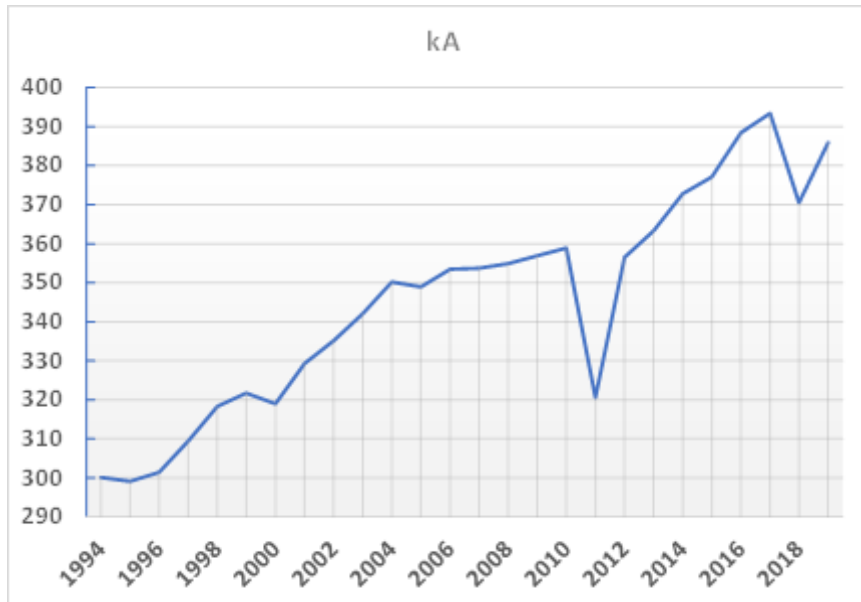
**Figure 1. Amperage increase in Aluminium Dunkerque.**

During the different amperage increase projects over the last 30 years (Figure 1), the busbar system was not modified. In the meantime, the increase in magnetic fields led to difficulties in welding on the anode risers thus deteriorating the resistance and increasing the temperature of the busbar system. In recent years, Aluminium Dunkerque noticed an increase in bus bar or weld

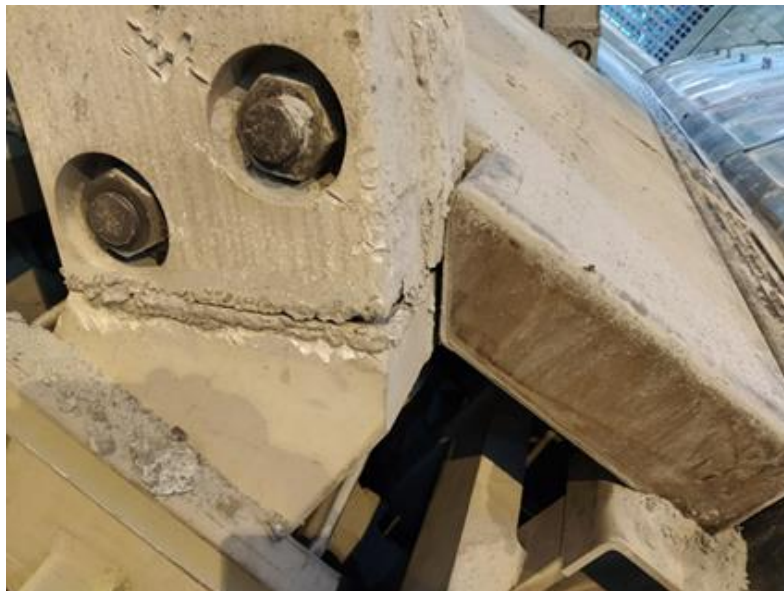
**Figure 2. Example of broken weld on the middle riser.**

breakages (Figure 2), deteriorating the stability of the pot itself or the neighboring pot. All repairs required a potline outage to weld on these pots; therefore, and like many smelters, Aluminium Dunkerque was usually waiting to have a minimum number of pots to repair to initiate a potline outage (duration 30 to 45 minutes). In the meantime, damaged pots were monitored closely and required multiple actions to maintain an efficient electrical contact on the damaged bus bar. Nevertheless, the pot instability would still remain higher than in a normal configuration thus leading to the loss of current efficiency.

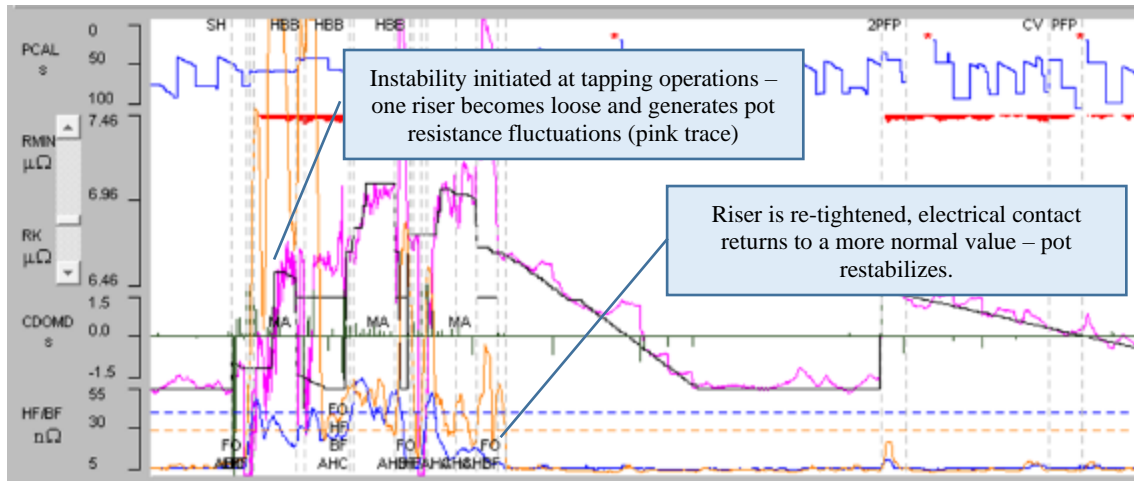
Figure 3 shows an example of pot behavior with damaged weld on an anode (positive) riser; even if the riser has been tightened to recover the best electrical contact possible; the anode beam movements during tapping generate movements on risers, ending up with a loose electrical contact. As soon as the riser is reconnected and tightened properly the pot recovers its stability.

**Figure 3. Example how a broken weld on an anode riser causes pot instability.**

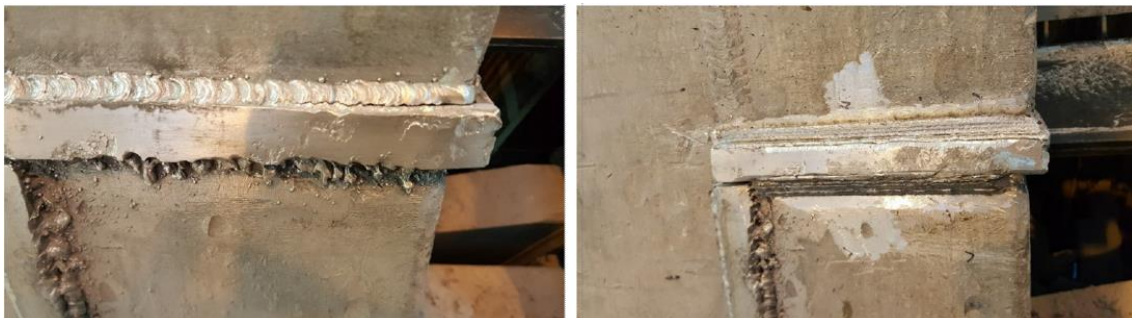
**Figure 4. Usual anode riser welding (left) vs laser welding (right).**

The main objective was to reduce the delay between busbar breakage and repairs, and repair the busbar without any potline outage. Aluminium Dunkerque investigated laser welding solutions. These enable welding at full amperage (tested up to 360 kA according to suppliers) and reduce voltage drop across the weld by at least 10 mV compared to regular welding. A visual comparison between these two types of welds is shown in Figure 4.

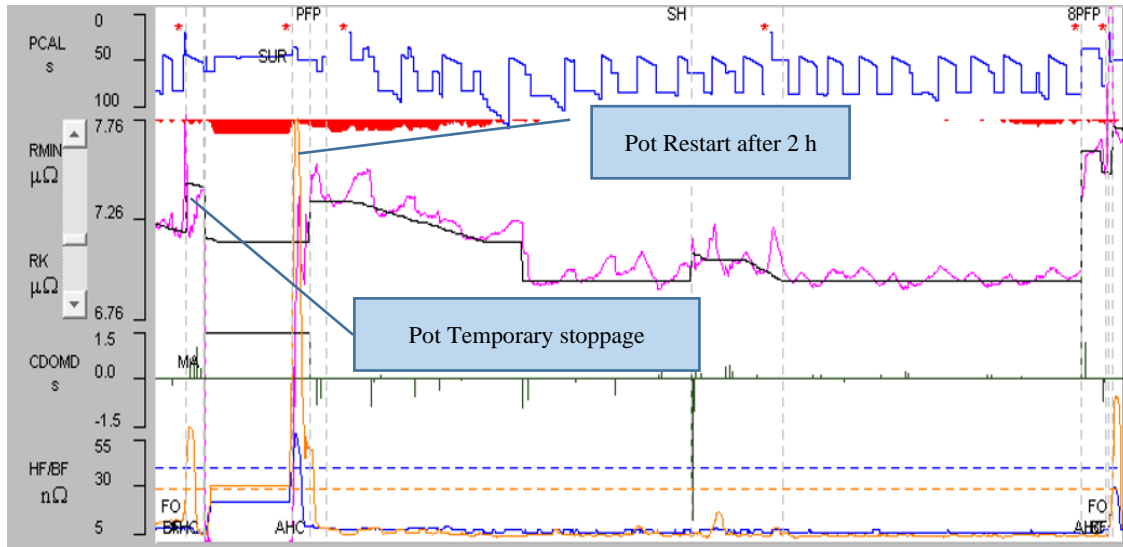
**Figure 6. Impact of a 2-hour shutdown of a pot.**

Aluminium Dunkerque has been able to reduce or eliminate the need for potline stoppages to carry out busbar and anode riser repairs. In 2020, no scheduled potline shutdowns were launched for repairs, compared to the usual 3 to 4 per year in previous years. The procedure developed by Aluminium Dunkerque for shutting down and restarting the pots allows for almost immediate return to normal operation (Figure 6). Aluminium Dunkerque, following its new procedures, is

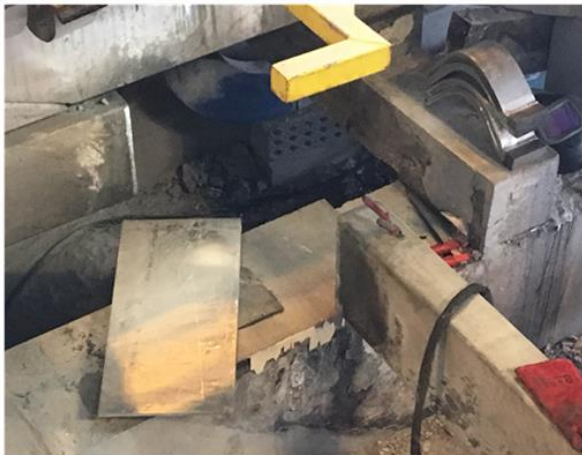
**Figure 7. Bus bar prepared before welding (damaged part has been cut off).**

able to re-weld massively damaged conductors due to pot leakage as well as anode risers. Some examples of welded busbars with the new procedure are shown in Figure 7.

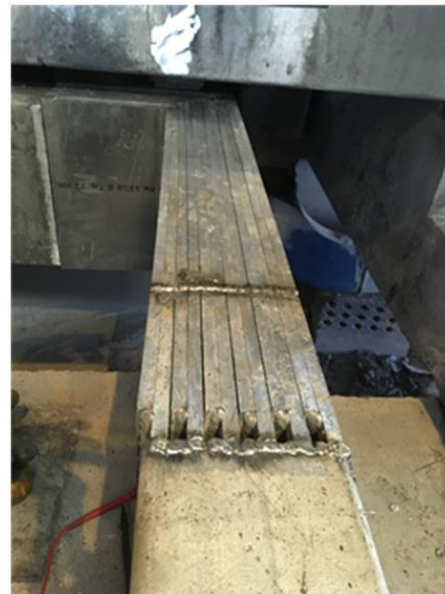
**Figure 8. Bus bar after its welding repair (located under the potshell).**

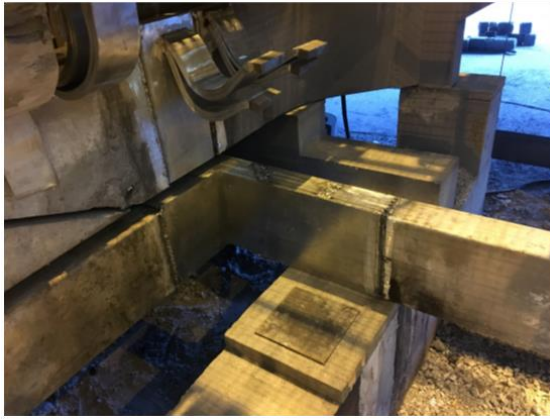
**Figure 9.** Same as Figure 7 with different view.

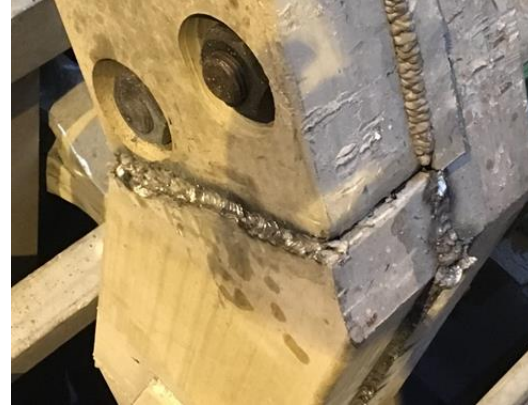
**Figure 10.** Anode Riser C located in the middle of the pot.
