## Welding Damaged Risers and Busbars without Potline Outage

Aluminium Dunkerque, Loon Plage, France

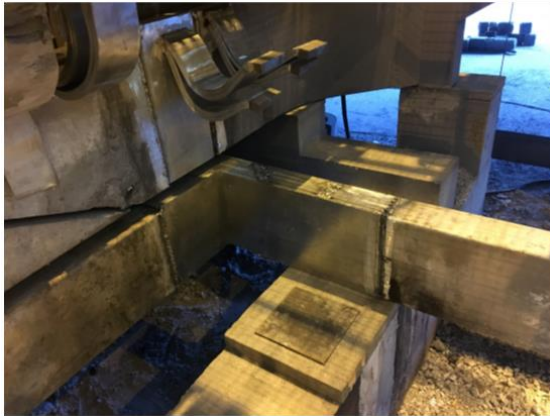
**Figure 9.** Same as Figure 7 with different view.

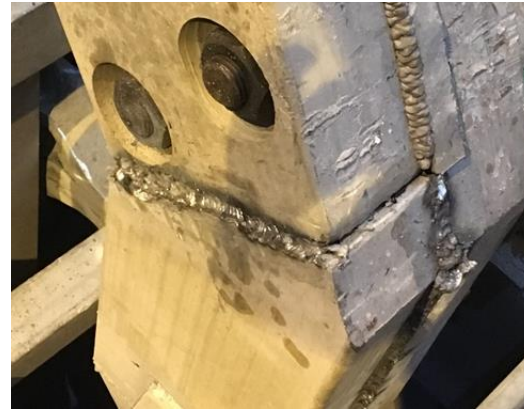
**Figure 10.** Anode Riser C located in the middle of the pot.
