## Busbar Integrity in Potline Tunnels in EGA Jebel Ali Smelter

### Abstract

This paper describes practical investigations of the busbar tunnels in EGA Jebel Ali, as well as examples of corrective actions for busbar integrity and safe future operation of potlines.

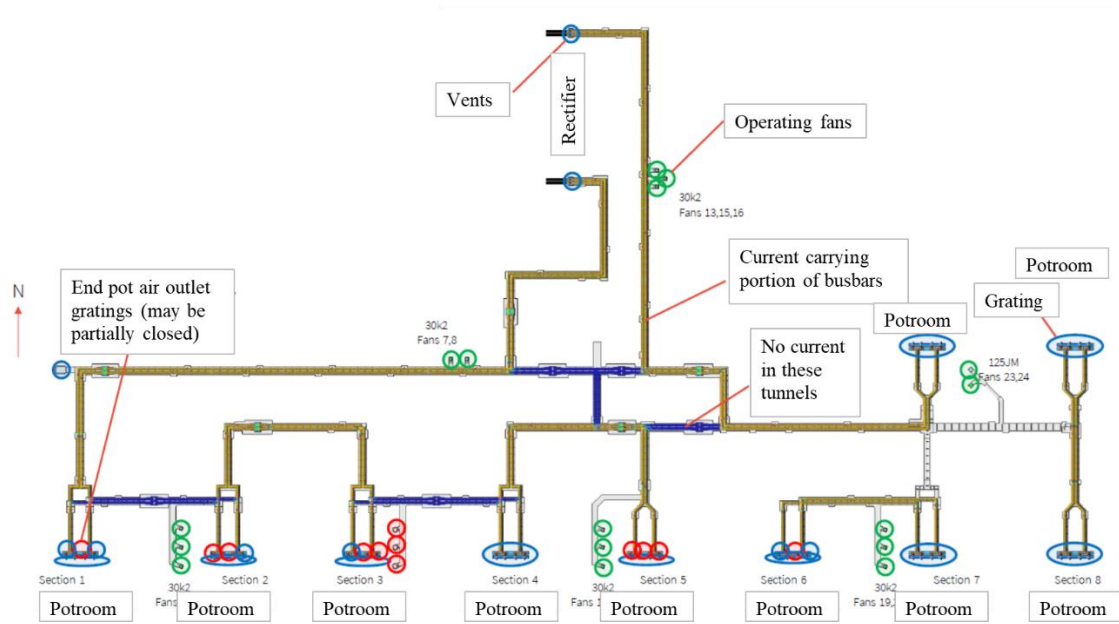
**Figure 2. System of busbar tunnels in Potline 9, which has 10 potrooms (modified from [2]).**

In Jebel Ali smelter (Figure 1), each potline consists of sections of pots and busbar linkages, connecting these sections. The linkages consist of passageways between pot sections, end-of-potline crossovers, emergency crossovers and connections from end pots to the rectifiers. All these linkages are installed in tunnels, from simple to complex, below the potline passageways or roads. The most complex system of linkages is in Potline 9 at the rectifier end, shown in Figure 2. Another complex system is Eagle Section of Potline 5 (Figure 3), where five demonstration cells are installed, and are fed by the current from Potline 5 and the booster circuit. All tunnels are equipped with powerful industrial cooling fans in different configurations; altogether there are 131 fans in Jebel Ali smelter. The tunnels and the fans were designed with traditional engineering practices at the time of potline construction without the aid of Computational Fluid Dynamics (CFD) which was not yet available.

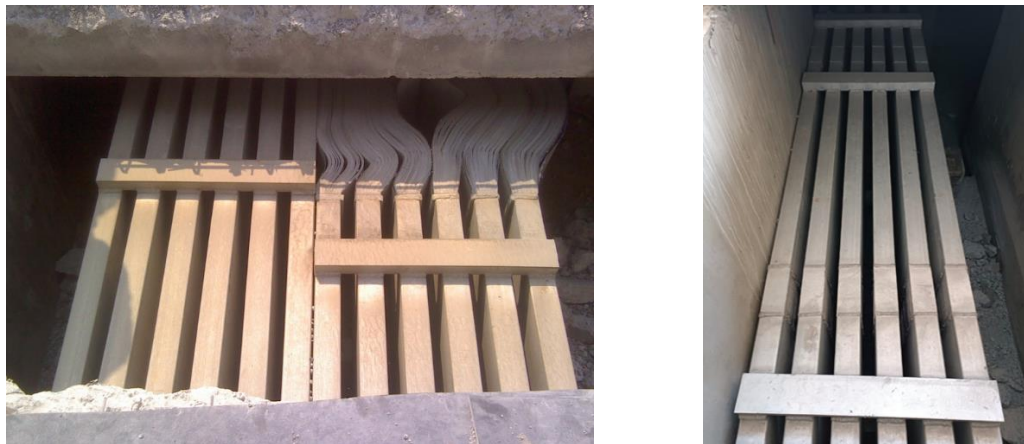
In crossover busbars between two potrooms, there are two packs of busbars carrying current in the same direction. In each pack, the busbars are separated and held in position by welded tie-bars on the top, whose role is to keep the busbars separated and at the same electrical potential which assures equal currents in each busbar. In the central section of the crossover, the two packs of busbars are in the same tunnel, which by design were separated by 350 mm, but no separators were installed. The result was the displacement of the two packs towards each other by attractive electromagnetic forces as shown in Figure 4. It appears that this happened all along the tunnels, starting at the first flexible. The only consequence of this is a reduction in cooling of the central two busbars. It is estimated that the busbar temperature in the two busbars in contact is less than 10 °C higher than if the busbars were separated. This abnormality does not affect the safe operation of the busbars, particularly since the tie-bars were not broken anywhere, and it was therefore decided to leave the busbars as they are. The flexibles were observed to be flattened on one side, but retained sufficient space for expansion; none were damaged (Figure 4, left).

In the approach to the end pot in all potrooms, the two crossover busbars are in separate tunnels as shown in Figure 3, at the distance of 6 m between busbar centrelines. The same situation is in the potroom passageways. On a few end crossovers, the electromagnetic force was strong enough to pull the busbar packs towards each other but they were retained by the inner wall of each tunnel as shown in Figure 4. In this case, too, the displacement does not affect safe operation and the busbars were left in displaced position.

The force between two conductors carrying current in the same direction is attractive, for currents in the opposite direction, it is repulsive. When the busbars are not far apart with respect to their height and width, the force per unit length of the busbar is given by Equation (6.1):

For the force between two busbar packs in consideration  $d \gg$  busbar height or width,  $k \approx 1$ , but for the attraction force between the busbars of a busbars in a pack,  $k = 0.5-0.9$ . For the busbar packs in the same tunnel, carrying 125 kA each at centreline distance of 0.54 m, the electromagnetic force between them is 5.8 kN/m by design and 8.9 kN/m when they are pulled together as shown in Figure 4. For busbars in separate tunnels at 6 m from each other, the force is 0.5 kN/m. This was still sufficient to displace the busbars as shown in Figure 4, right, since the flexibles at each end do not present much resistance against lateral displacement.

**Figure 4. Busbars displaced by attractive electromagnetic forces; left - 2 packs in one tunnel, right – 2 packs in different tunnels. Tie-bars were not damaged.**

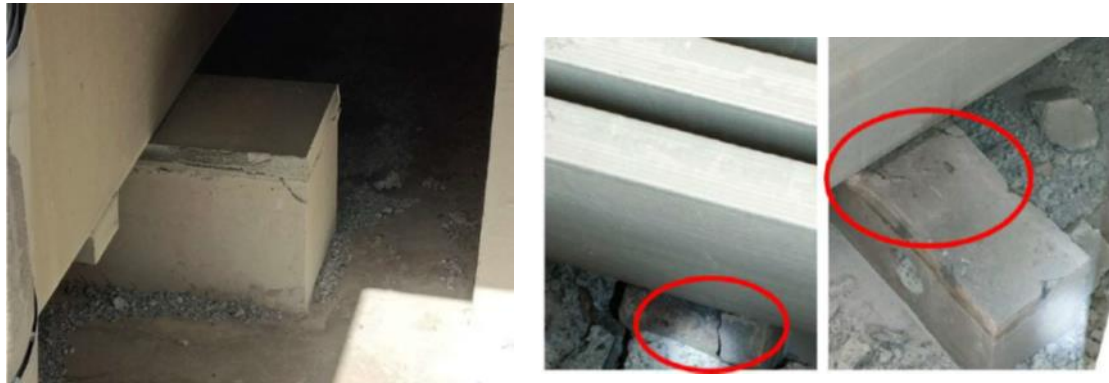
Observations were made on the sides of the busbars. Typical damage is shown in Figure 5. There could be cracked epoxy grout, cracked concrete or detachment of epoxy grout from the concrete below. In most cases, it looks that the damage is only peripheral and will not be a risk for future operation since the busbars in a pack are tied together and act as a whole block. For the damage to be significant the whole length of the support would have to be damaged, but this evidence was

**Figure 5. Typical damage to the busbar supports. Left: detachment of epoxy grout; this does not need repair. Right: Cracks that were recommended for repair, even though they do not compromise busbar integrity.**

not found. Nevertheless, it was recommended to evaluate possible repairs and to examine the supports below the busbars with a remote camera before any repair is undertaken. Of course, some supports will be repaired in the side channels, where the access is possible.

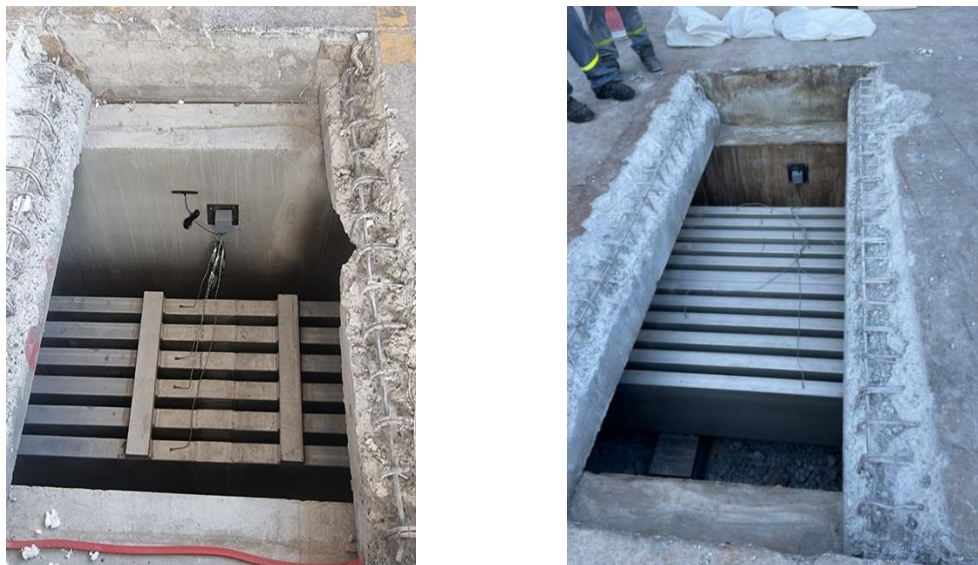
**Figure 6. Tunnel sidewalls not damaged. Left – Potline 9, right – Potline 7 long tunnel. Both show busbar temperature monitoring thermocouples discussed later.**

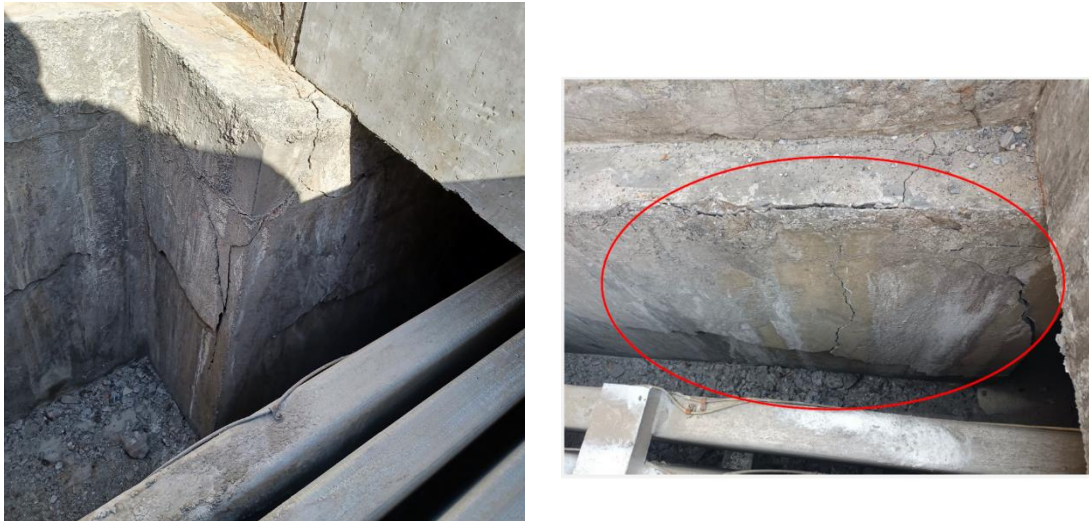
The most vulnerable parts of the tunnel concrete are cover slabs and the upper parts of the sidewalls because these are at the highest temperature. Most cover slabs were damaged by excavation, but some were also cracked by heat. All these had to be replaced with new ones, which were designed so that they can be easily opened in the future. Most sidewalls were also not affected or very little and were strong enough to hold the new slabs (Figure 6). In a few cases, however, the damage to the cover slabs and sidewalls was substantial: the cover slabs were heavily cracked or disintegrated when being removed. In two tunnels, the sidewalls were also heavily cracked; an example is shown in Figure 7. In these two cases the entire tunnels were rebuilt, which required an installation of the busbar bypass and the removal of the existing busbars in order to continue the potline operation.

**Figure 7. Damaged tunnel walls in Potline 6 south below the gantry road, which had to be rebuilt.**

Most of the tunnels were in good condition, however, Potline 5 north and Potline 6 south tunnels showed signs of major deterioration and required immediate action. In Potline 5, civil work in B-room north tunnel has been completed, Work is ongoing in A-room tunnel and it is estimated to complete it by the end of November 2022. Potline 6 south tunnel repairs are starting in September 2022.

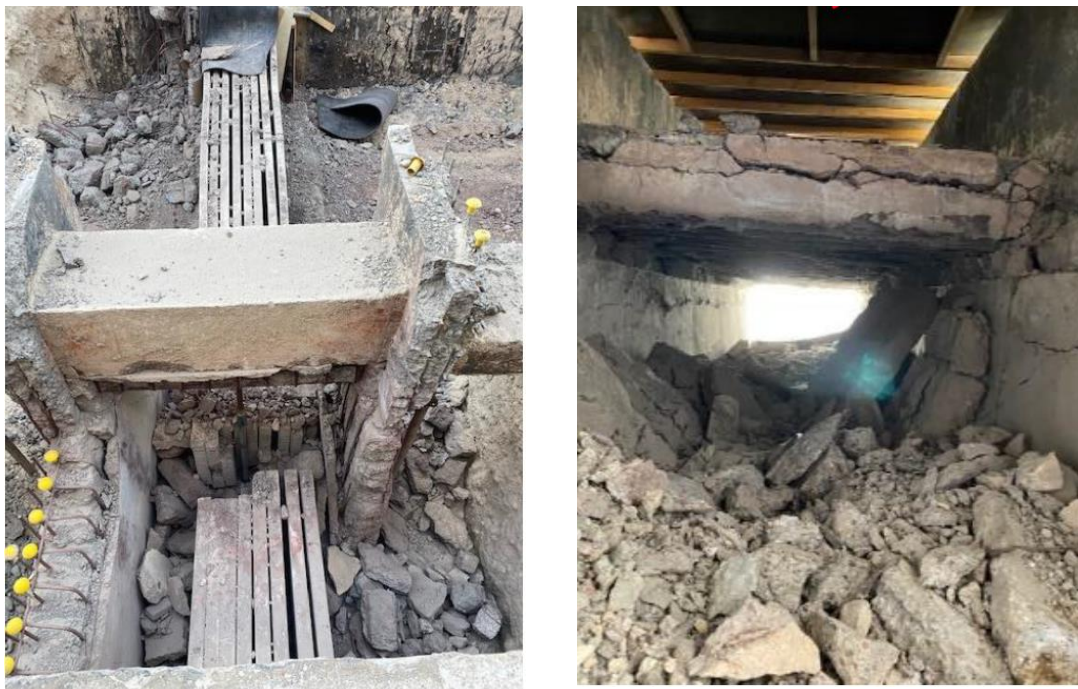
**Figure 9. Root cause of Eagle incident. Left: busbar cut off in east tunnel. This was the first event. Right: lower ceiling (of double ceiling) decomposed and collapsed onto the busbars in east tunnel.**

During a few months when it was not known that the busbar in east tunnel was cut off, calculations were made to explain the incident. By reverse engineering, starting from the position of the compensation loop at tap end, the electromagnetic force required for the loop displacement was calculated and from the force it was calculated that more than 400 kA had to flow in the loop. This was confirmed later as described above. In fact, 480 kA was flowing in the loop when it was displaced. With this current, the electromagnetic force on the loop was 7 kN/m, which gave it a horizontal acceleration of 1.7 times the gravity.

It was also calculated that no electrical pulse produced by the electrical arc in the west tunnel would be able to send such a high current in the loop. In fact, a pulse of only +15 kA, -53 kA was recorded in the booster circuit on the current monitoring systems during the incident. Calculations show that in steady state, the compensation loop carried only 65 kA when busbars were still connected in only one tunnel, which is not even twice the normal loop current. It was not possible to explain what happened if the busbars were cut only in one tunnel as it was assumed initially.

As the solution for safe operation in the future the following actions were taken:

Both, east and west tunnels below the gantry road supplying Eagle current were enlarged and completely rebuilt,

- The busbar cross-section was increased by 25 %, thus reducing the current density from 58 A/cm<sup>2</sup> at 480 kA to 48 A/cm<sup>2</sup> at 500 kA
- The ventilation of Eagle busbar circuit was optimized as described in [2],
- The compensation loop was rebuilt as before, but with much stronger lateral supports. Continuous current monitoring with LKAT Hall sensor device from Dynamp was installed and a high-speed, high-power ABB circuit breaker was installed in the loop to switch it off, should the current, measured by LKAT, increase beyond a specified limit.
- Eagle pots were restarted with a new design in March 2022 at 500 kA.

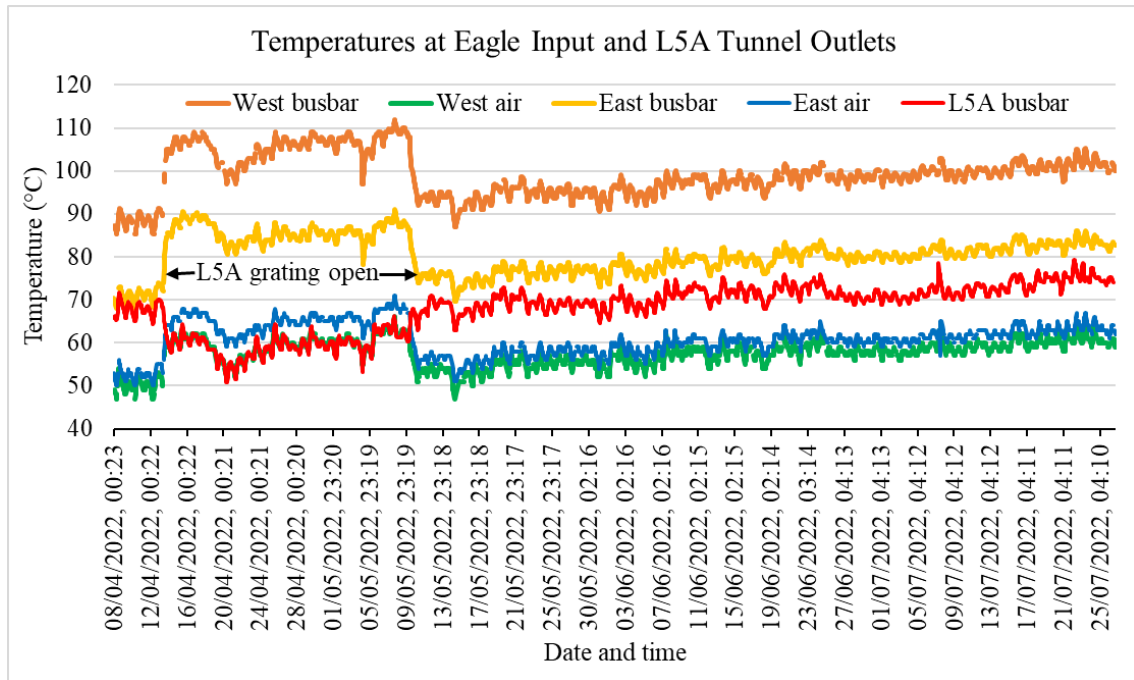
The optimal amount of partial closure of pot-well gratings at Pot 121 of Potline 5A was determined with these measurements and also the air deflector size and inclination of Eagle fan at entrance into the basement upstream of Eagle pots. Four 50 mm wide, 1000 mm long gaps are sufficient for the two tunnel outlets at Pot 121. In another measurement the gratings at Pot 121 were completely open; in this case 12.3 kg/s was escaping through these gratings and only 4.2 kg/s went through each Eagle tunnel. High air flow rate in the tunnels towards Pot 121 is not required, which is witnessed by quite low busbar temperatures at that location, shown in Figure 10.

Figure 10 shows busbar temperatures at the outlet of the two Eagle input tunnels, at the same place where the cooling air flowrate was measured, given in Table 2. Measured busbar temperatures at the outlet of the east tunnel to Pot 121 in Potline 5A (PL 5A) are also shown. As discussed in the previous section, it is essential for Eagle input tunnels cooling that the large gratings at Pot 121 be partially closed to allow more air into Eagle input tunnels. The impact of closure on busbar temperatures was tested. Before 11 April the gratings had 4 openings of 75 mm x 1000 mm. From 12 April to 10 May, the gratings were completely open and since then, only 4 gaps of 50 mm (width) x 1000 mm (length) are open. During the opened gratings, the busbar temperatures at the outlet of Eagle input tunnels were 20 °C higher than when the PL 5A gratings were nearly completely closed. On the other hand, the large air flow through PL 5A tunnels decreased the busbar temperature in that location only by 10 °C. The optimized system now gives safe busbar temperatures, much below the acceptable limit, at both locations as seen in Figure 10.

**Figure 10. Continuous (hourly) monitoring of busbar temperatures in Eagle input circuit from 8 April 2022 to 26 July 2022. Temperature oscillations on the curves are daily variations.**
