Bauxite Residue Deposit Reclamation – a Pathway to Reintegration

Abstract

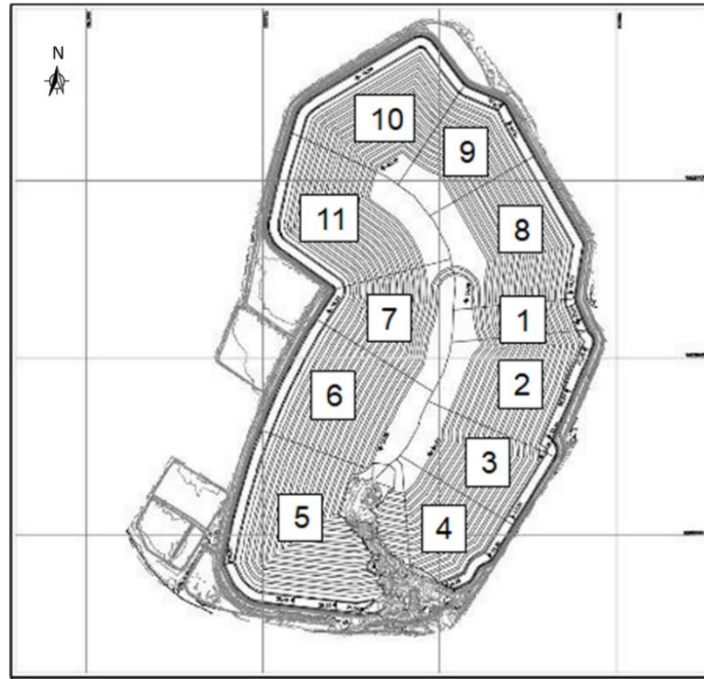
Figure 2. Rehabilitation s – DRS1, Hydro Alunorte.

The closure plan includes 11 divisions or strips within the 270 ha deposit area. The division areas vary from 6.7 ha (lane 1) to 30.5 ha (lane 5). The sequence for rehabilitation prioritized the areas with the highest potential for fugitive dust and visual impact mitigation (Figure 1). As a result, the rehabilitation starts from the center moving towards the edges. The starting point is from the oldest sectors of the deposit in the southeast (areas with no disposal since 2009), moving forwards to the southwest, and ending in the northern disposal areas. The construction sequence is presented in Figure 2.

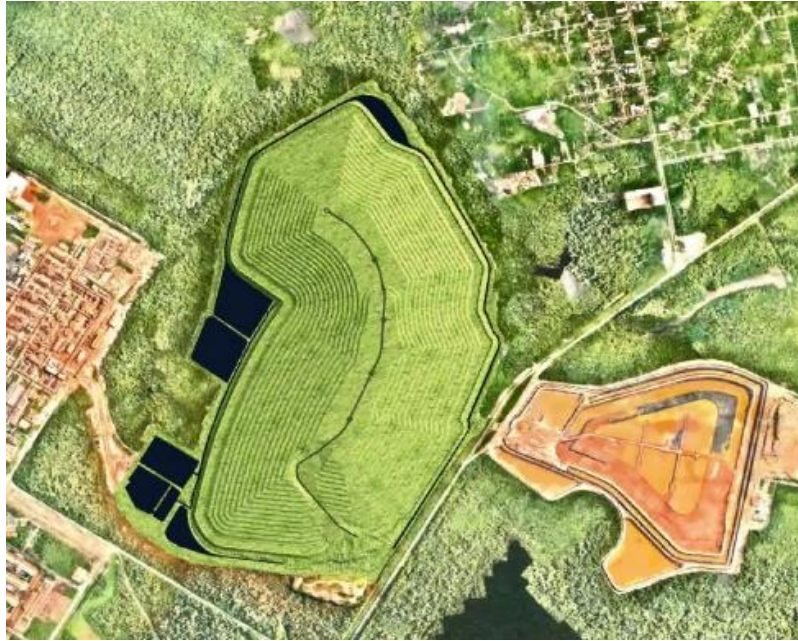
Figure 4. Digital Model of DRS1 Reclamation.

The final layout is presented in Figure 4.

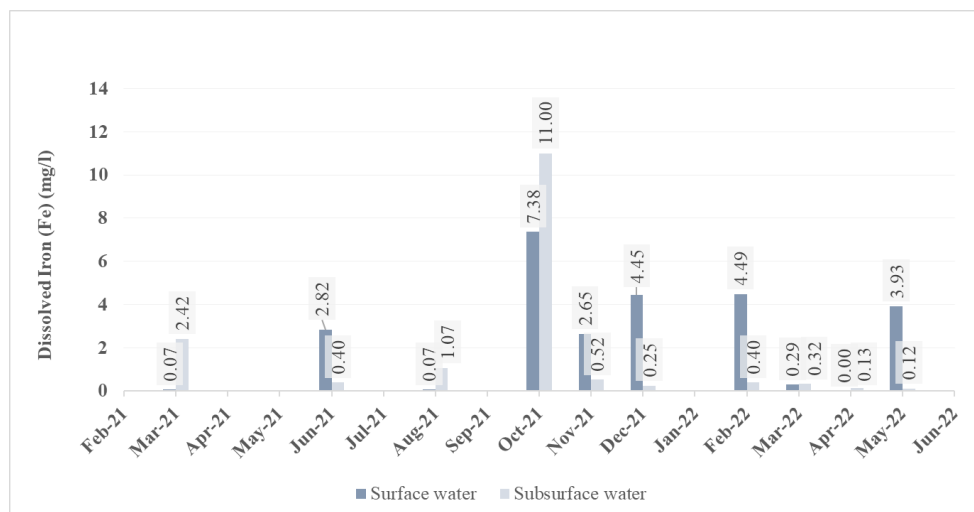
Figure 5. Dissolved Iron– strip 2 – DRS1, Hydro Alunorte.

The dissolved iron found in run-off samples from strip 2 was within limits defined by CONAMA 430, namely 15 mg/l, for the entire data collection (Figure 5). The monitoring showed a peak for dissolved iron in October 2021, potentially related to external interferences such as reshaping works in residue surfaces nearby the sampling point. The iron concentration in the run-off was mainly associated with natural occurrences in soil used in the coverage of strip 2, obtained from local excavations, which has an average concentration of 8.713 mg/kg for iron.

Based on water analysis, dissolved iron and aluminium reached peak values in October 2021, possibly due to external interferences. Nonetheless, the subsurface water showed consistently higher values of dissolved aluminium when compared to surface water, which might be related to soil origin. The pH results demonstrate compliance with the CONAMA 430 limit value of $\text{pH} < 9$ for the 12 months of monitoring for all samples from surface run-off and subsurface. The CONAMA 430 legislation was also complied with dissolved iron during the 12 months monitoring.

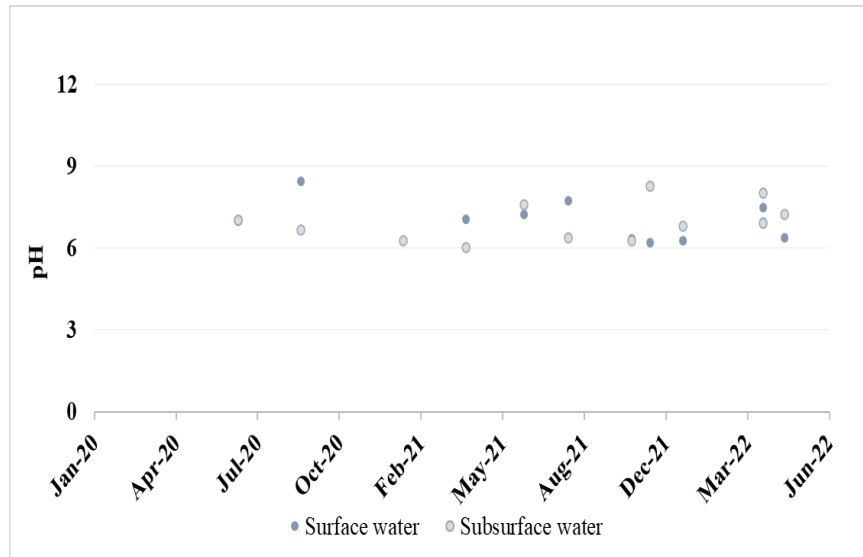
Figure 6. pH Monitoring – Stripe 2 – DRS1, Hydro Alunorte.

Regarding pH monitoring, there is no evidence of a relation between surface and subsurface drainage circuits and the pH magnitude (Figure 6). The monitoring indicates average pH of 7.01 (standard deviation of 0.69) in samples collected from run-off. At the same time, subsurface water showed an average of 6.96 for pH (standard deviation of 0.65), demonstrating compliance with CONAMA 430 limit value, pH < 9.

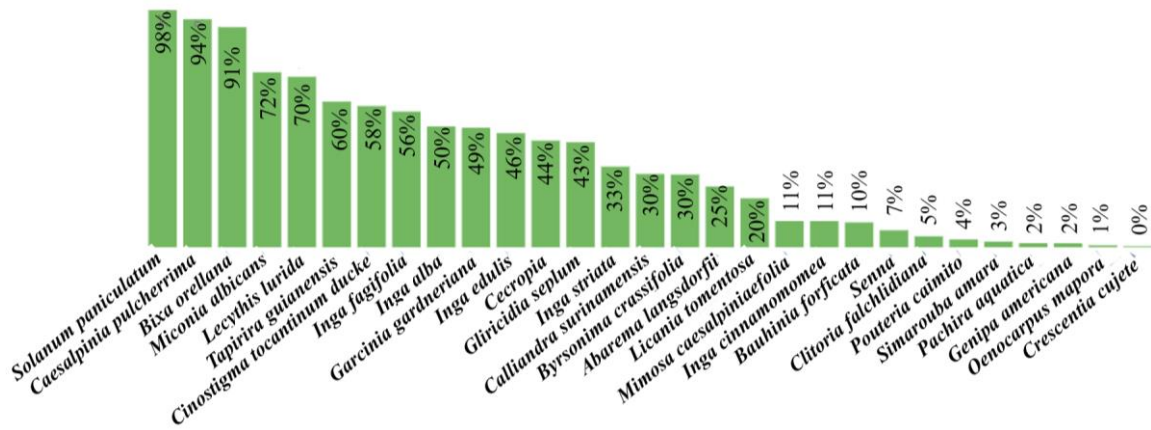
Figure 7. Plant Mortality Rates – Rehabilitated Strips 2 and 3 – DRS1, Hydro Alunorte.

The results included 12 months of monitoring since seeding. Figure 7 resumes the plant mortality rates registered for the DRS1 rehabilitated area. The graph shows the species with higher mortality rates, *Jurubeba*, *Mini Flamboyant*, and *Ucurum*, all with mortality rates higher than 90 %. On the other hand, seven species have distinctly performed, with less than 5 % mortality; these were *Sombreiro*, *Abiú*, *Marupá*, *Mamorana*, *Genipapo*, *Bacabi*, and *Cuieira*. All the selected species are from the local biome.

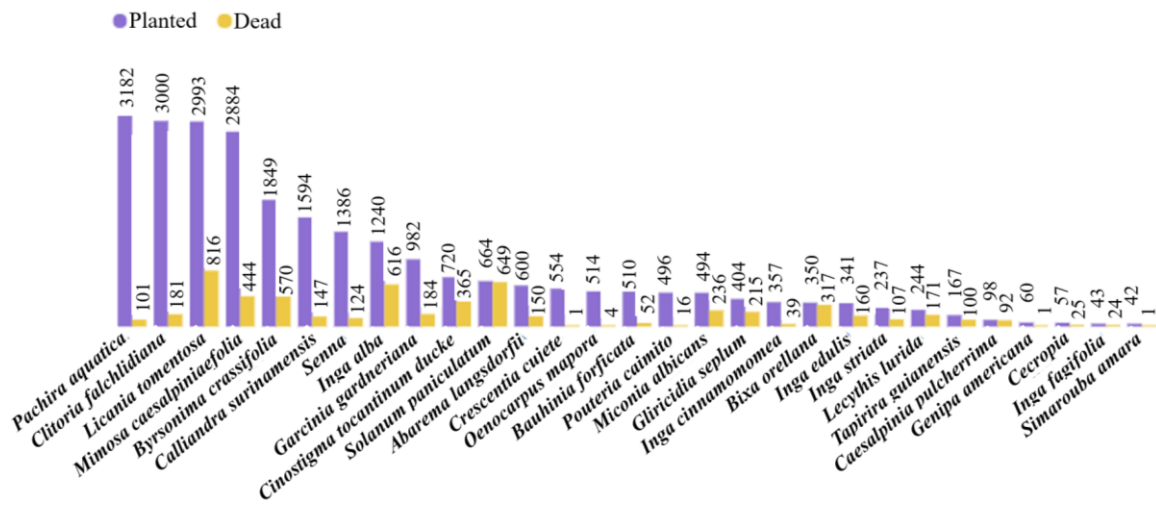
Figure 8. Plant Mortality – Rehabilitated Strips 2 and 3 – DRS1, Hydro Alunorte.

According to monitoring results, over 5 900 plants died out of over 26 000 seedlings. The mortality rate of approximately 32 % is slightly higher than 25.9 % observed in experimental area 2A [2]. Figure 8 shows the relation between seedlings and dead plants, individually presented by species.

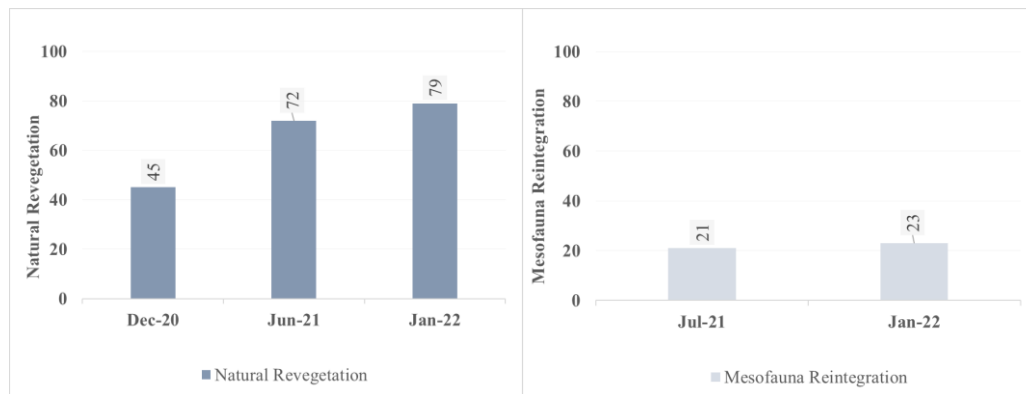
Figure 9. Natural Revegetation (a) and Mesofauna Reintegration (b) – Strips 2 and 3.

The natural revegetation with native species from local fauna integration increased from 45 immigrant species found in December 2020 to 79 in January 2022. The mesofauna notes 21 species in July 2021 and 23 in January 2022 (Figure 9).

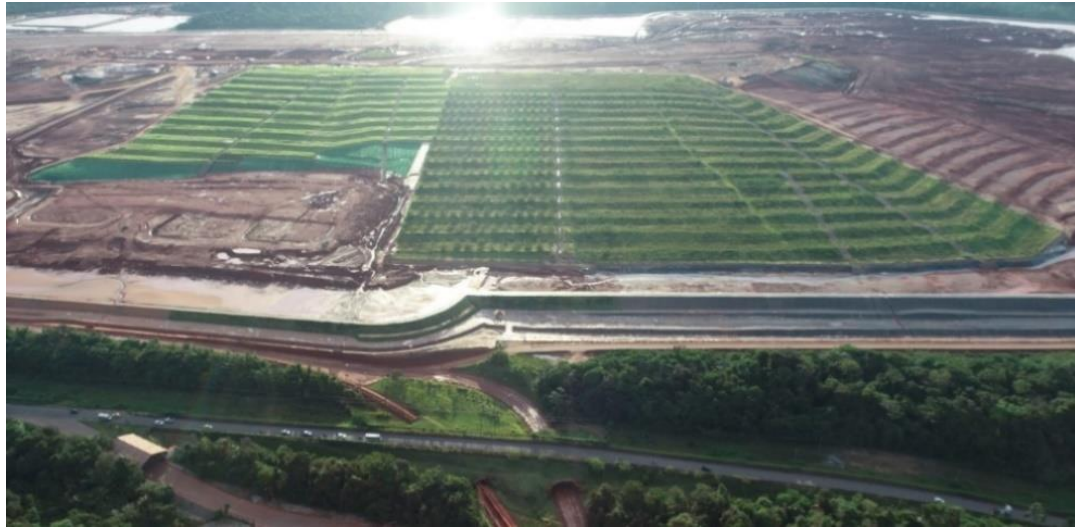
Figure 10. General View – DRS1 Reclamation, Hydro Alunorte.

Figure 10 shows the general view of strip 2 rehabilitated area and strip 3 in progress, highlighting the visual mitigation.
