## **Performance of an Impact Crusher used as an Alternative to Produce Anode-Covering Crushed Bath during Autogenous Mill Refurbishment**

Sohar Aluminium Smelter, Sohar, Sultanate of Oman  
Corresponding author: olivier.rival@sohar-aluminium.com

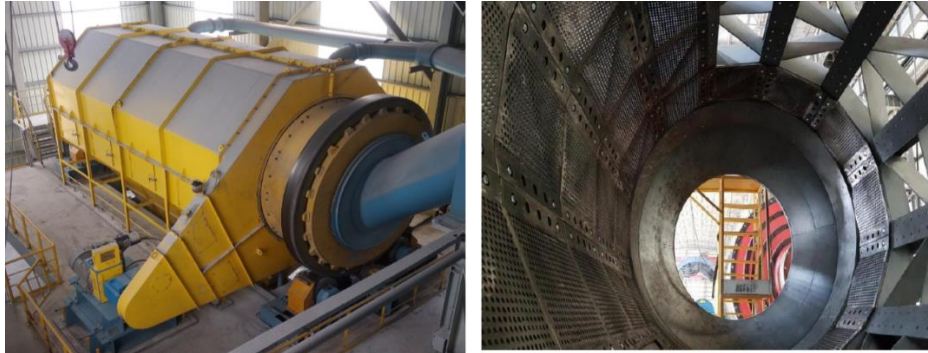
**Figure 1. Pictures of the 2013 autogenous mill.**

Sohar Aluminium smelter was designed with a facility to crush bath for anode covering and for crushing of tapped bath. The breaker function, an autogenous mill (AM), is to crush 250 to 300 t of bath daily to supply the potrooms with bath at a certain particle size. Figure 1 shows the AM. The granulometry of the bath covering the anodes, and its consistency are both critical for the crusting behavior, the pot heat balance [1] and the control of the liquid bath level, as pointed out by Taylor [2] and Gudmundson [3]. As per Aluminium Pechiney specifications, the optimum granulometry of the anode cover bath once crushed must be for less than 5 % , smaller than 0.75 mm and for at least 50 % , greater than 3.15 mm. The crushed bath granulometry plays a role in protecting the anode against the air oxidation, regulating the heat losses above the top of the anode, forming the desirable crust on and around the anode, scrubbing the fluorides emission,

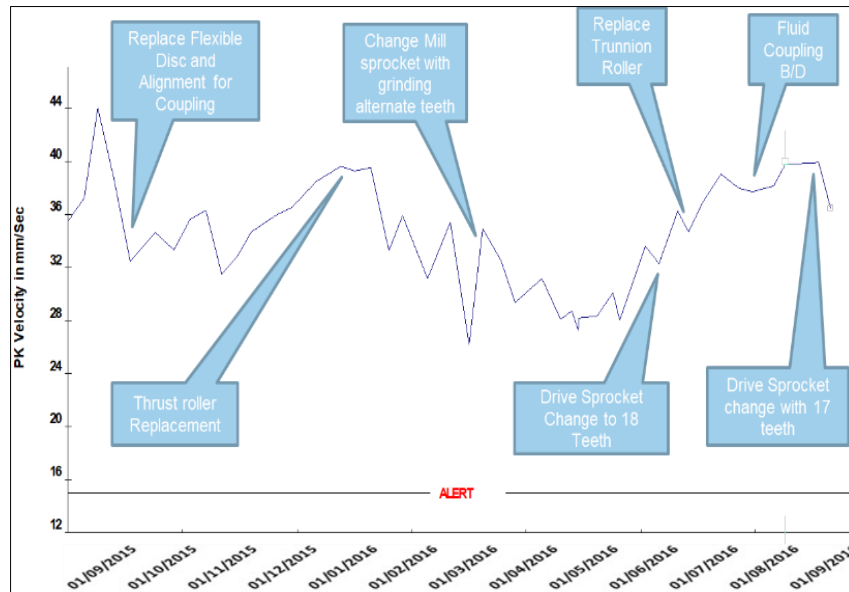
Figure 3. Failures and issues with the AM from January 2015 to January 2016.

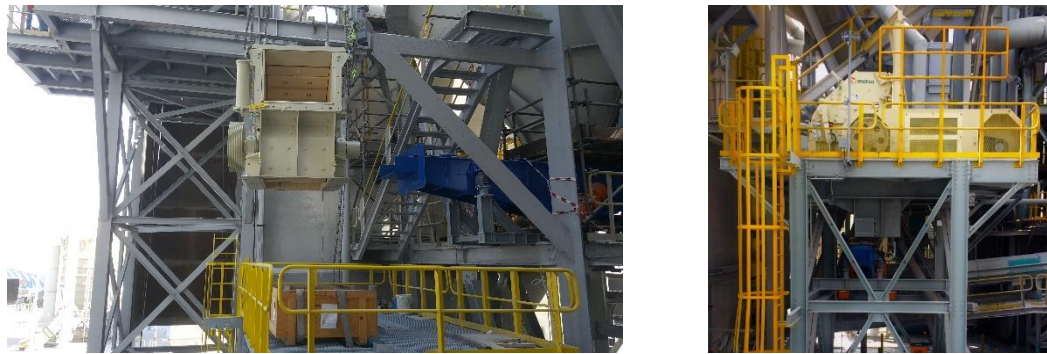
Figure 5. Installation of the impact crusher.

The installation and commissioning of the bypass impact crusher took six months. The pictures in Figure 5 show the installation of the crusher Metso. A vibrating feeder was installed to feed the crusher initially with a screen of 20 mm so that only the bath size greater than 20 mm was crushed.

During a week stored crushed bags were used to supply the potrooms exclusively. During that time, both the autogenous mill and the impact crusher had to be stopped for the final integration and the replacement of the original outlet belt by a vibrating conveyor to supply the crushed product and the fine bath (< 20 mm) to the two storage silos.

The crusher remained a contingency equipment, i.e., kept in case of need. There was no return line implemented to crush a second time the material that would be rejected at the storage silo inlet due to a size greater than 20 mm. Instead, the oversize material was redirected into bins that were manually returned daily to the crusher inlet feed.

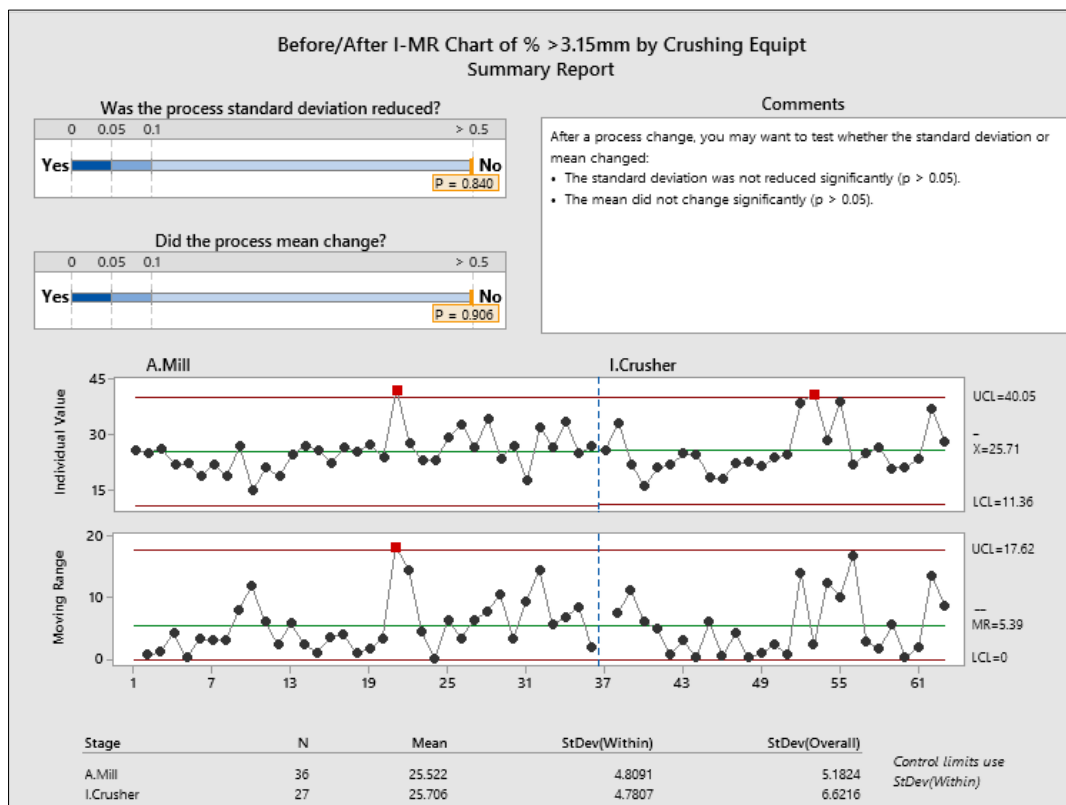
Figure 6. Crushed bath particle size distribution for particles > 3.15 mm.  
A.Mill = autogenous mill and I.Crusher = impact crusher.

Figure 6 and 7, show that the crushed bath particle size did not differ drastically between the autogenous mill and the impact crusher. The statistical analysis shows that the probability of the product is high enough to conclude that nor the mean nor the standard deviation of the crushed bath granulometry are impacted by the impact crusher utilization (after optimizing its supply rate, speed and blow bar gap). The fines fraction of 0 to 0.75 mm remains in average at 12 % all along the 63 days of collection (X-axis). The grains fraction of 3.15 mm to 22 mm stays at an average of 25 %. Too fine bath would create a problem in the pot rooms when covering the anode due to spillage and excessive consumption. Coarser bath exceeding the specification would induce greater heat loss and difficulty to form a crust.

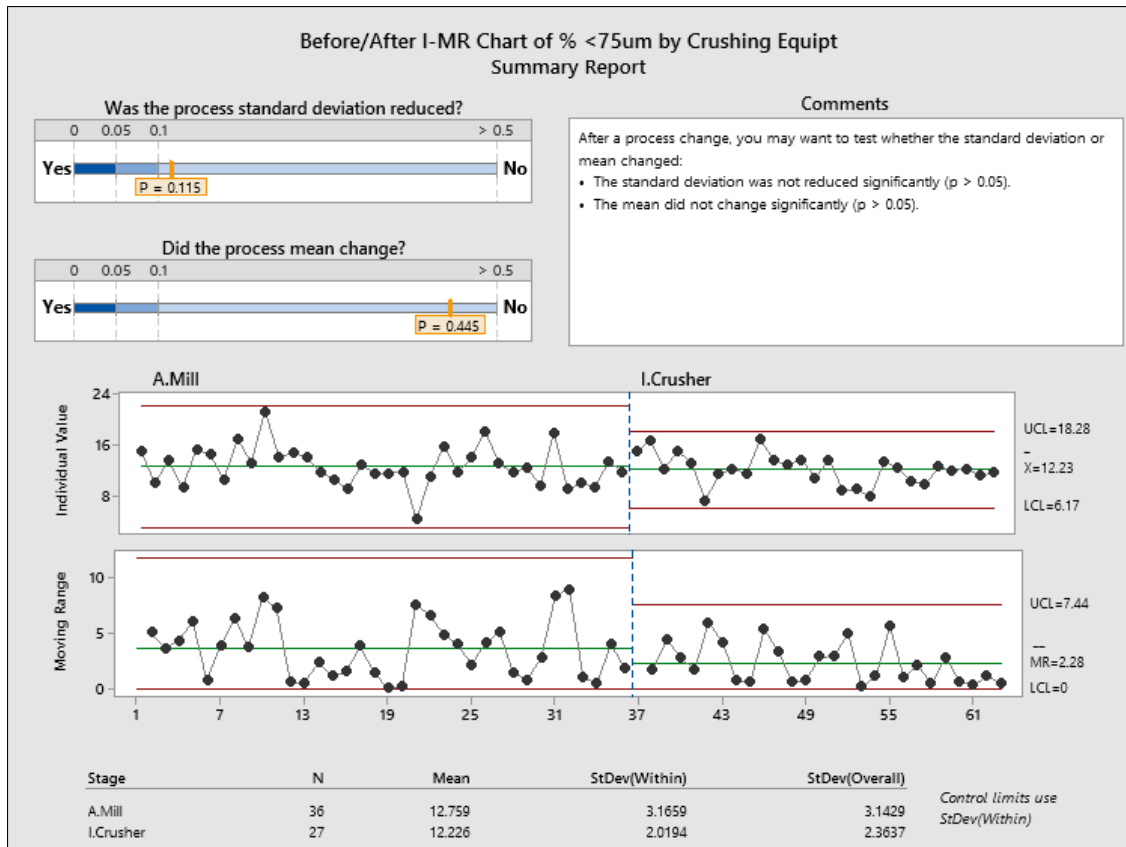
**Figure 7. Crushed bath particle size distribution for particles  $\leq 0.75 \mu\text{m}$ .  
A.Mill = autogenous mill and I.Crusher = impact crusher.**

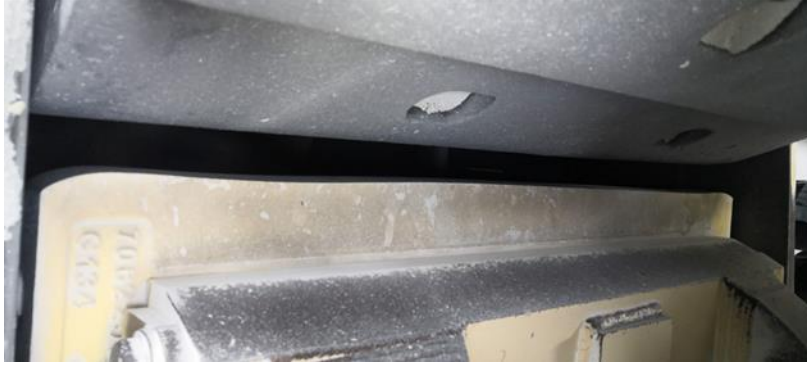
**Figure 8. Blow bar gap and profile after utilization.**

- The wear of the blow bar was not uniform among the four bars, nor along the length of each bar as shown on Figures 8 and 9. An average tolerance figure had to be considered to decide when and by how much to adjust the gap.

- The blow bars required an adjustment every 5 weeks. Initially at 25 mm based on the OEM recommendation, the gap increased up to 31 mm which resulted in doubling the quantity of oversize bins to recycle.
