AA22 – Corrosion Inhibitor Use in the Gland Seal Water System of a Greenfield Alumina Refinery

Emirates Global Aluminium - Al Taweelah alumina refinery, Technical Department,
Abu Dhabi, UAE

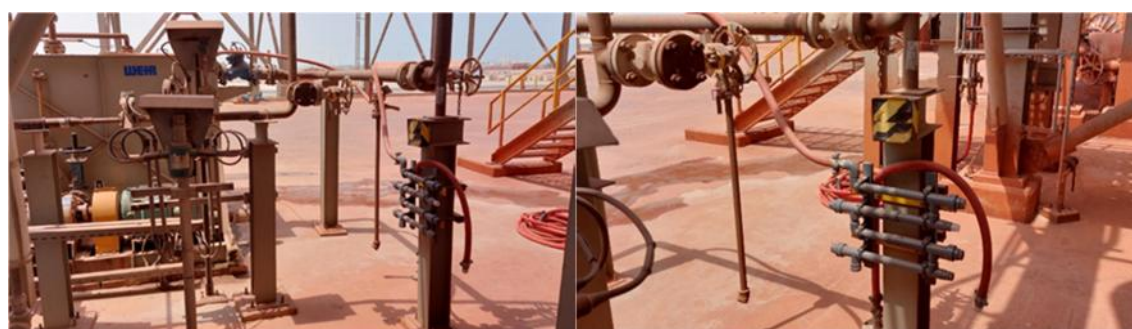
Figure 2. Left: field setup, Right: PVC rack for probe and coupon.

The main distribution tank (Process Water tank) feeds the GSW systems and other applications across the refinery. This water is a mixture of generated hot process condensate from the digester units and imported water (average ratio 25:75). To measure the corrosion rates of the untreated water, mild steel coupons were installed on the discharge line of the Process Water tank via a PVC rack on a recirculation line.

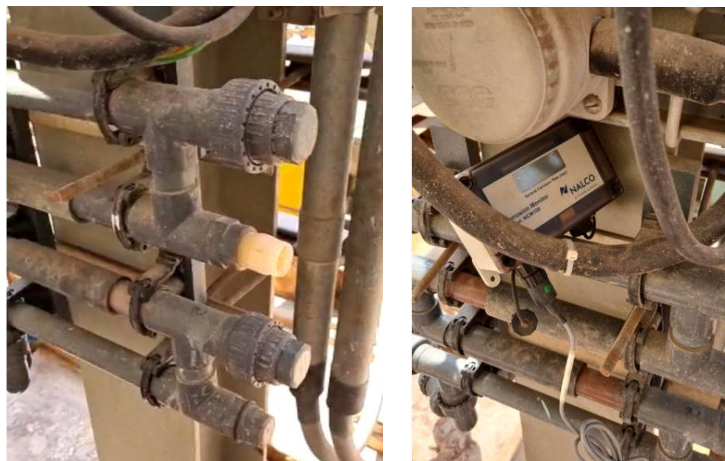
Figure 3. Left: coupon sample location on rack, Right: PVC rack with NCM monitor attached to corrosion probe.

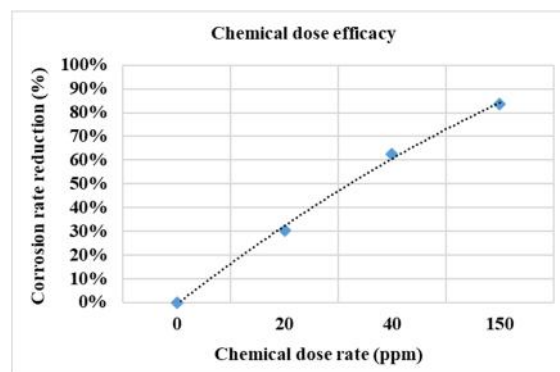
Figure 8 and table 1 below show an estimate of the results which are derived from the laboratory tests and is expressed as corrosion rate reduction.

Figure 8. Corrosion rate reduction with different dose rate.

Based on the laboratory result and by using the corrosion probe, it was demonstrated that chemical injection shows a reduction in corrosion rates varying from 30 % to 84 % with increased dose rates. By interpolating this laboratory data and comparing these to actual field results, the corrosion rate reduction in the field was higher by 19 % at the same dose rate of 25 ppm.

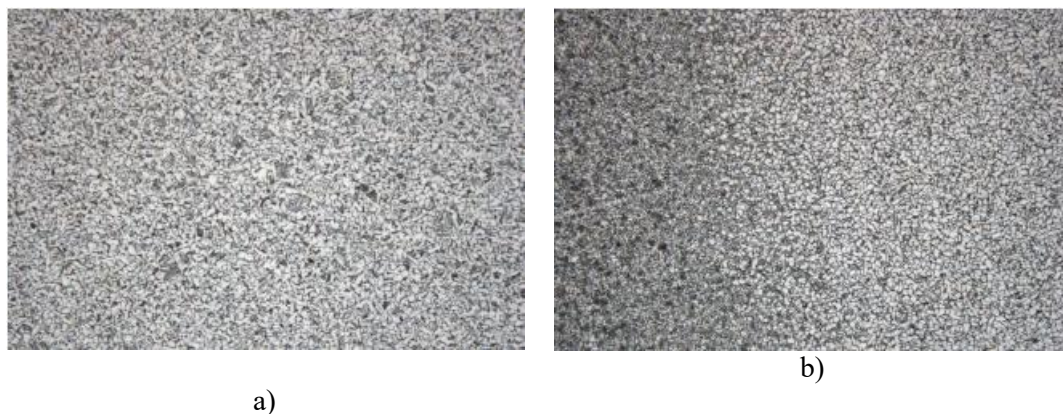
Figure 11. Microstructure of gland seal water pipe. Base metal (a), Across heat affected zone (boxed area “c”), 200x magnification (b)

It was also concluded based on the pipework sample analysis, that the failures were found around the welding joints, as shown in Figure 10. Comparing the microstructures of the weld heat affected zone and the weld to the base metal, it can be observed that these differed, caused by a metallurgical change in the carbon steel, as shown in Figure 11.

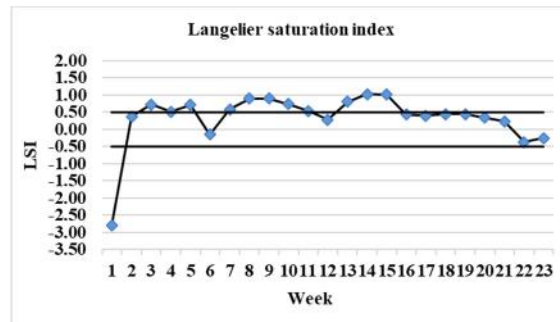
Figure 14 shows the Langelier Saturation Index (LSI) which was calculated to indicate potential scale formation and/ or corrosivity. The LSI indicates the saturation of water with calcium carbonate which is naturally present in water. The other required analyzed indicators to calculate the LSI were calcium hardness, total alkalinity, total dissolved solids (TDS), pH, and temperature (Figures 15 and 16) show whereby:

According to the Langelier Saturation Index, the ideal range should be between -0.5 and 0.5 for resp. slight corrosivity and scale formation. The field trial results appear to be in the positive range, indicating non- corrosivity and potential scale formation but still not serious.

Figure 14. Calculated LSI of treated water.

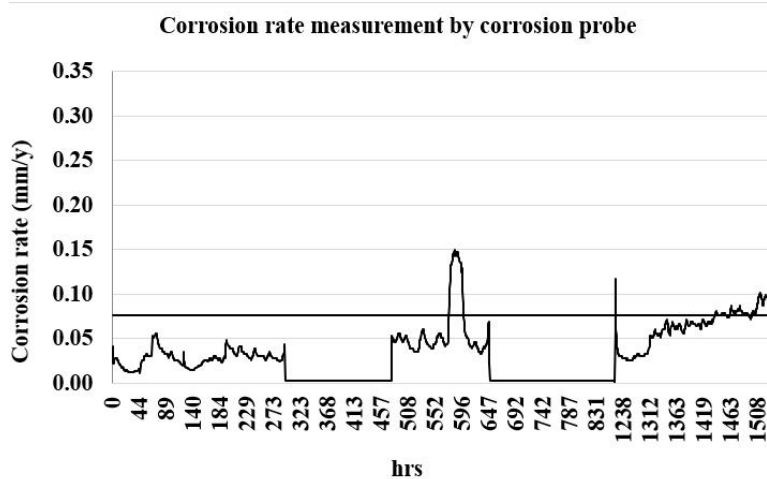
The NCM100 Corrosion Monitor 400 - NCM100.88 with the corrosion probe failed prior the end of the trial and its stored data could not be extracted. Corrosion rates were measured between 0.038–0.102 mm/y as shown in Figure 17.

Figure 17. Corrosion rate during field trial.

Of all the different measurements methods on the chemically treated water, the corrosion rates happen to be in different ranges after comparison. The corrosion probe measuring average 0.063 mm/y, by calculations using the average water quality resulting in 0.0127 mm/y and using physical mild steel coupons 0.021 mm/y and 0.005 mm/y. Both the corrosion probe and modelled results are higher than the physical mild steel coupon method. The calculated results showed higher numbers as the model predicts the worst-case scenarios.
