BX12 - Cutting-edge Technology Supporting Hydro Paragominas Transmission Line Management System

Hydro Paragominas bauxite mine (MPSA) is a Norsk Hydro enterprise and contemplates the implementation of an integrated system for the production of processed bauxite, which includes mining activities and ore processing at Plateau Miltônia 3, in Paragominas-Pará (PA).

The electricity supply for the enterprise is made through a Transmission Line (TL) of 230 kV composed of 560 transmission towers and 236 km long, starting at the substation of Vila do Conde in Barcarena-PA, to the substation in the MPSA in Paragominas-PA, crossing seven municipalities: Barcarena, Abaetetuba, Mojú, Acará, Tomé-Açu, Ipixuna do Pará and Paragominas, as shown in Figures 1 and 2. The Pump Station 2 (PS 2) pump station is located in the municipality of Tomé- açu and is also served by the said Transmission Line, through a bypass existing at km 120.

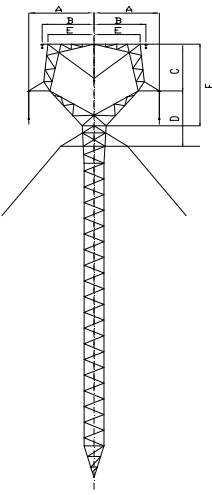
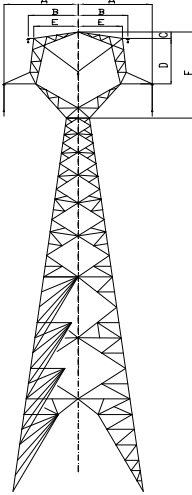
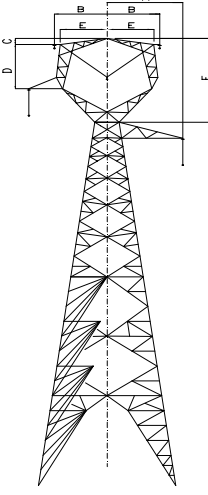
Table 2. E3, S3, SE, S7 and ST Structures [1].

E3 Structure	S3 Structure	SE and S7 Structures	ST Structure

The E3 tower is a guyed-type structure, this structure is formed by the union of overlapping modules, forming a tower that must be tied to the ground or guyed; the other types of towers in this TL are self-supporting, that is, they are towers that support themselves independently, dispensing with the aid of other structures, such as stays.

The E3 structure corresponds to approximately 63 % of the Transmission Line towers. In the Transmission Line project there was a preference for the use of this type of tower because they are low consumption steel towers, compared to self-supporting towers, which guarantees lower cost and easier installation.

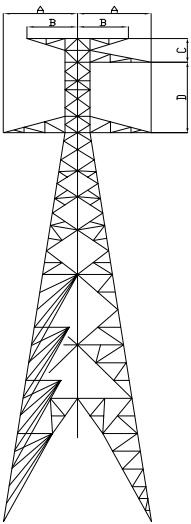
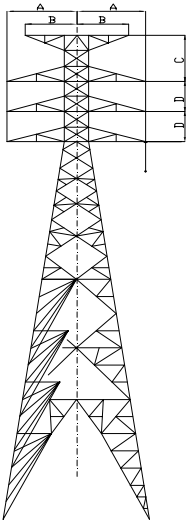
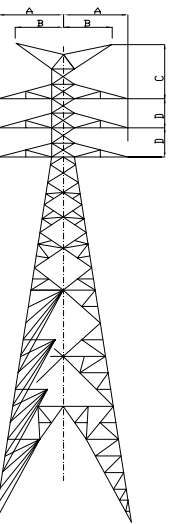
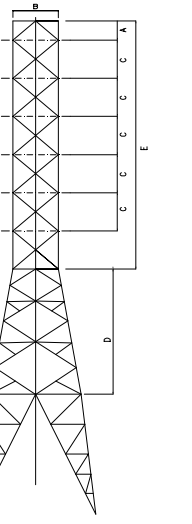
Table 3. A30, A60F, DS3, D60F e DG Structures [1].

A30 and A60F Structures	DS3 Structure	DA60F Structure	DG Structure

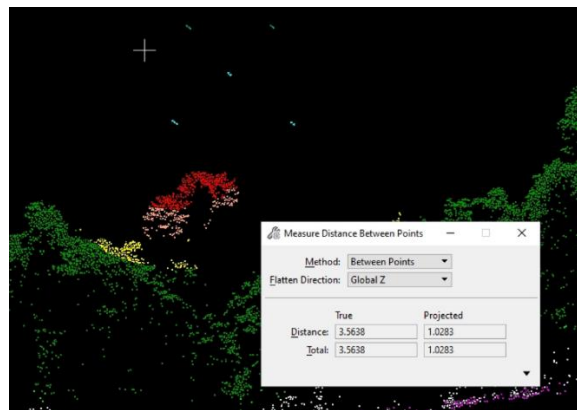
Figure 4. Proximity between the tree and the conductor [2].

LiDAR analysis occurs after the manual process of classifying the point cloud, using automatic macros, which can, through a pre-defined distance, identify and categorize anomalies/interferences according to their level of danger in relation to the transmission line.

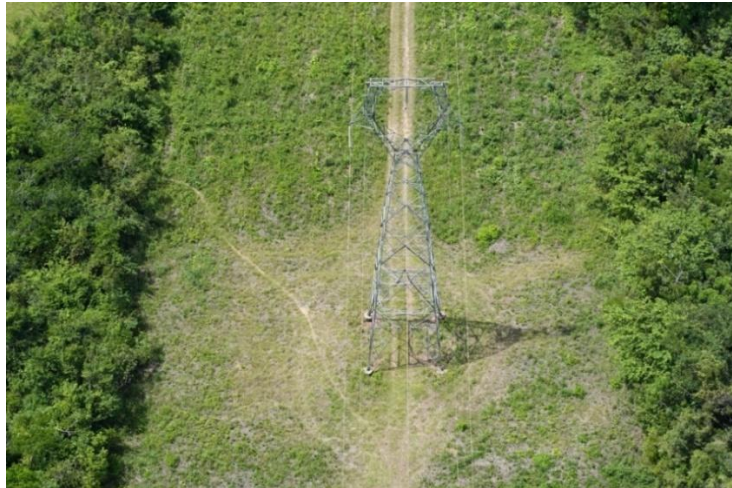
Figure 5. Digital photography of aerial inspection [2].

Besides to be very promising, the use of digital photographic images provides an easy acquisition of important information about the integrity of the TL. The use of digital images improves the process phases and makes it less expensive in terms of time and cost. Figures 5 and 6 show images acquired using digital photography technology.

The analysis is carried out using digital photographs and the anomalies identified involve everything from oxidation of equipment, broken/defective parts, transformers with oil leaks, deteriorated structures, cracked/burned/broken insulators, among others.

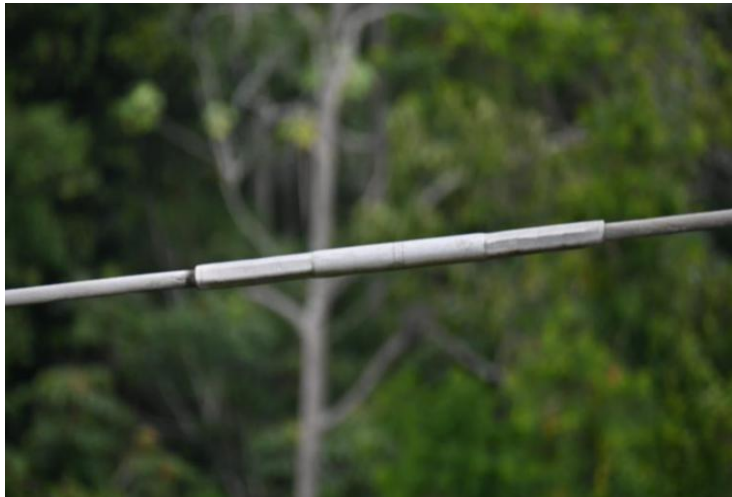
Figure 6. Inspection of splices in conductor cables [2].

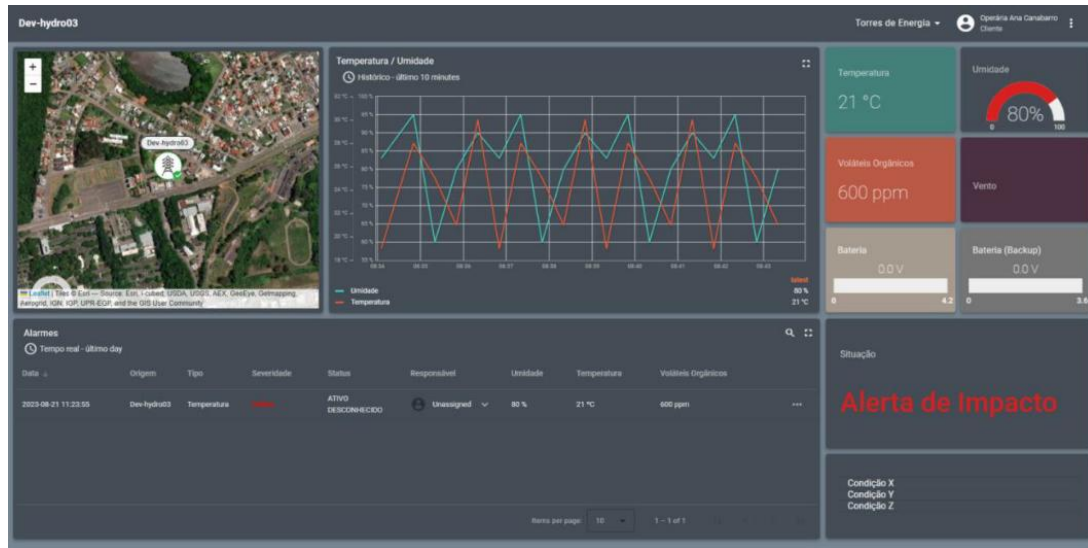
The specific panel of each monitored tower is accessed both through the alarm panel and the tower monitoring panel. It displays a map with the location of the tower in evidence, a graph with temperature and humidity variation over time, alarms triggered by current conditions, the most recent data from the tower's sensors, including main battery levels and backup and tower status (Normal or Impact Detected) as showed in Figure 10.

Figure 10. Tower monitoring panel.
