CB11 - Challenges in Operation of Rodding Induction Furnaces in Ma'aden

Arvind Verma¹ and Ghanem Al-Osaimi²

Ma'aden Aluminium Company, Ras Al Khair, Saudi Arabia

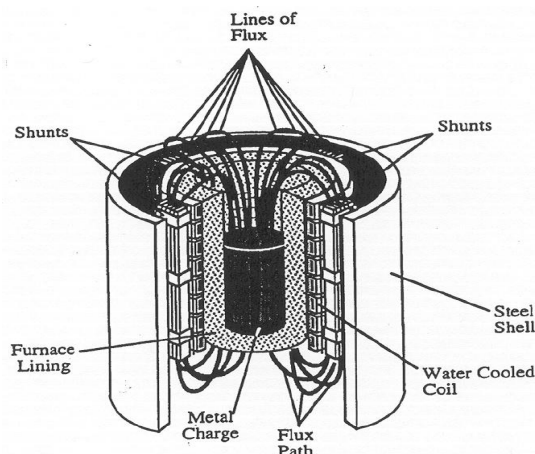
As a basic principle of Induction, an alternating electric current from an Induction power unit flow into a water-cooled copper coil (Figure 1). Electric current flowing in one direction in the induction coil creates an electromagnetic field that induces an electric current flow in opposite direction in the metal charge inside the furnace, producing heat that rapidly causes the metal to melt [1]. The copper coil is kept from melting by cooling water flowing through it. These furnaces operate at a nominal frequency of 250 Hz with output of 1500 kW.

Figure 1. Typical induction furnace cross-section.

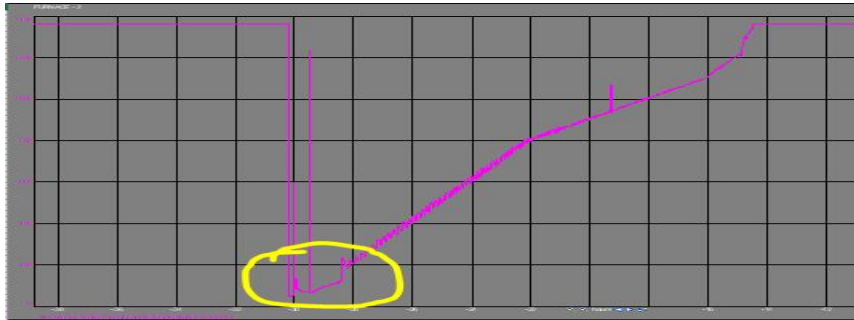
at the beginning or at the end. At the beginning, this was due to malfunction either at the Thermocouple joints or at the cabinet plug (Figure 2). There were no options for physical verification of the actual sinter temperature inside the furnace. At the end of the cycle, sinter aborted due to design limitations of steel former where liquid metal forms at the bottom of furnace and starts melting which leads to sinter cycle abort and need to operate the cycle in manual mode (Figure 3).

Figure 2. Sinter abort at the beginning due to high temperature.

Temperature verification was considered as one of the important steps during the whole cycle. The Melt-manager program was designed in to maintain the power input based on the measured temperature attached with the former cylinder. Any malfunction or connection issue leads to abort the cycle to protect the furnace. However, at the same time damages already started within few minutes before trip.

To overcome the situation as Melt-manager program not allowing us to modify the sinter curve with manual input of time based on pre-defined curve, some alternatives were considered for a trial:

1. An alternate temperature monitoring system through manual handheld device kept little at some distance from the furnace to verify the difference between auto and manual sinter temperatures.
2. A thermocouple protection tube was installed inside the former to protect the cable during the cycle and to avoid temperature malfunction.
3. The pre-defined sinter curve with an operator's checklist was issued to ensure monitoring the difference of both the temperatures and take necessary action if deviations from the program temperature are observed.
4. Pre-defined sinter curve with hourly break-up cycles to continue the cycle in case of sudden trip due to high temperature at middle level of cycle.

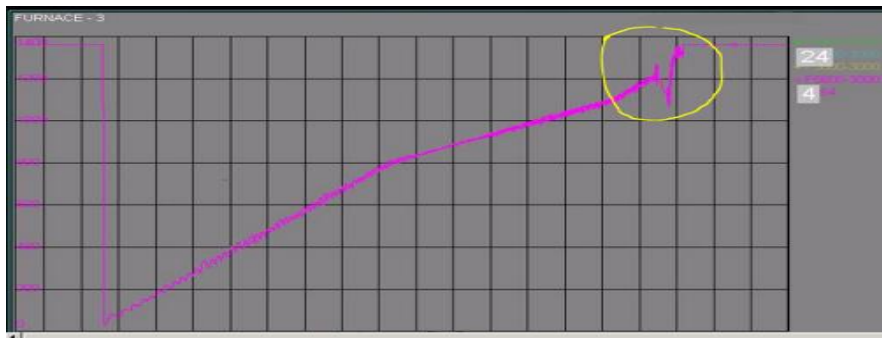
Figure 3. Sinter abort at around 1200 °C.

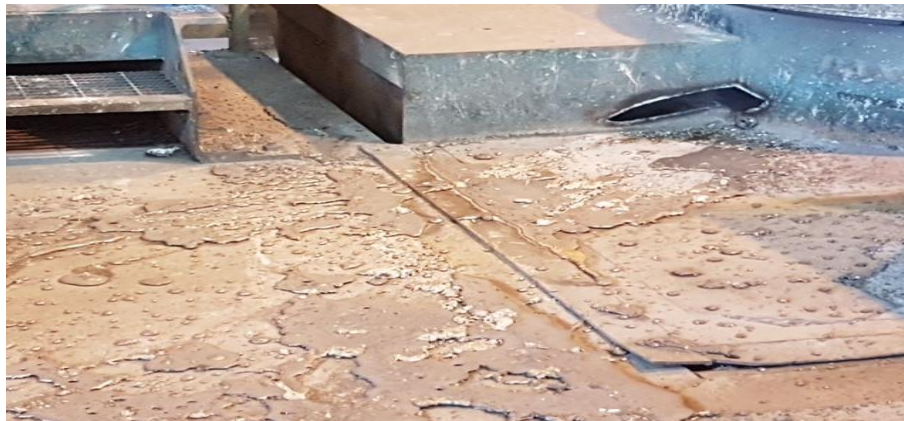
Figure 4. Molten metal leak due to premature lining failure during sintering.

We had occasions where due to cycle abort, the temperature increased abruptly and damaged the lining (Figure 4).

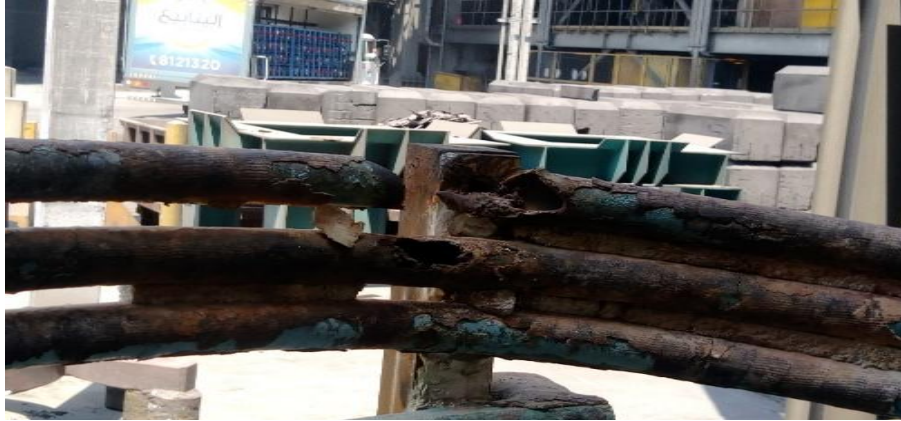
Sudden thermal shocks during sinter cycle or normal operation created severe cracks of the refractories and allowed molten metal penetration near the coil (Figures 5 to 7). It can be detected by changing Furnace parameters (water temperature), by the ground leak detector, or during the routine inspection on the furnaces.

Figure 5. Coil damaged due to molten metal leak during sintering.

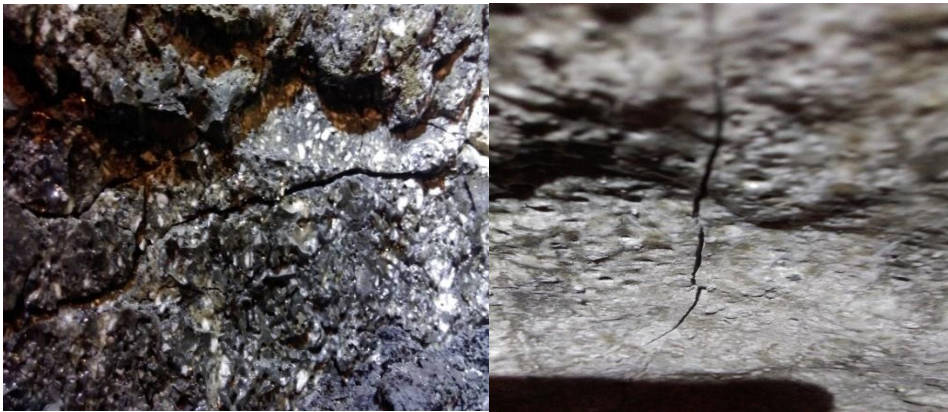
Figure 6. Cracks on the refractory lining.

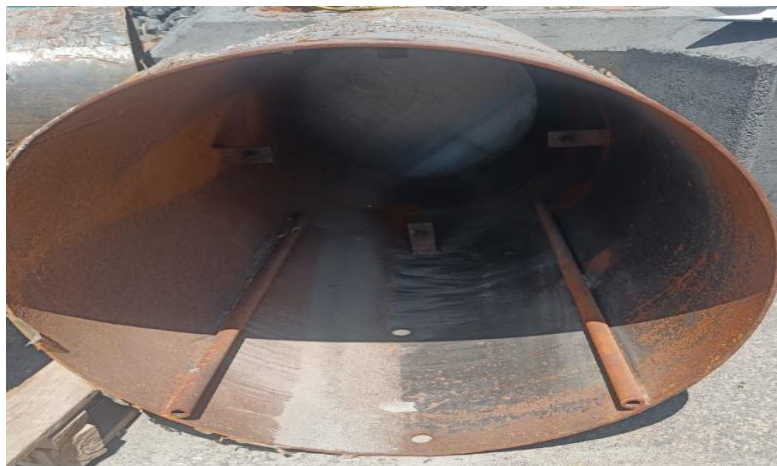
Figure 7. Coil damaged due to molten metal leak during sintering.

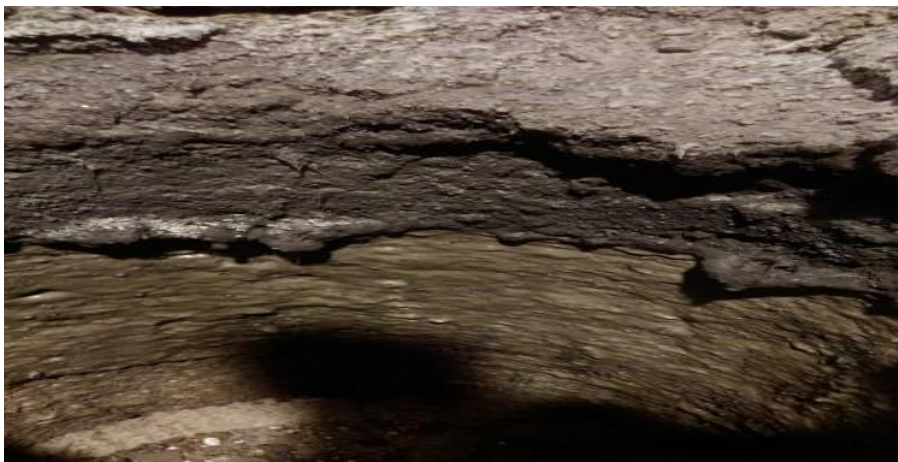
Apart from the upper lining crack, bottom erosion (Elephant Foot) was a common pattern observed during initial production (Figure 8). This erosion was due to continuous stirring of liquid metal on the lower portion of the refractory since two furnaces were in operation and liquid metal poured to ladles from each furnace for casting. Leftover metal kept at around (40-50) % level and fresh cast iron charged into it for next pouring which allows the liquid metal stirring at the same level during life cycle and eroded the refractory at faster rate compared to the top layers.

Figure 8. Refractory lining erosion by metal stirring (elephant foot).

A trial was conducted for the Hot area operations control with different pouring practices with the cast car. The objective was to avoid the type of failure on the furnace refractory without affecting the Rod shop production. As per initial discussion with Furnace operators and general consideration, keeping some molten metal inside the furnace was helping the Furnace operators for quick melting the charge metal and easy slag skimming, overall work-motion study considered to reach on win-win situation without affecting the Rodding productivity (Figure 9).

Four different possible scenarios were tested during trial:

- 2 Induction Furnace & 2 Casting Cars (each CC taking metal from each Furnace)
- 2 Induction Furnace & 2 Casting Cars (each CC taking from same Furnace)
- 1 Induction Furnace & 2 Casting Cars
- 1 Induction Furnace & 1 Casting Car

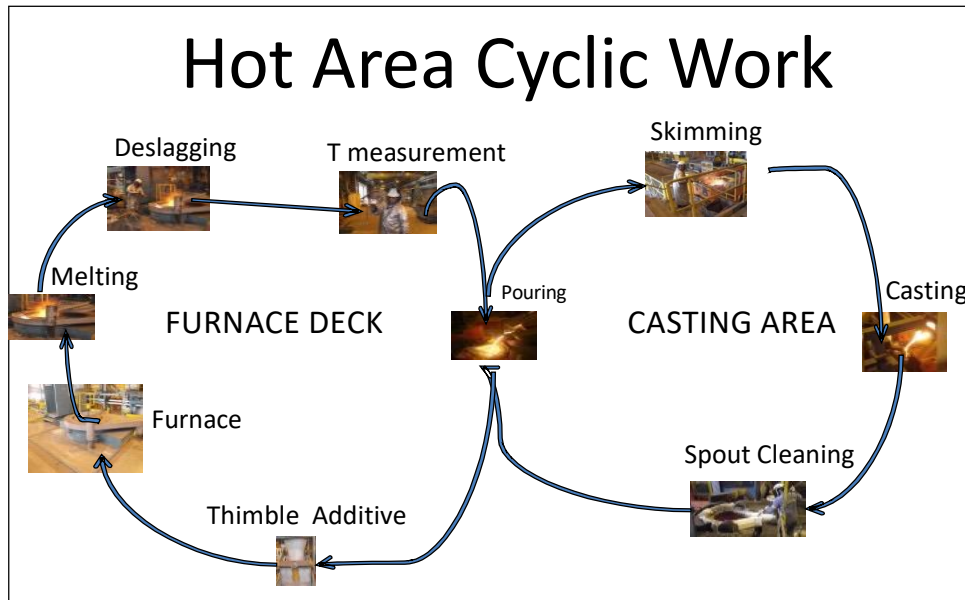
Figure 9. Hot area cyclic work-flow study.

Table 1. Various metal pouring scenarios (scenario 2 is the option chosen and still being followed)

Criteria	Scenario-1 2 Furnaces with 2 CC (each ladle from each furnace)	Scenario-2 2 Furnaces with 2 CC (Both ladle from same furnace)	Scenario-3 1 Furnace with 2 CC	Scenario-4 1 Furnace with 1 CC
Productivity (Assemblies/ shift)	336	410	308	249
Furnace Life	Faster erosion on bottom due to stirring movement	Increased life due to low erosion on the bottom	Increased life due to low erosion on the bottom	Faster erosion on bottom due to stirring movement
Remarks	Tight in terms of preparation as both furnaces should be ready at the same time to give metal to both CC at the same time, no options for Spout-top repair due to molten metal inside	Flexibility to prepare 1 furnace at a time while get ready the requirements before charging into empty furnace, easy for Furnace spout-top repair	Tight in terms of logistics and metal preparation as Furnace to keep ready before the next pouring	Easy to operate with low demand but can't continue

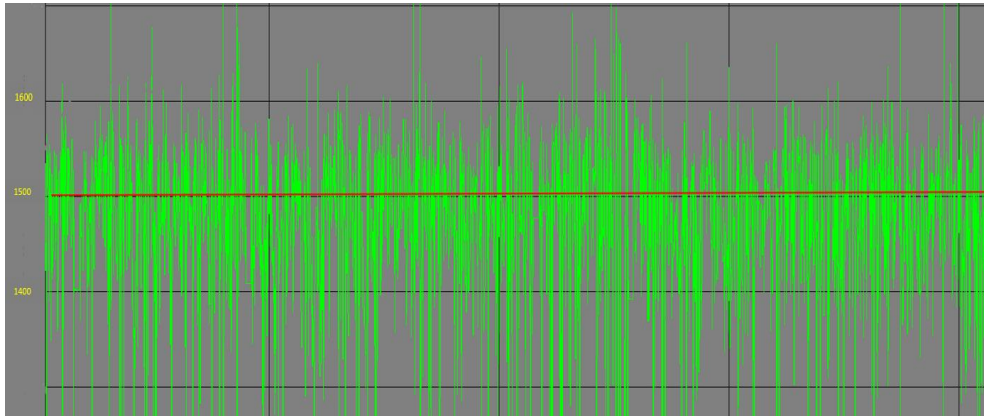
Uncontrolled liquid metal temperature during melting (higher than 1500 °C), before pouring, or during bridging is not only a safety risk associated with the furnace but also severely contributed to refractory deterioration (Figures 10 to 11) which could lead to multiple stoppages of furnace due to various faults. Figure 10 shows the trend of the furnace temperature(°C), as measured.

Figure 10. Furnace temperature(°C) measurement trends.

Minor digitalization initiatives were implemented on each furnace to capture the metal temperature and displayed with an alarm once the maximum temperature was exceeded. An automatic temperature capturing system was installed. Tempstik probes for manual measurements were removed from the furnace floor to ensure that all the temperature data are taken by automatic measurement only. This automatic temperature sampling system was connected to a Programmable Logic Controller (PLC) server and linked to the daily reporting system. A high temperature alarm system was installed on the Furnace to avoid increasing the power input to Furnace by operators.

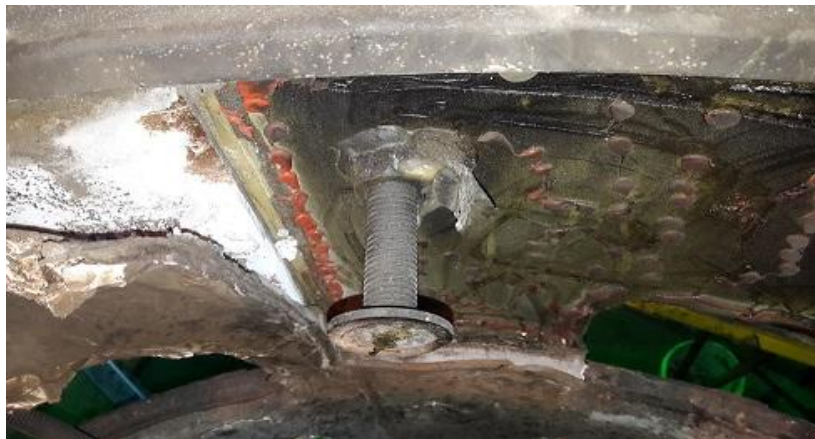
It was difficult to identify and track the temperature readings as measurement was done manually, using tempstik temperature indicators before pouring to Cast cars. The high temperature mostly got unnoticed without tracking and was only observed at the time of Furnace inspection with eroded condition, high furnace parameters, or damaged insulation sheets. This resulted in downtime of the furnace for repair and servicing.

Figure 11. Burnt insulation layers on high temperature.

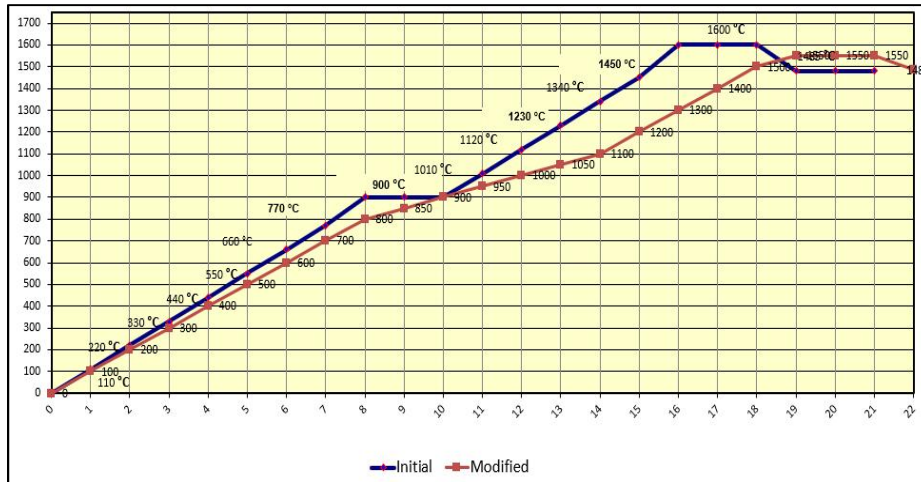
The original sinter curve started with preheating rate of 110 °C/h. The peak temperature was 1600 °C for holding. This was considered too high for the furnace refractory based on lining life results. Thus, lower peak temperatures were tested. The holding time at fusion period and the pre-heat rate were also modified (Figure 12)

Figure 12. Initial vs modified sinter curve.

Start Timeline	Preheat rate (°C/h)	Holding temp (°C)	Fusion (800-1100 °C) duration (h)	Sintering duration (h)	Tonnage life (t)
Aug-12	110	1600	5	21	265
Oct-14	110	1550	5	21	414
Sep-15	100	1550	6	22	510
Jun-16	100	1530-1550	6	22	590

Several changes are considered on the sinter curve based on the different timeline with the changes on preheat rate, final holding temperature, fusion duration, and total sintering hours. Sinter curves can be selected based on the different ramming mass used for the lining of furnace and binder content present in it. It was important to minimize the fusion temperature to avoid any potential cracks, which was a very common observation with the initial cycles. Below is the improved life based on the modification on the sinter curve (Figure 13).

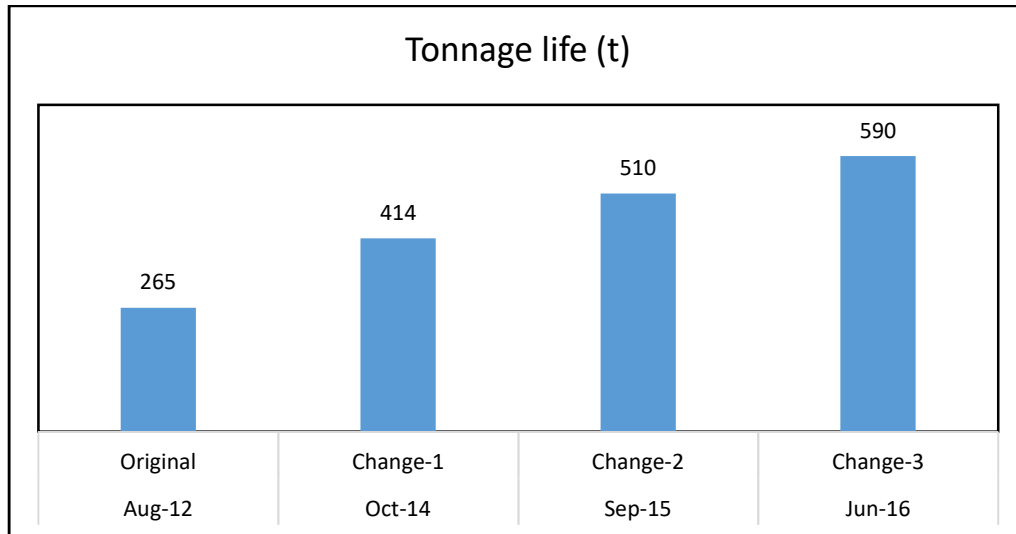
Figure 13. Improved life with sinter curve modifications.

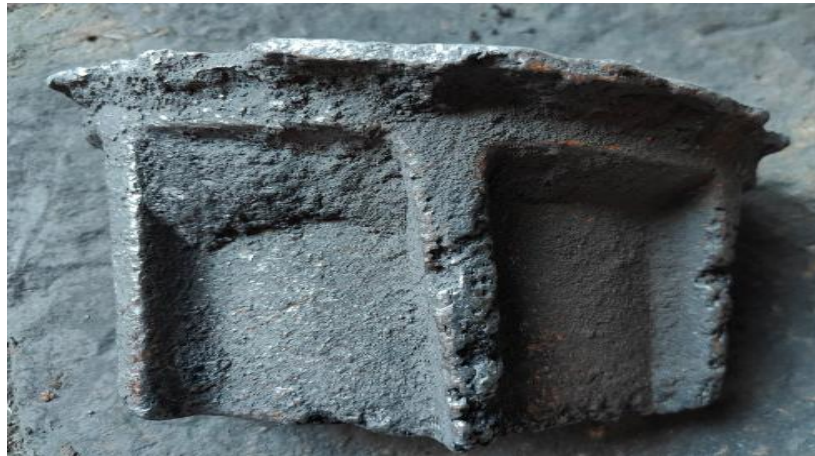
Recycled cast iron from spent butts is cleaned in the cleaning drum after the thimble press machine (Figure 14). Cleaning drum efficiency is directly linked to the impurity's removal from the recycled cast iron and the charge metal quality to the furnaces [2] Frequent lifter failure in the drum resulted in poor (low) retention time of cast iron and blockages on the discharge mesh. Furthermore, dedusting inefficiencies increased the fines content in the recycled metal. Impurities (mainly Sulphur) due to their nature attack the Silica refractory and generate excess amounts of slag at the end of melting (Figure 15).

Figure 14. Output of cleaning drum.

Cleaning drums are considered as one of the main equipment affecting cast iron quality. They were prioritized in terms of maintenance focus to improve cleaning efficiency. Some long term and short-term actions identified to maintain the cleaning efficiency of thimbles:

1. Modifications on the lifter design and material to increase the retention time of thimble inside the drum.
2. RPM monitoring and linked with PLC to confirm design parameter of rotation during operating cycle.

3. Routine cleaning of the mesh to remove the blockages for proper impurities elimination from the drum.
4. Periodic flow measurement to ensure the suction rate inside the drum to separate the fine particles from thimbles.

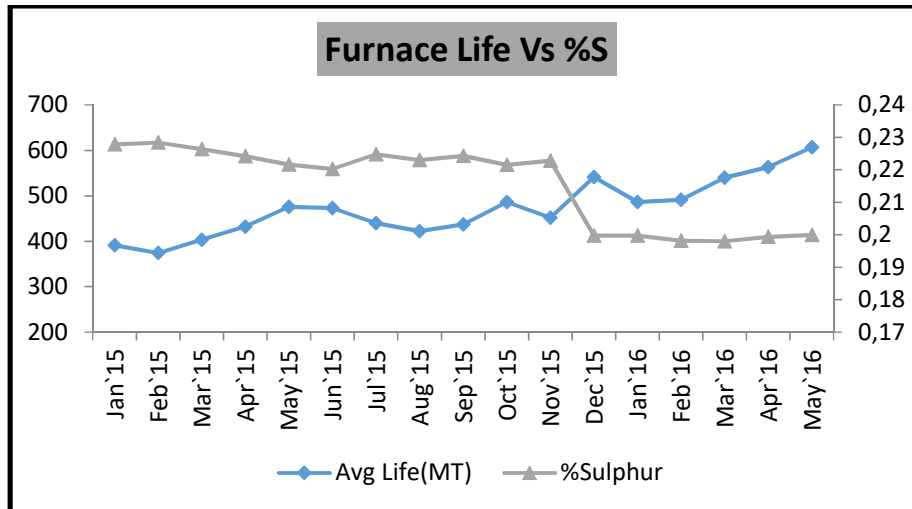
Figure 15. Correlation between the furnace life and the sulphur concentration in the metal (S% trial timeline of 2015 and 2016).

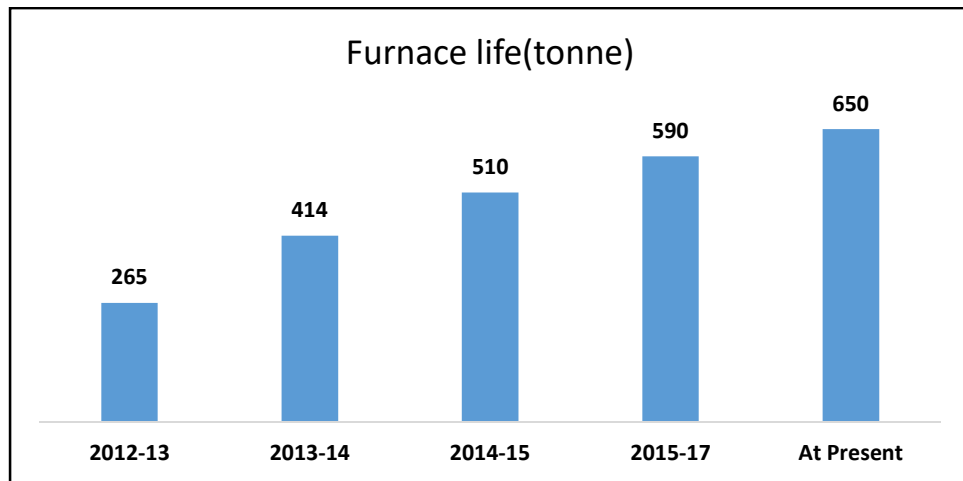
Consistent operational performance was achieved from the hot side with stabilization of Induction furnace availability. The Ma`aden Rodding shop did not suffer any production loss due to Furnace service life since many years of Operation which achieved by gradual improvement over the years by implementation of all modifications (Figure 16). Sustained performance assures the safe practices with low hazards on the high-risk molten metal area.

Figure 16. furnace life timeline, considering all different actions taken during the timeline.
