## Impact of Lining Materials Degradation on Reduction Cell Performance

Emirates Global Aluminium (EGA), Abu Dhabi, UAE C

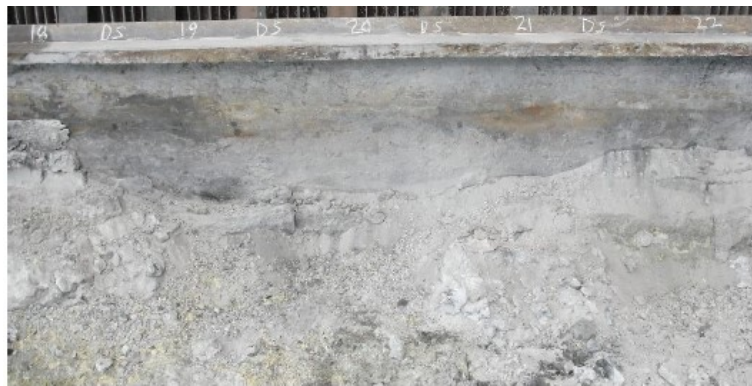
EGA has been using SiC bricks in the side wall lining since many years, while testing the bricks from various sources. In one of the tested materials, a noticeably higher degree of degradation of side wall SiC bricks was observed, which resulted in 30-40 % lower cell life in trial pots. Figure 1 shows a highly deteriorated sidewall SiC brick, even though the cell autopsy showed that the sidewall freeze protection against the chemical attack of molten electrolyte was adequate.

**Figure 1. Highly reacted sidewall SiC bricks at lower cell life.**

Due to the abnormal increase in silicon content in the metal of the test cell, the cell was cut out and autopsied before its target cell life. The test cell operation was thermally stable in terms of bath temperature and superheat, comparable to the rest of the potline. Cryolite resistance test was made on the trial cell SiC slab, shown in Figure 2 as sample A. The showed that the trial cell SiC slab had the highest rate of volume reduction and the lowest cryolite resistance. The chemical analysis of these SiC bricks showed the lowest  $\text{Si}_3\text{N}_4$  content of 8.31 % and highest residual Si content of 3.9 %. Thus, it had a very low chemical and mechanical resistance to bath

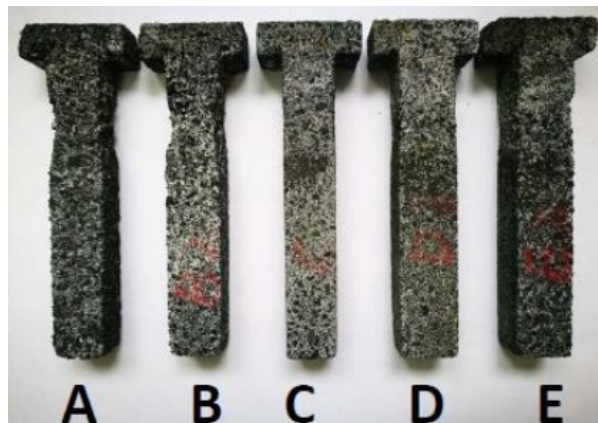
**Figure 2. Cryolite resistance test for five different sources of SiC slabs.**

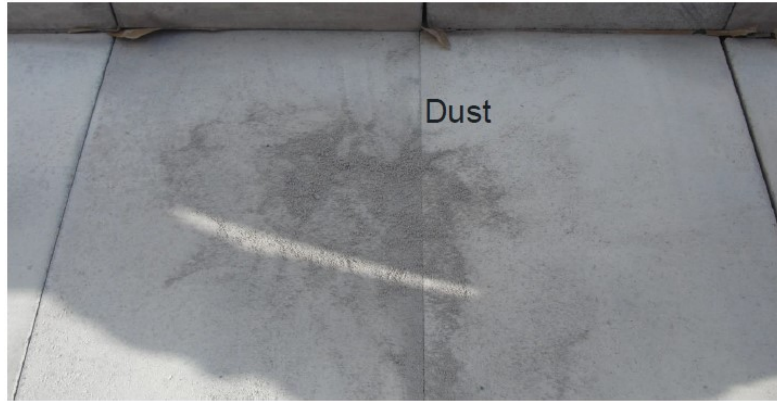
The same tested SiC slab was analysed and observed to have highest free silicone content, and inspection of newly received bricks showed the presence of abnormally high free dust as shown in Figure 3. In the process of SiC bricks production, controlling the microstructure, grain distribution and binder content of material are crucial for good performance. The presence of higher free silicone, higher porosity surface area as a result of poor nitridation process allows faster degradation in electrolytic cells.

Figure 3. High level of free dust observed in tested low quality SiC slab.

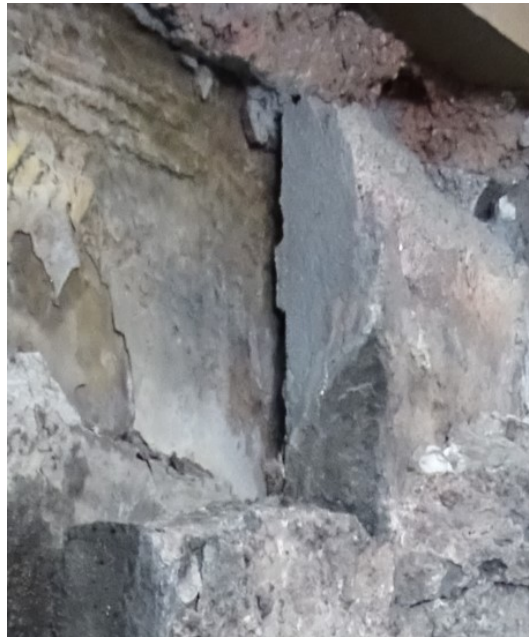
An increase of cathode block sodium expansion could occur while operating at higher current density which could result in higher local stress on cathode blocks and total cell lining structure [5]. The structural changes in cell cathode blocks due to sodium expansion is considered as main contribution of crack formation in the blocks [6]. The penetrated sodium will increase the strength of material initially, but at later stage of cell operation the bending stress would reduce as a result of internal stress [6]. From cathode blocks, sodium penetrates into the side ramming joint and up the SiC slab. The sodium reaction zone is seen in Figure 4; it is the darker triangular zone at the bottom of the slab.

Poor quality SiC blocks are prone to higher microscopic cracking, spalling on the upper part which also coincides with debonding from the potshell, and creation of air gap between the shell and sidewall SiC brick, shown in Figure 4. This may lead to the loss of freeze and high temperatures in the sidelining, leading to higher rate of sodium penetration into lower sidewall, accelerated reaction with refractory bricks (Figure 5), and sodium penetration through the collector bar sealing window to the outside of the potshell. There it creates sodium ooze and attacks the bolted cathode flexible tabs, Figure 6. This increases the bolted contact resistance between the collector bar and copper tab, which is uneven between collector bars, making also the collector bar currents uneven. As a result, the external voltage drop (the voltage drop between the collector bars and the central point on the anode beam on the downstream cell) also increases. At EGA, the overall voltage drop between the metal pad and the downstream anode beam, called the combined drop, is measured at regular intervals for cell control. Figure 7 shows the combined voltage drop vs cell age, and we can see an increase in some cells with age from approximately 1000 days. This identifies the cells with collector bar joints attacked by sodium.

**Figure 4. Air gap formed between SiC slab and steel shell.**

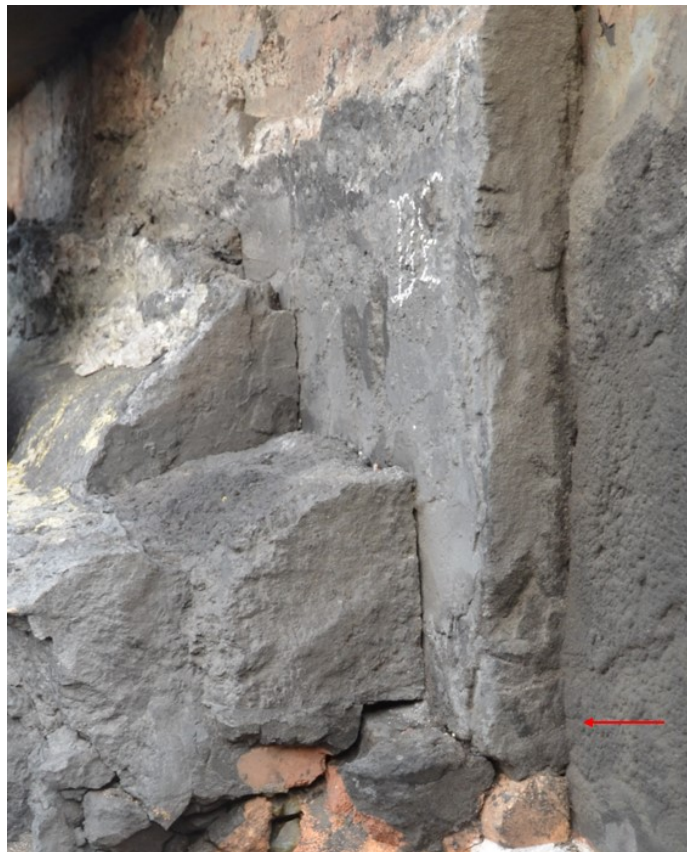
**Figure 5. Reacted refractory brick at base of SiC on the shell side.**

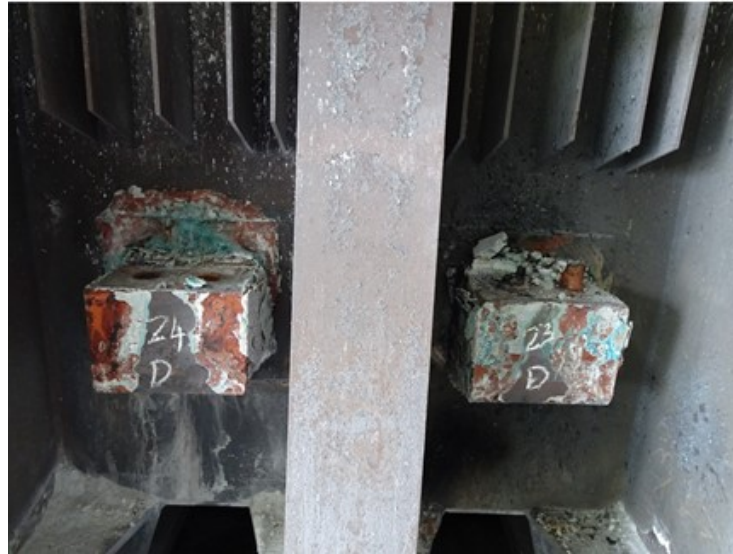
Figure 6. Collector bar attack by Sodium ooze.

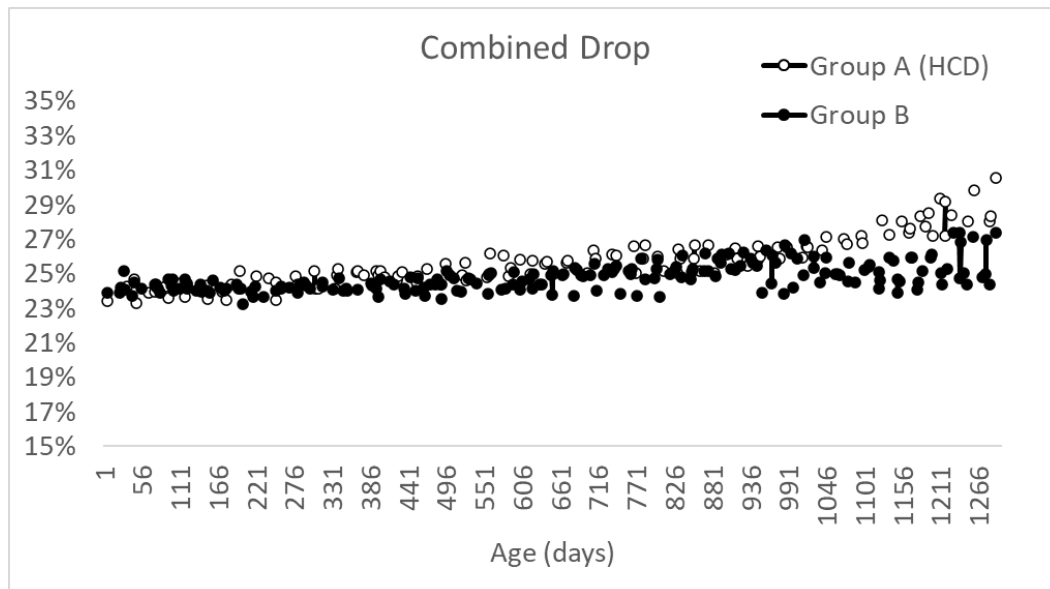
Figure 7. Increase in combined drop of cells whose cathode copper joint was attacked by sodium.

The uneven current distribution in the collector bars could result in increases variability of cathode erosion with deeper erosion in cathode blocks which carry more current. This could decrease cell life.
