## Using Soil Bioengineering to Recover a Gully in the Amazon Forest

Hydro Bauxite & Alumina, Paragominas, Brazil

### Abstract

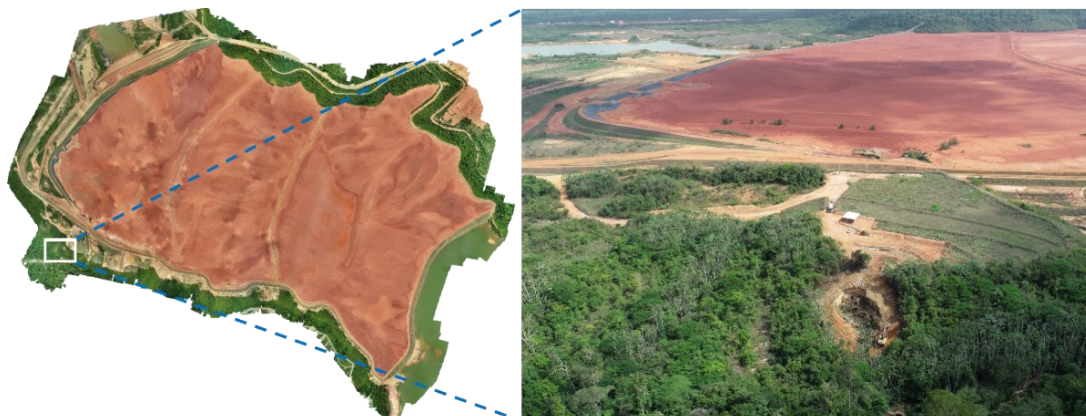
Figure 2. Left: Location of the soil bioengineering work relative to the residue dam, Right: borrow area.

The target area (borrow area) of the intervention project consists of a large gully approximately 575 m<sup>2</sup> in area, 35.5 m in length along the central axis, and 9.0 m in depth at the highest point (Figures 2 and 3). The gully originated due to the absence of a drainage system that adequately directed water from the contributing basin at the top of the slope. The gully features high, very steep slopes, with a 77° incline at its highest point at the head and visible negative grades at several points (slope > 90°), as observed in Figure 3.

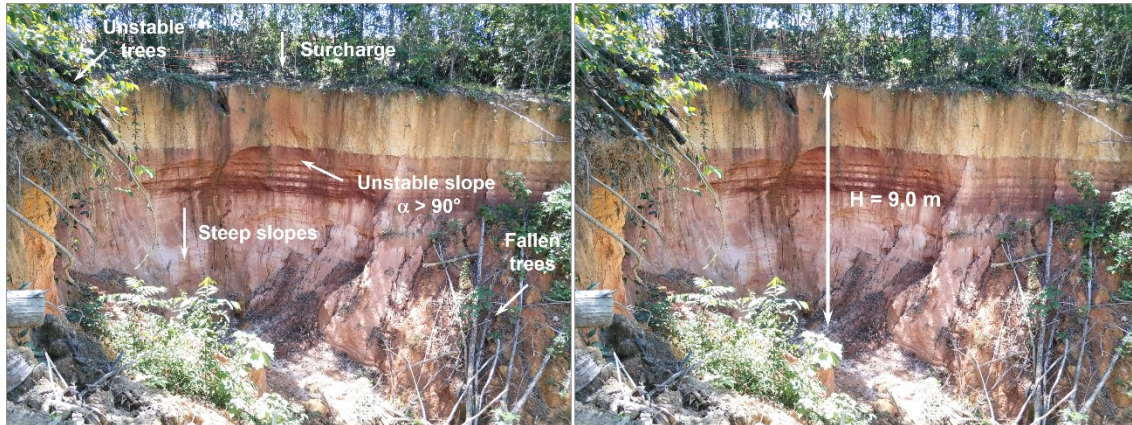
**Figure 3. Geometric and geotechnical characteristics of the gully before intervention.**

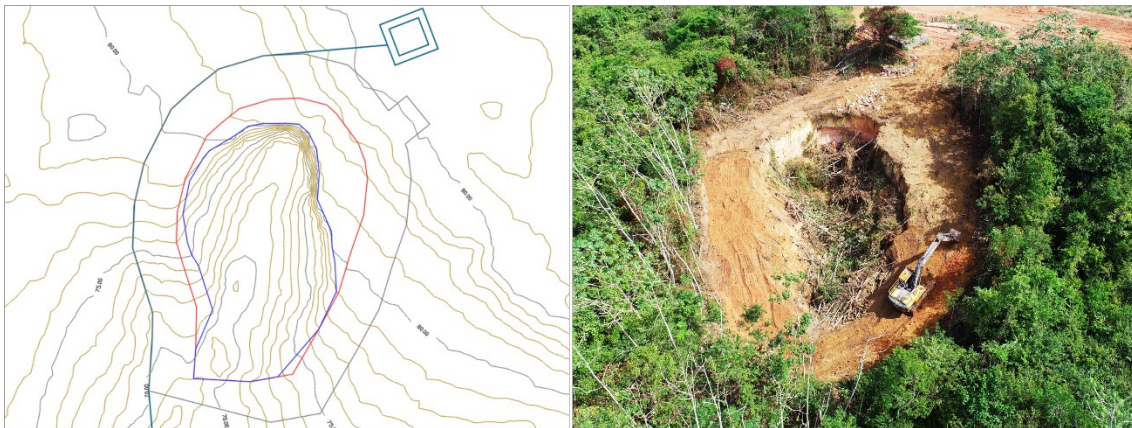
Earthworks involves the reconfiguration of the gully, i.e., cutting to reduce the slope gradient and subsequent filling inside and behind the designed structures (Figure 5).

**Figure 4. Planialtimetric topography and earthworks (12/08/2023).**

The slopes must be reconfigured to inclinations lower than the current ones, which increased the geotechnical stability of the slopes. In this regard, an estimate of the cut volume (480 m<sup>3</sup>) and fill (377 m<sup>3</sup>) was made. Since the soil will not support loads, the material should be compacted only using the bucket of the machine used for cutting, without the need for a soil compactor. Thus, the soil compaction should allow the development of the vegetation implemented in the interventions.

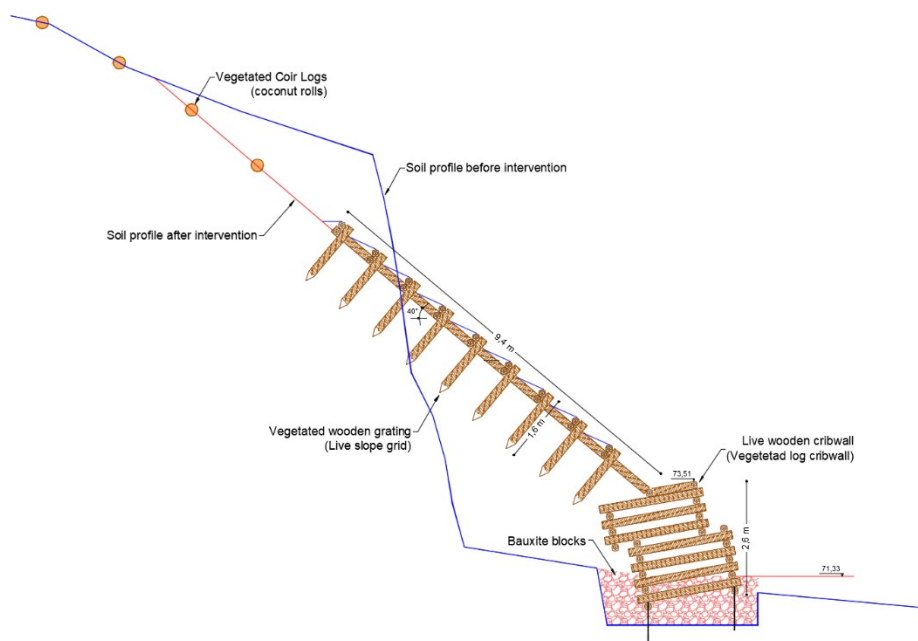
The live wooden cribwall will be used to stabilize the highest and steepest part of the slope located at the head of the gully, in addition to serving as support for the live slope grid. The live wooden cribwall consists of a structure where layers of longitudinal and transverse logs are arranged and fixed alternately, forming a gravitational box-shaped structure. The structure will be executed linearly with a length of 6.2 m at the base, a length of 10.20 m at the top, and a height of 2.60 m (measured vertically), consisting of 2 levels. Firstly, the terrain modeling should be carried out for the implementation of the structure, and excavation on the slopes for the lateral fittings. The structure will be filled with soil, and planting of autochthonous species from the region will be conducted on its face. Figure 5 shows some construction details of the structure.

The live slope grid is a widely used technique to support and contain very steep terrains, both on riverbanks and on slopes, to systematize landslides and to requalify gullied slopes. The live grid is a structure consisting of the application of vertical and longitudinal logs anchored by vertical posts fixed between them, forming a grid-shaped structure. Subsequently, the structure must be filled with soil, and in the soil grids, planting of autochthonous species from the region will be carried out. Figure 5 shows some construction details of the structure.

On the remaining slopes and on top of the live slope grid (Figure 5), vegetated coconut rolls will be used, arranged transversely on the slopes to reduce the slope length and consequently the water velocity and its erosive capacity. The coconut rolls dissipate the kinetic energy of the surface runoff, also acting in retaining soil particles and organic matter transported by the runoff, promoting improved fertility conditions for the establishment and development of vegetation. Transverse barriers composed of coconut rolls with a diameter of 30 cm combined with the application of shrub seedlings will be executed.

**Figure 5. Cross-sectional profile of the soil Bioengineering interventions. The drawing does not represent the plantings with autochthonous species in the designed structures.**

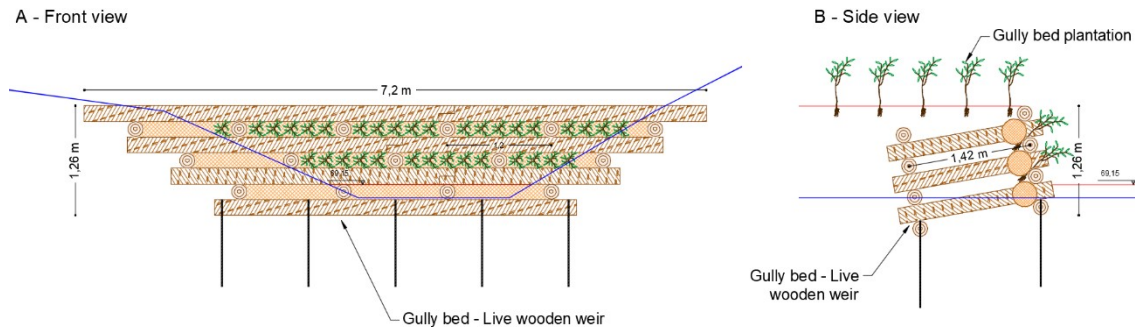
The live wooden weirs will be constructed with a wooden cribwall, using logs arranged in overlapping levels, perpendicular to each other, to form a containment structure for inert material (Figure 6). Two structures will be executed transversely to the direction of water flow at the bottom of the gully. They should be combined with the application of shrub seedlings.

**Figure 6. Specified interventions for the bottom of the gully.**

Subsequently, the gully bed plantation will be executed, which consists of planting seedlings in the areas formed between the live cribwall at the head of the gully and the weirs, after the filling and modeling of the soil. The planted area has a total dimension of 152 m<sup>2</sup>.

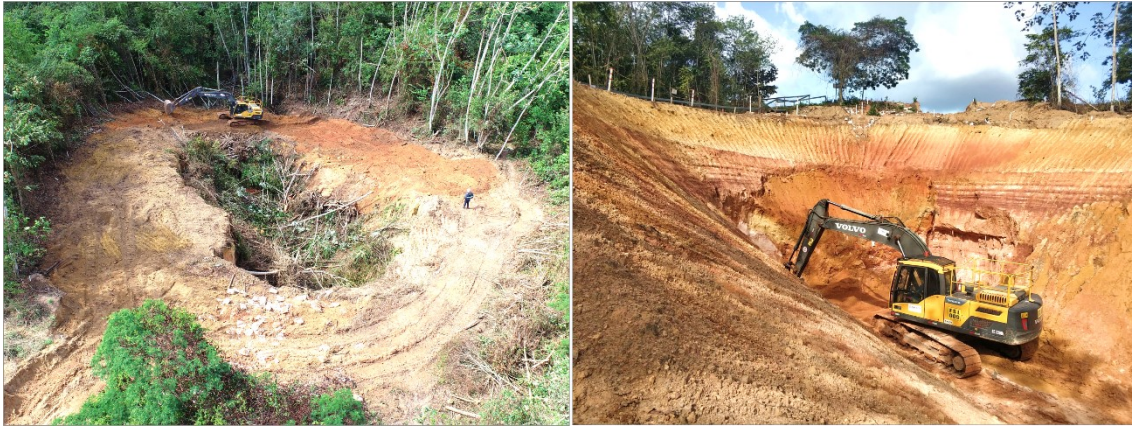
The soil bioengineering work took place between December 2023 and May 2024, lasting approximately 6 months. The work began with the reformation of the terrain, with earthworks carried out using a hydraulic excavator that enabled the cutting of slopes with heights of up to 9.0 m under adequate safety conditions. During the earthworks, cleaning and removal of all vegetative debris, such as fallen trees and logs, were performed at the bottom of the gully (Figure 7 on the right), to enable the proper implementation and execution of the designed soil bioengineering techniques.

**Figure 7. Earthworks (12/08/2023) and slope reshaping (09/01/2024).**

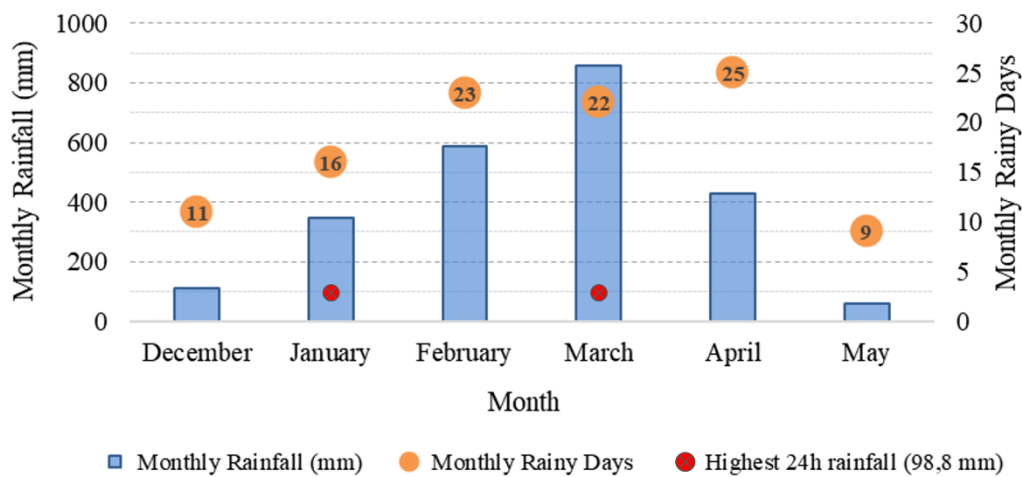
January, high rainfall totals reached 347.8 mm for the month, notably on January 10<sup>th</sup> (98.8 mm), as shown in Figure 8. Since the work was being conducted in a depression (gully), at the top of the slope, a temporary soil ridge was constructed to divert the water flow from the contributing basin, preventing water from flowing into the gully and the occurrence of erosive processes on the slopes.

**Figure 8. Monthly precipitation and number of rainy days during the project execution period.**

During the project execution period, between 01/12/2023 and 17/05/2024, a total of 169 days elapsed, of which 63 % (106 days) experienced rainfall events. Notably, the days 11/01 and 22/03 recorded the highest daily accumulated precipitation of 98.8 mm. The total accumulated precipitation during the work was 2 389.3 mm. Figure 8 represents the accumulated volumes and number of rainy days monthly during the activities. However, despite the high rainfall events recorded, no soil losses were observed in the intervened areas, neither damage to the Soil bioengineering structures that were under construction. This denotes and confirms the viability of Soil bioengineering structures to mitigate and correct erosive processes, despite them not yet being completed and fully functional (vegetation is still in the initial establishment stage) during the precipitation events. With the development and full establishment of the vegetation over the years, the intervention tends to increase its technical and environmental efficacy.

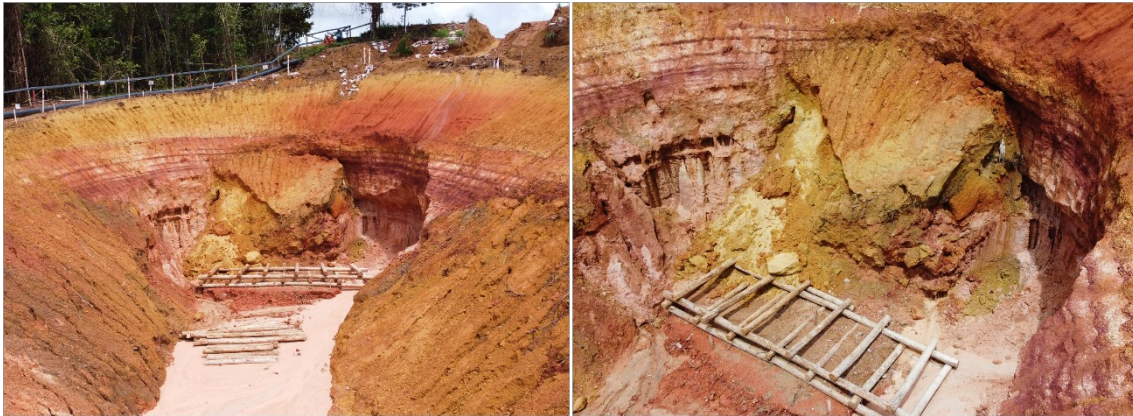
The high volume of precipitation on January 11<sup>th</sup> (75.9 mm) caused the breach of the temporary ridge, leading to water inflow into the gully and consequently exacerbating the erosive process and transporting material from the slope. Thus, some damage to the work was observed, with the emptying of the cribwall structure which was in the initial phase of implementation (Figure 9).

**Figure 9. Exacerbation of the erosive process after high rainfall on 11/01/24.**

During the intense precipitation events, the execution of the work was suspended for safety and operational reasons. After the decrease in precipitation, on January 13<sup>th</sup>, 2024, the construction activities were resumed (living support wall). Figure 10 on the left shows some details of the execution activities.

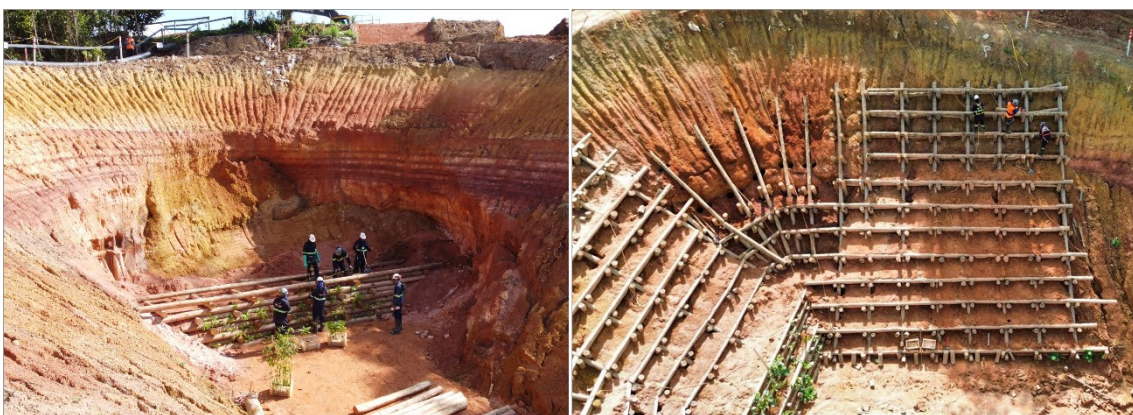
The live cribwall was constructed with wooden logs, where rows of longitudinal logs were alternated with rows of transverse logs, forming a box-like structure. Notches and fixations between longitudinal and transverse logs were made with ribbed steel bars. During construction, the structure was filled with soil, which was slightly compacted to allow vegetation growth. The soil bioengineering work was carried out during the Amazonian winter (December to May). In

**Figure 10. Execution of the activities of the double living support wall live wooden cribwall on 18/01/24 (left) and the live slope grid on 14/03/24 (right).**

After completing the live wooden cribwall, the execution of the live slope grid over the wall and on its left wing began (Figure 10 on the right). Vertical and longitudinal logs were placed, anchored in vertical posts. All logs were fixed together with ribbed steel bars, and then the structure was filled with soil. In the soil quadrants, planting of native species of the region was carried out. Subsequently, the live wooden weirs at the bottom of the gully, the application of vegetated coir rolls on the slopes, and the planting of the gully bed were executed. At the end, hydroseeding was performed throughout the intervention area with native herbaceous species. All soil bioengineering interventions involved planting seedlings of native species from the region, always alternating between species. During the planting, fertilization, and application of hydrogel were carried out. Figure 11 shows the project in the final stage of its execution, before finishing with hydroseeding.

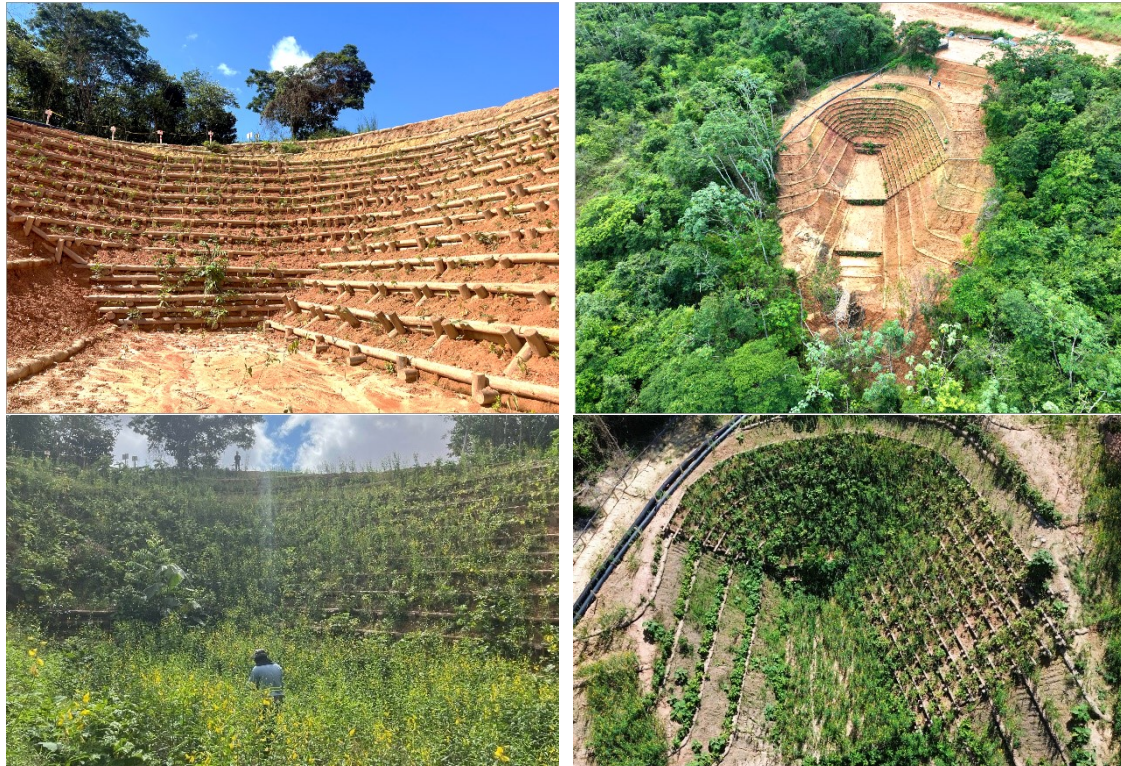
**Figure 11. General aspect of the soil bioengineering project at the conclusion phase on 03/05/24 (above) and 15/07/2024 (under).**

The applied vegetation shows good survival and field development rates. In the coming months, maintenance tasks necessary to aid the initial development of the vegetation will be carried out. With the development and full establishment of the vegetation, the intervention is expected to increase its technical and environmental efficacy in the coming years. Monitoring of the project with an assessment of the integrity of the structures and the development of the vegetation in the coming years should be conducted to obtain data about the technical and ecological efficacy of the soil bioengineering, as these interventions are innovative in the Amazon Biome.
