Casthouse Refractory Methods for Risk Control and Quality Assurance

Rio Tinto Aluminium – Atlantic Operations, Saguenay, Canada

Keywords: Refractory maintenance, Casting furnace, Steam explosion, Health and safety, Casthouse risk reduction.

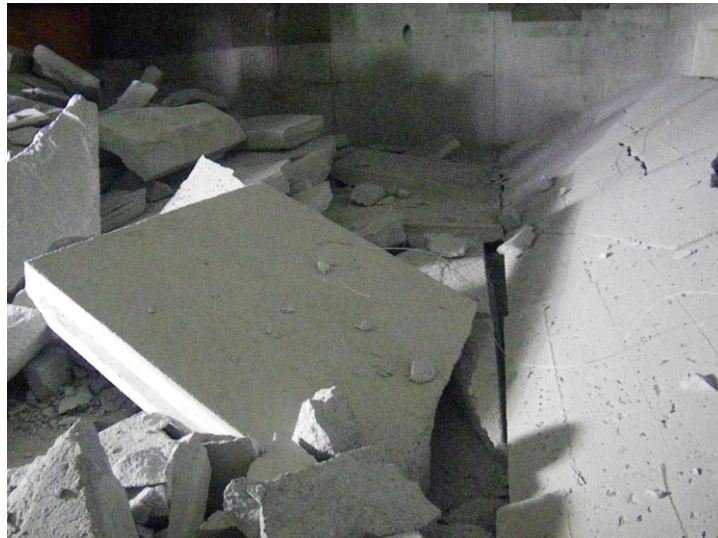
Figure 1. 100 t furnace severely damaged by a steam explosion in 2015 during dry-out [2].

Refractory maintenance in casting furnaces can be a hazardous task. For example, during most steps workers are routinely exposed to crystalline silica dust, which is a known carcinogenic substance [1]. Other specific tasks such as demolition and work inside chimneys involve additional risks: the former involves working in very close proximity to heavy machinery, while the latter exposes employees to falling pieces of refractory or debris from great heights. Because of process risks, even steps where no manual labour is involved can be dangerous to nearby personnel. The penultimate stage of a furnace shutdown is the dry-out, during which new refractories must be carefully brought up to temperature following a precise schedule. If the schedule is not strictly adhered to, a steam explosion within the new lining may occur. Such an explosion can also occur during the first batch in the furnace if molten metal penetrates the lining through expansion joints or cracks and contacts trapped residual water from the dry-out. Although rare, severe steam explosions in casting furnaces can be quite destructive, as shown on Figure 1.

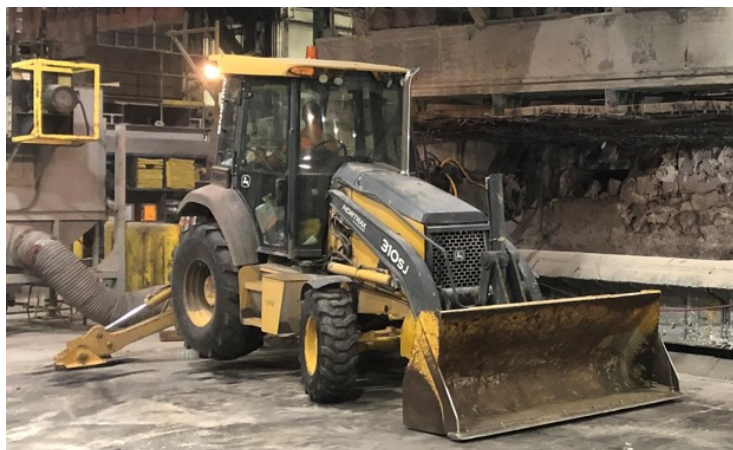
Until recently, refractory tear-out was performed using conventional excavation machinery, like the backhoe shown on Figure 2. This figure clearly shows the main problem with this type of equipment: the operator sitting in the cab is too high to have a direct line of sight on many areas inside the furnace (roof, front ramp, floor, etc.).

Figure 2. Typical backhoe used for furnace demolition (author's image).

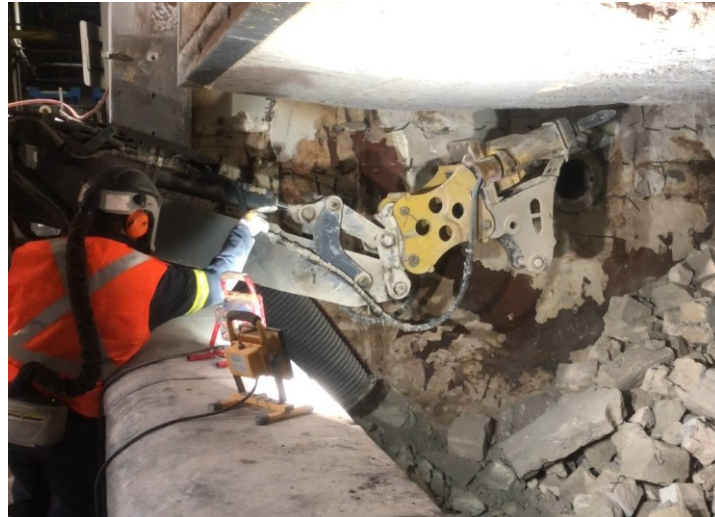
This issue mandated the use of a spotter to guide the backhoe operator when tearing out components invisible to the operator. Unfortunately, to be able to see the jackhammer while visually communicating with the machine's operator, the spotter had to stand extremely close to the backhoe's swing arm. Figure 3 shows a spotter near the machine.

Figure 3. Example of a spotter guiding a backhoe during roof demolition (author's image).

This level of proximity placed the spotter at great risk of being hit by or crushed by the swing arm against the furnace in case of operator error. The vehicle itself was also a considerable risk, as the backhoe frequently had to be repositioned during demolition and the spotter was often standing in a blind spot. Even though internal safety requirements mandate a safe separation distance between heavy machinery and personnel on foot, it could not be always implemented during refractory tear-out due to the necessary visual communication.

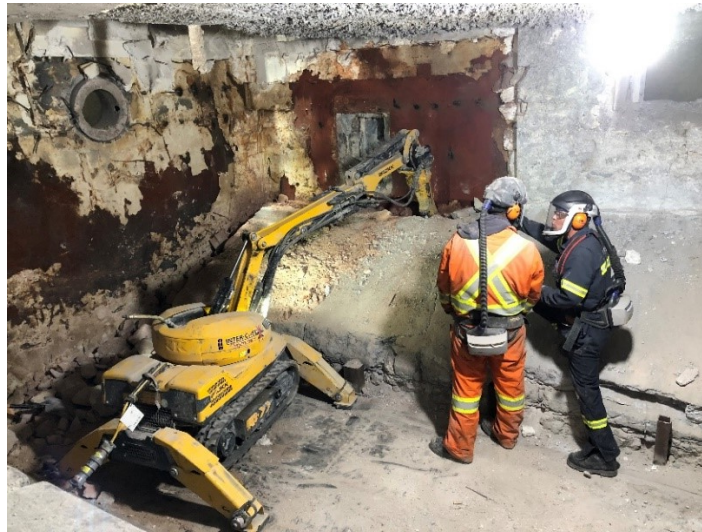
from the Swedish manufacturer Brokk. They were first used to tear out hard-to-reach furnace components, such as lower wall sections located behind ramps. Figure 6 depicts a small unit in operation within a furnace:

Figure 6. One of the first trials with a small Brokk unit in 2020 (author's image).

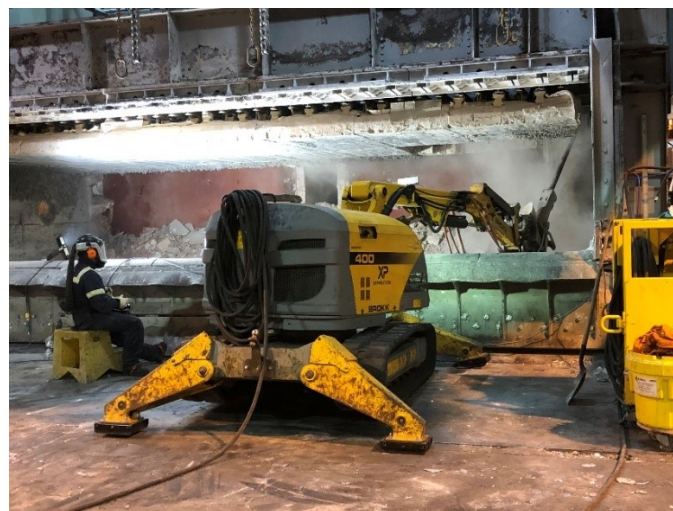
Once these trials proved successful, the author initiated discussions with potential business partners in order to find larger robots that could efficiently replace conventional machinery. The first full-scale trial took place in Alma in early 2021. During this trial, two 115-tonne furnaces were completely stripped of their refractory lining using only demolition robots. Given the size of these furnaces, much larger machines were required; Brokk 400 units were utilized for both demolition and debris removal tasks. The difference in unit size can be seen in Figure 7.

Figure 7. Brokk 400 at work in a 115-tonne furnace (author's image).

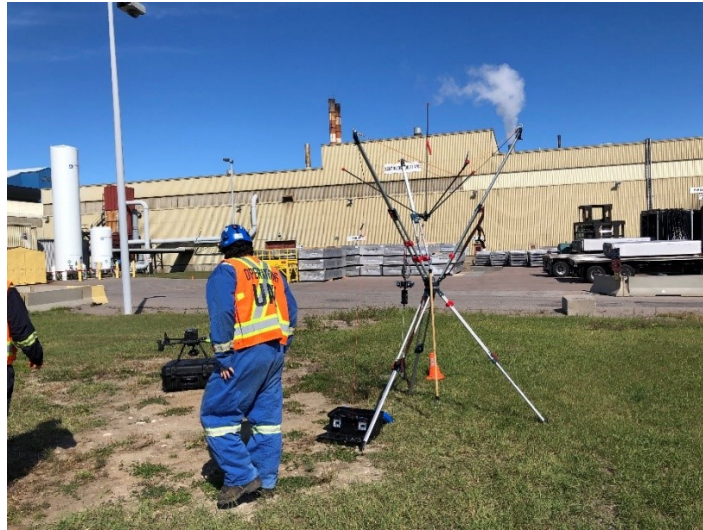
In order to reduce the usage of man-baskets for stack inspections, drones were first trialed in April 2022. The drones used were large commercial quadcopters, modified and operated by Torngats, a Quebec-based company specialized in non-destructive testing and remote 3D scanning. The drones were equipped with high-resolution cameras, thermal cameras and 3D scanners. Initially, the drones were used only to inspect the exterior of stacks, but they were soon also utilized to visually inspect the refractory inside. In the latter case, the drone does not actually enter the stack; instead, it lands on top of the chimney and lowers a 3D camera and lights inside, using a motorized winch.

Figure 8. Drone operations at Rio Tinto's Grande-Baie smelter in 2022 (author's image).

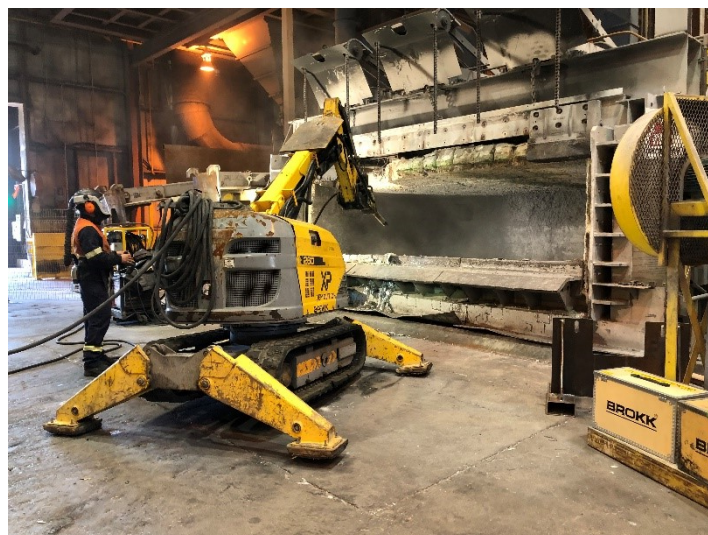
The main safety risk posed by traditional excavation machinery during furnace tear-out was contact between the machine and the required spotter, as they had to work in unacceptably proximity. The introduction of remote-controlled robots has greatly reduced this risk, as a worker no longer must position himself in the “line of fire” to guide the driver. Since Brokk robots are operated with a wireless remote, the machine’s operator can stand far away from the “line of fire”. However, the crushing risk has not been fully eliminated for two reasons: the first is that in certain circumstances, the Brokk operator must still stand close to the machine in order to get a good field of view. This means the operator could be struck or crushed by the robot, should they make a mistake with the controls or if there were a malfunction. This type of situation is shown in Figure 11.

Figure 11. Operator standing close to a Brokk robot (author’s image).

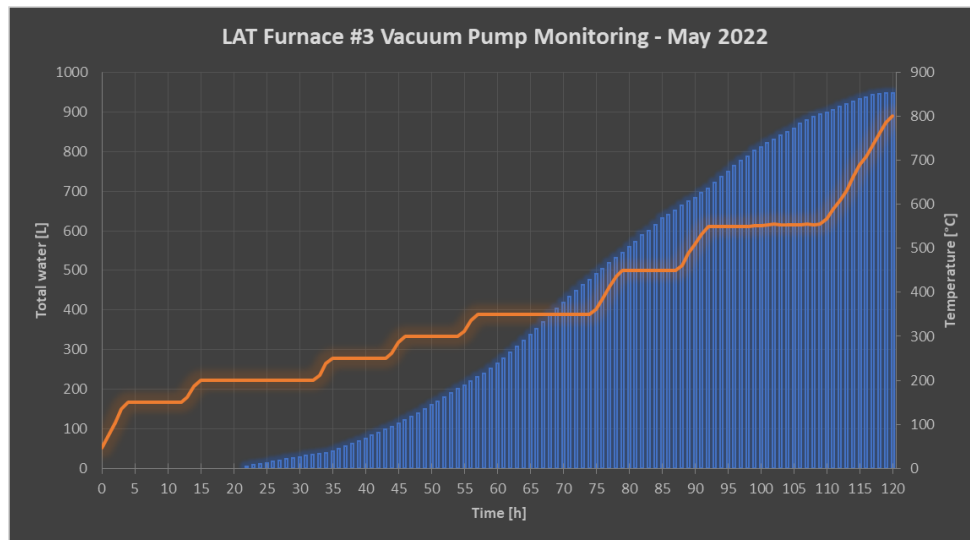
Not only was moisture sucked out of furnaces in much greater quantities and more reliably than expected, but it was also quickly realized that by measuring the amount of water being drained out of the pump’s tank every hour, monitoring of the flow rate of moisture could be done almost in real-time. As shown in Figure 13, when plotted against time and temperature it enables a new type of dry-out analysis.

Figure 13. Plot of water output against time and temperature for Laterrière furnace #3 in May 2022.

As shown above, in this case the water output rate decreased once the temperature exceeded 700 °C and almost stopped at 800 °C. This suggests there is little moisture remaining in the refractory lining and the furnace can be safely charged. Figure 13 also highlights a problem that plagued the vacuum system during the first year of usage: the temperature trend does not extend beyond 800 °C and 120 hours, even though the furnace was maintained at that temperature for another 12 hours. This is because some components overheated at higher temperatures, causing them to melt or collapse on themselves, disabling the system. Several design iterations were required before the pump and hoses could be function for the entire dry-out.

Unfortunately, water output from the pump cannot yet be used as a precise “go/no-go” criterion for safe furnace charging. On larger furnaces (exceeding 100 tonnes) with very thick linings (> 500 mm of total thickness), pump output tends to be more variable. While it does drop significantly during the final 800 °C hold, it seldom plateaus as neatly as shown on the chart above. In such cases, no liquid water is usually observed when the vacuum lines are disconnected, which serves as a qualitative indicator that the furnace can be safely charged. However, a quantitative indicator would be more reliable, and work is ongoing to achieve this with pump output.
