## A Robust Fume Treatment Centre of the Global Aluminium Industry

**Peter Klut<sup>1</sup>, Travis Turco<sup>2</sup>, Jamal el Filali<sup>3</sup> and Edo Engel<sup>4</sup>**

Danieli Corus, IJmuiden, The Netherlands

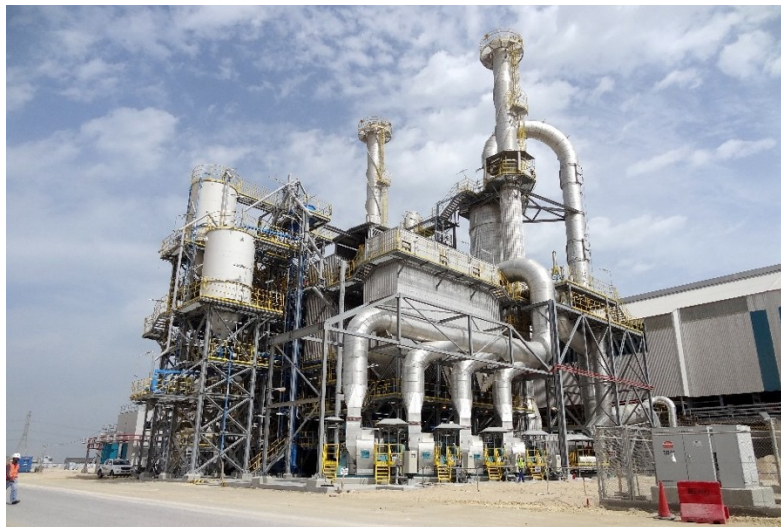
**Figure 1. Pleno V Fume Treatment Center.**

The Fume Treatment Centre designed by Danieli Corus for the primary aluminium smelting sector has shown its robustness and reliability over decades. Now in its fifth generation the Pleno design has been updated and improved while retaining its tried and tested design. Pleno V relies on a design dating back to the 1980s that has proved itself over the years, while undergoing improvements in each successive generation. The Pleno V design as seen in Figure 1, provides additional platforms, easy access for inspection and maintenance, and isolation points.

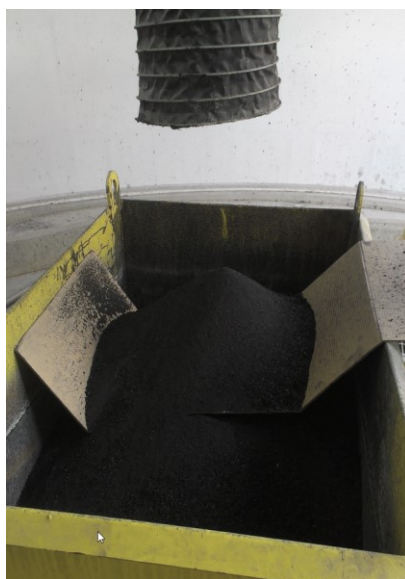
Figure 2. Separated pollutants with “dry bottom” operation.

“Dry bottom” operation of the conditioning tower as seen in Figure 2, is the operating mode whereby pollutants are discharged at the bottom without containing any moisture. This reduces corrosion risk and makes for a service life of 30 years and more, against typical design life of 20 years.

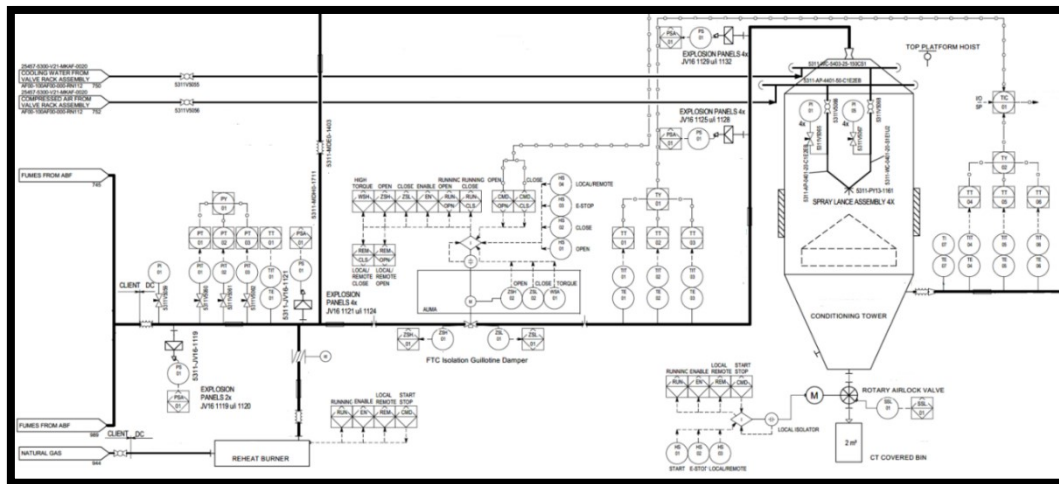
Figure 3. Control philosophy and instruments of the Conditioning Tower.

Highly automated temperature control, with three sensors on the inlet and three on the outlet ensure constant temperature, allow total evaporation of the water spray and prevent condensation, ensuring a straight temperature line throughout the process – refer to Figure 3. Feed forward control on the quantity of gas passing through provides information in advance to the control system to support this control.

In the feed forward control, the incoming heat load is calculated by multiplying the gas volume, measured at the stack, by the temperature measured by the inlet of the riser duct. As the desired outlet temperature is known, it is possible to calculate the amount of water required. This value is given as start point for the water control valve. The final adjustment of the water control valve is done by the outlet temperature of the conditioning tower. Large swings in flow or temperature are therefor early detected and can be handled without any problem. The setpoint for the conditioning tower outlet is typically set at 105 °C and will be maintained at +/- 2 °C provided the spray lances are properly maintained. The shape of the conditioning tower, along with the positioning of the spray lances and the coverage they provide make for a high residence/retention time of eight seconds that provides sufficient time for the reactions and the water to evaporate.

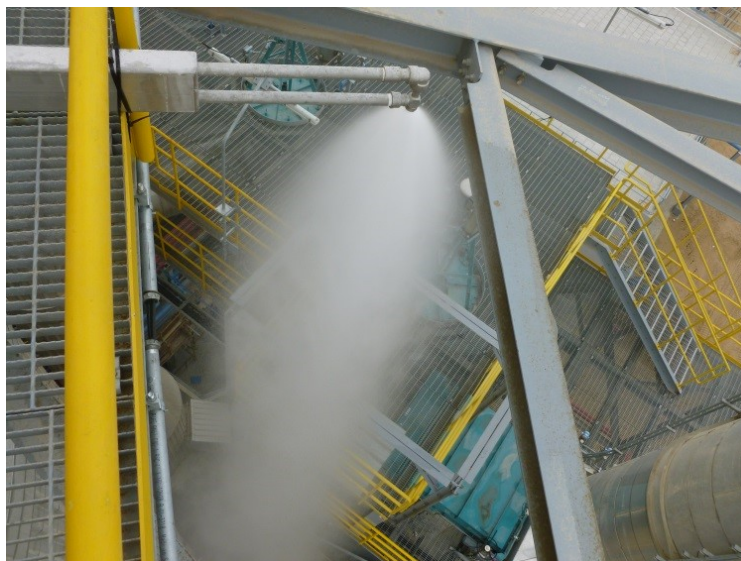
**Figure 4. Inspection of lance spray with correct pattern.**

The operational maintenance of the conditioning tower is limited to the inspection of the spray lances. A bi-weekly inspection on the spray pattern of the operational lances is required. All operational lances should be removed and tested one by one. Due to the presence of shut-off ball valves, quick coupling hoses and speedball nuts flanges, the removal of the lances is easy. Once removed, the lance is put on the platform and is reconnected to the hoses and the shut-off valves are opened. The spray pattern should show a plume of mist similar as shown in Figure 4.

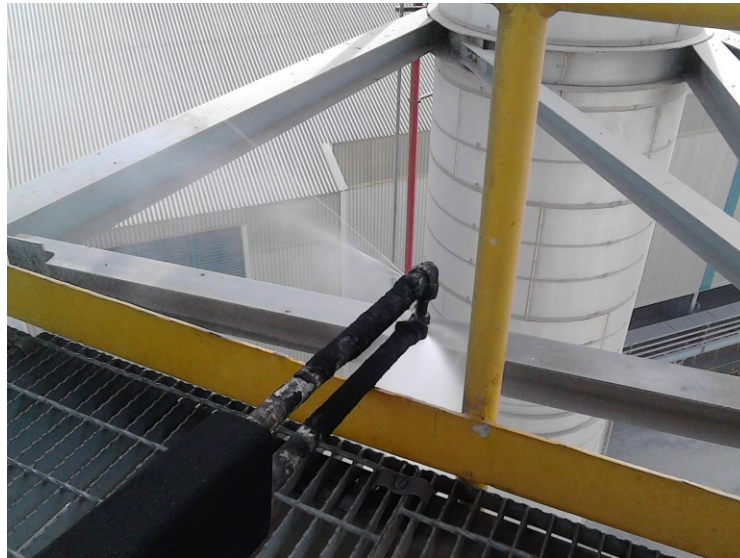
**Figure 5. Inspection of lance spray with faulty pattern.**

Faulty spray patterns demonstrate sideways spraying or dripping as shown in Figure 5. Such patterns are mostly caused by fouled or corroded lances, an example of which is given in Figure 6. Faulty lances should be cleaned or replaced. After the inspection the lance can be re-inserted and put back in operation. In case of mechanical damage of the nozzle, the tip can be exchanged separately.

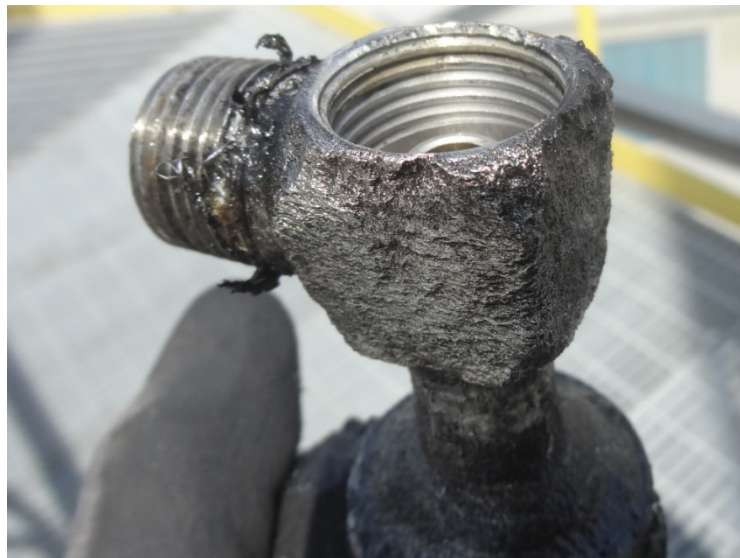
**Figure 6. Fouled spray lance.**

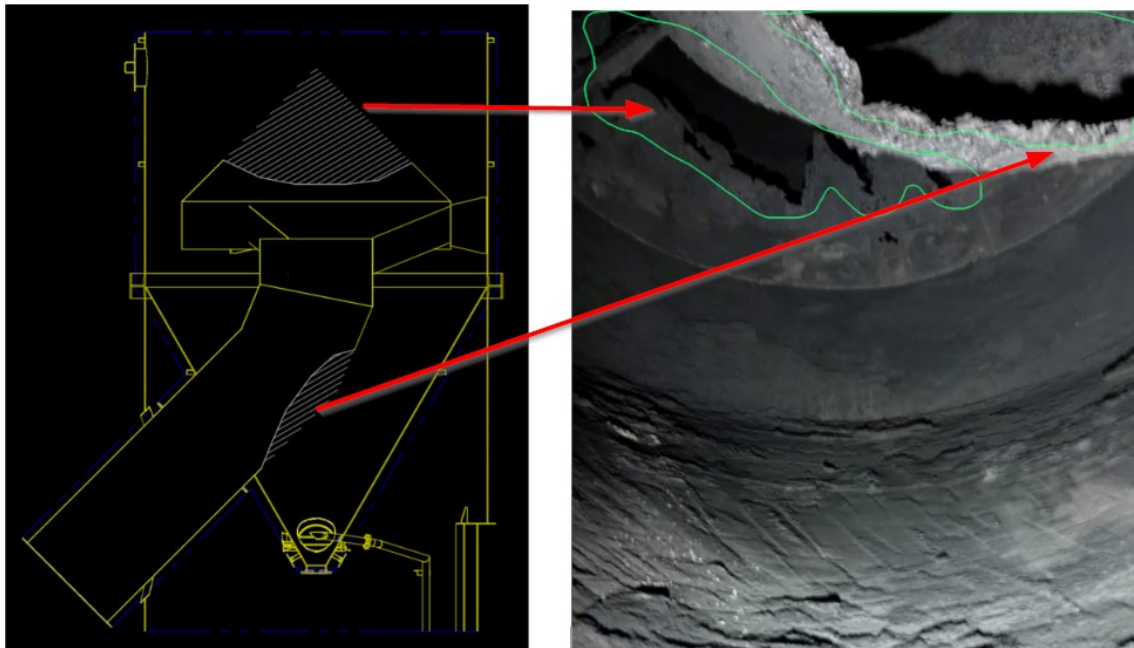
**Figure 7. Corroded diffuser cone and internal duct.**

Our conditioning tower has reputation of continued performance in extreme operational ranges, spray lance issues and severe corrosion. During a visit to Plant A, inspection of the conditioning tower showed almost complete loss of the internal diffuser, internal duct and the airlock at the bottom of the conditioning tower as per Figure 7.

With the diffuser out of service, there is potential for hot ambers or large particulate to make its way to the baghouse and cause further damage. This corrosion was direct result of excess spray water caused by compromised spray lances. If the spray nozzle tips are not cleaned, the spray nozzles will suffer corrosion themselves and the injected water is not atomized sufficiently for complete evaporation. Despite the ultra-conservative retention time in the tower, the un-vaporized water droplets collect on the diffuser and cone and ultimately causing corrosion.

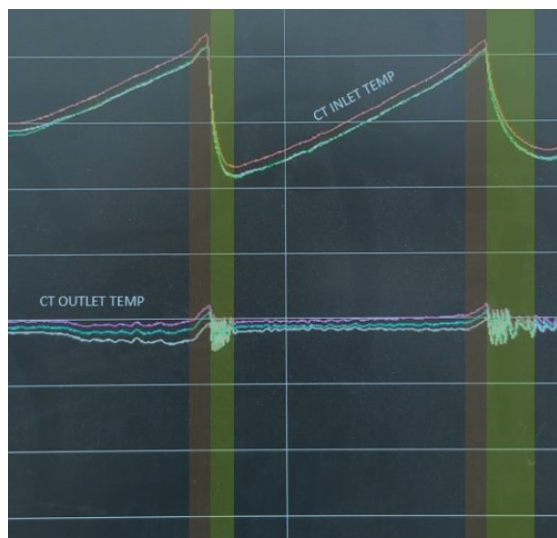
**Figure 8. Conditioning tower inlet and outlet temperatures observed during fact finding.**

This degree of damage does not happen swiftly and there is ample time during routine maintenance and inspection where this could be easily corrected. However, after years of neglect the extent of corrosion is evident, yet the conditioning tower kept performing for many years. The corrosion continued to grow and yet the outlet temperature from the conditioning tower was generally maintained as can be seen in Figure 8: this screenshot shows the inlet and outlet temperatures of the conditioning tower over time and clearly demonstrates that despite major swings in inlet temperature (which is inherent to the nature of the ABF), outlet temperatures remain very stable.
