Casthouse Refractory Methods for Risk Control and Quality Assurance

Philippe Gauthier¹ and Mathieu Bergeron²

Rio Tinto Aluminium – Atlantic Operations, Saguenay, Canada Corresponding author: philippe.gauthier@riotinto.com https://doi.org/10.71659/icsoba2024-ch013

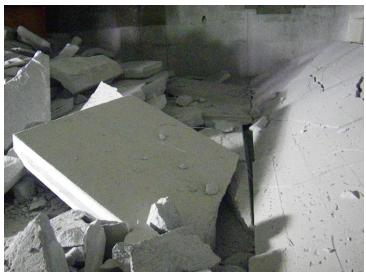
Figure 1. 100 t furnace severely damaged by a steam explosion in 2015 during dry-out [2].

Refractory maintenance in casting furnaces can be a hazardous task. For example, during most steps workers are routinely exposed to crystalline silica dust, which is a known carcinogenic substance [1]. Other specific tasks such as demolition and work inside chimneys involve additional risks: the former involves working in very close proximity to heavy machinery, while the latter exposes employees to falling pieces of refractory or debris from great heights. Because of process risks, even steps where no manual labour is involved can be dangerous to nearby personnel. The penultimate stage of a furnace shutdown is the dry-out, during which new refractories must be carefully brought up to temperature following a precise schedule. If the schedule is not strictly adhered to, a steam explosion within the new lining may occur. Such an explosion can also occur during the first batch in the furnace if molten metal penetrates the lining through expansion joints or cracks and contacts trapped residual water from the dry-out. Although rare, severe steam explosions in casting furnaces can be quite destructive, as shown on Figure 1.
