Management of HDPS Siphon System in AP40 Kitimat Smelter - Roadmap of Challenges and Process Optimization

Abstract

Keywords: Hyper dense phase system (HDPS), Siphon, Alumina supply disruption, Static flow control (SFC).

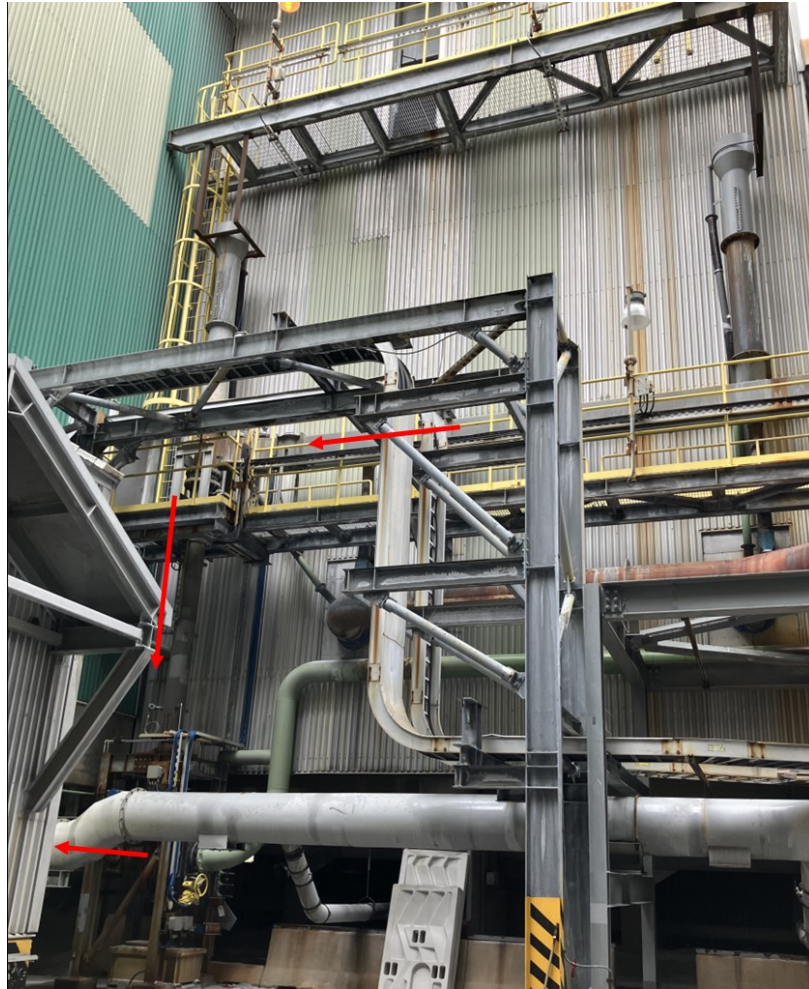
Figure 2. HDPS feeding the inlet side of the siphon.

Figure 1 shows the cross section of the Siphon System, Figures 2–6 Show the material flow from the North HDPS branch to the 6.5-meter descent to the siphon, the 6.5-meter ascent to the South HDPS branch and a 300-meter stretch of HDPS on the South branch. Arrows in these Figures indicate the alumina flow.

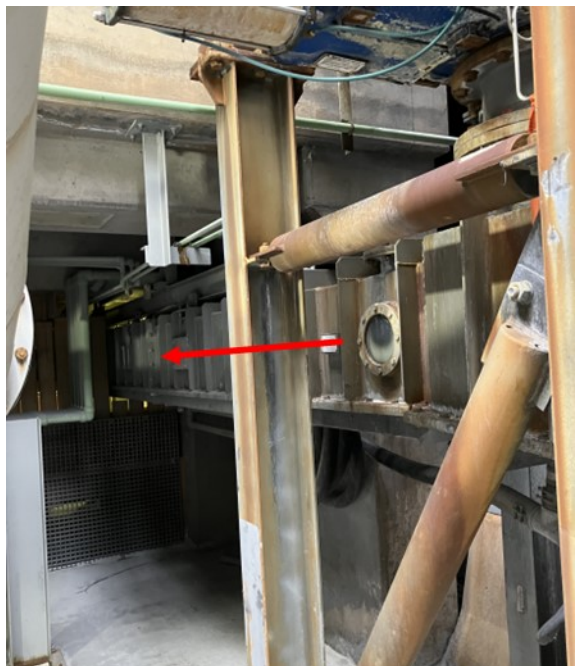
Figure 3. Siphon under center passage.

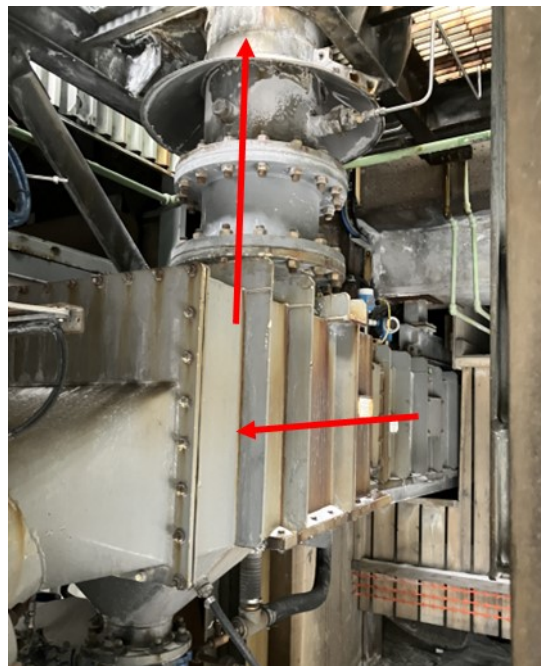
Figure 4. Siphon outlet column.

To have a reliable supply of alumina to the South HDPS branch, the siphon needs to maintain a consistent flow of alumina from the input on the North side to the output on the South. The natural gravity-driven portion of the siphon worked well, but lifting the alumina 6.5 m back up the South column requires additional air pressure and system support. Without the additional support the siphon over pressurizes causing a stoppage of alumina flow and loss of material to the south HDPS.

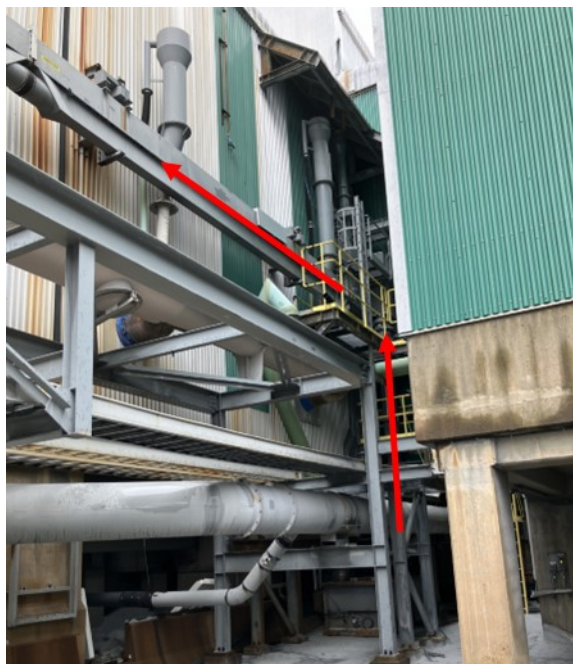
Figure 5. Outlet column feeding south HDPS.

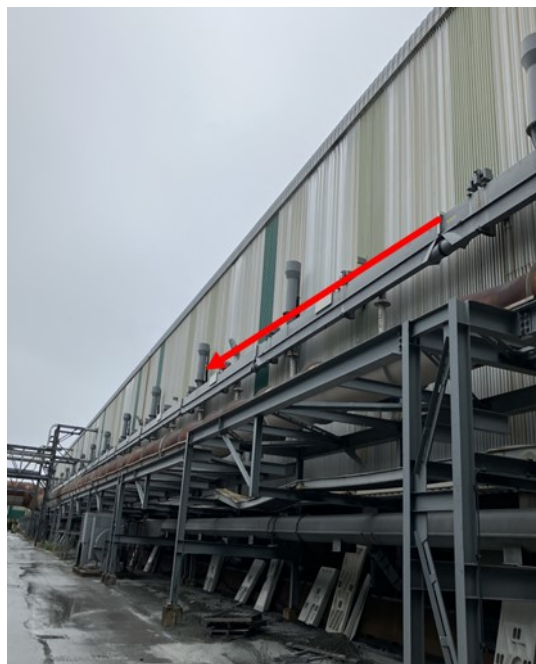
Figure 6. South HDPS branch

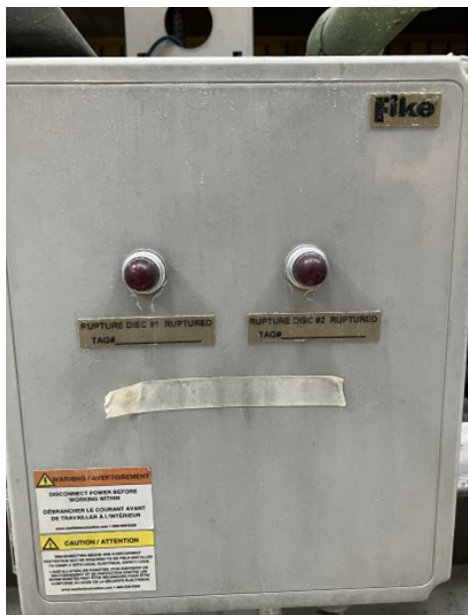
Figure 7. Decommissioned rupture discs.

In 2015 during the startup of the HDPS, the original design featured rupturing discs rated at 95 kPa to relieve excessive pressure and protect the system. However, these discs ruptured prematurely under normal operating conditions and were unable to support the pressure levels required to move alumina efficiently through the siphon.

Resolution: The rupturing discs were removed and replaced with process safety relief valves set to 150 kPa approximately (22 psi) as depicted in Figures 7–8 below. Process safety relief valves regulate pressure effectively by venting excess air only when required and reseal automatically once the pressure normalizes.

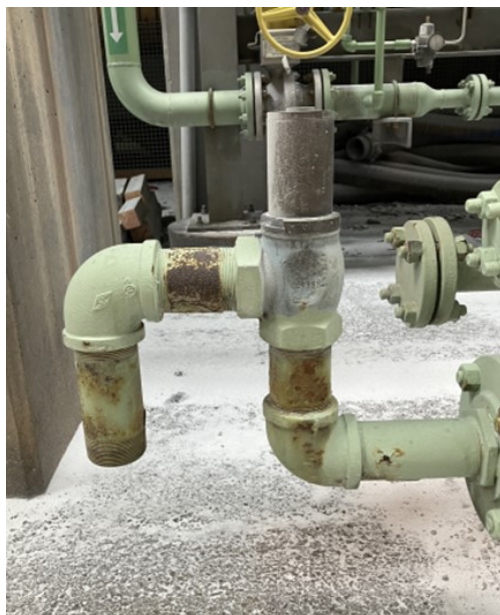
Figure 8. Process safety relief valve.

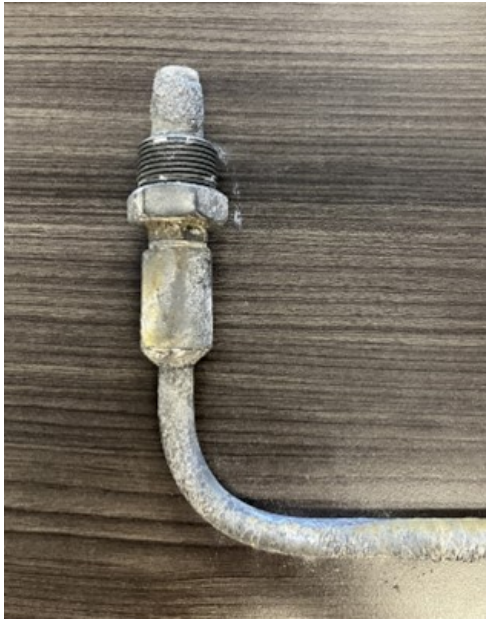
Figure 9. Siphon column nozzle.

The south column after the siphon requires additional air support. To achieve this, two air nozzles were installed originally mid-way up the south column to inject compressed air and aid the upward movement of alumina. However, these nozzles quickly experienced severe scaling, rendering them ineffective after only a few weeks. In 2015 the nozzles were removed from service. Shown below in Figure 9 and Figure 10 are the nozzles and their location in the column.

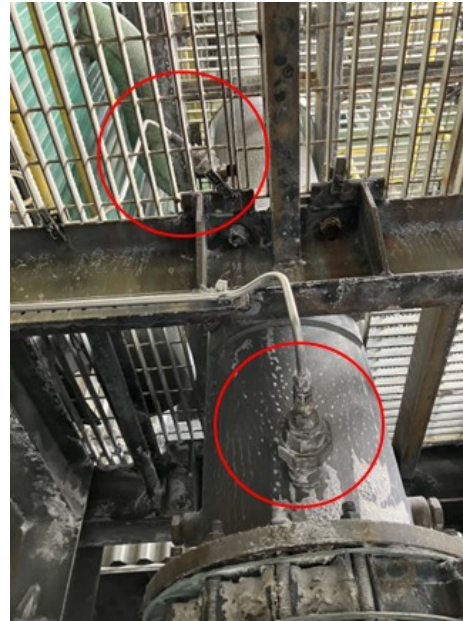
Figure 10. Nozzles location in the column.

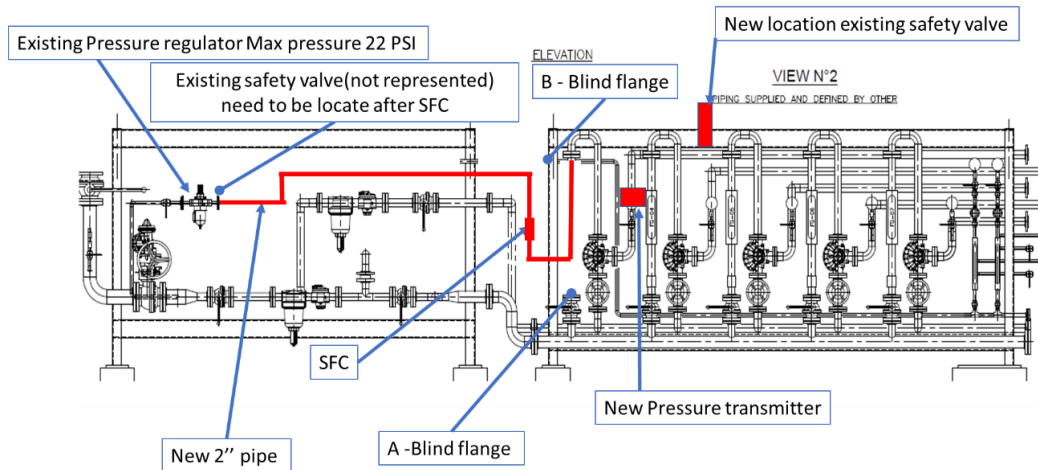
Figure 11. Static flow control improvement drawing.

Resolution: The failure of south column nozzles led to the implementation of the Static Flow Control (SFC) system. The SFC injects air beneath the south column outlet at a slightly higher pressure than the rest of the system. This design creates a more efficient flow and reduces the risk of back pressure inside the siphon. The siphon was in critical condition and struggling to operate since November 2022, and the SFC was implemented in 2024 (Figure 11).

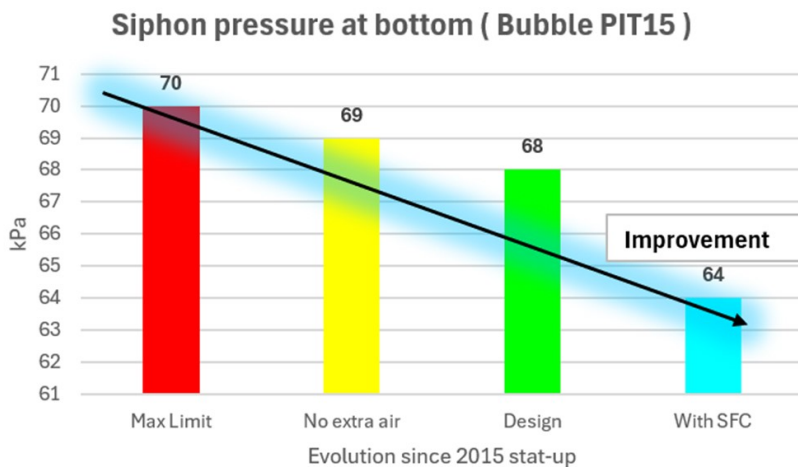
Figure 13. PIT-15 bubble pressure improvement after SFC.

Following the initiation of the SFC project, a significant reduction in siphon bubble pressure was observed. This decrease suggests improved efficiency in alumina flow through the siphon. Additionally, the HDPS was able to achieve its bubble pressure set point downstream of the siphon with reduced material input or a lower inlet bubble pressure. This improvement contributes to decreased operational stress on the system as shown in Figure 13. Figure 14 shows the location of the siphon bubble pressure transmitter.

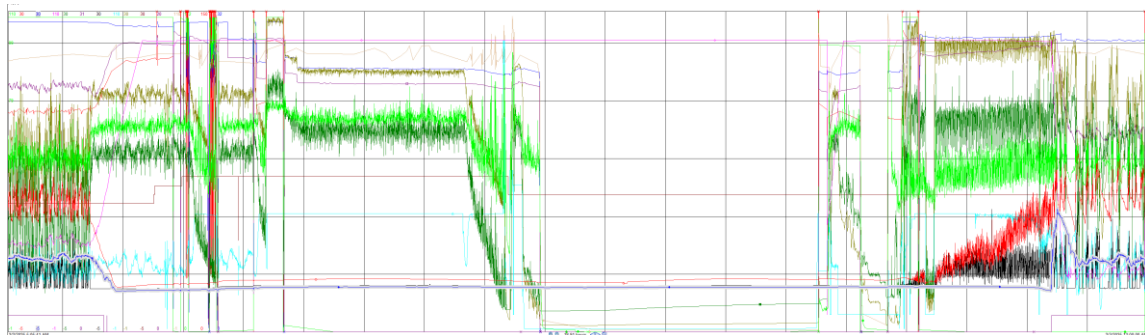
Figure 15. Siphon bubble pressure loss.

In February 2025 there was a siphon failure on a weekend at 6:30am, taking 14 hours to fix the issue and an additional hour and a half to fill the HDPS, shown in Figure 15. This is an example of a siphon failure that brought the plant close to putting pots in “Sleeping mode” or euthanizing pots.
