Study on Oxidation Resistance Technology for Aluminium Electrolysis Anode Stubs

Abstract

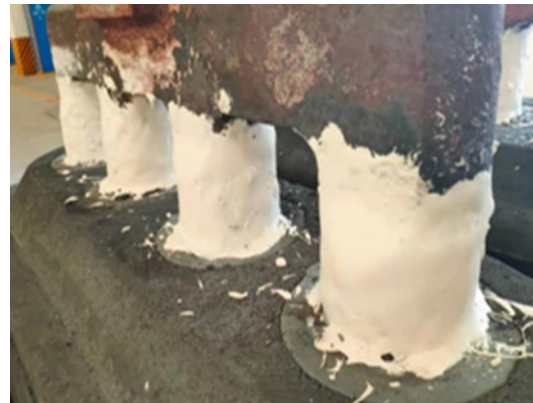
Figure 2. Application of anti-oxidation coating.

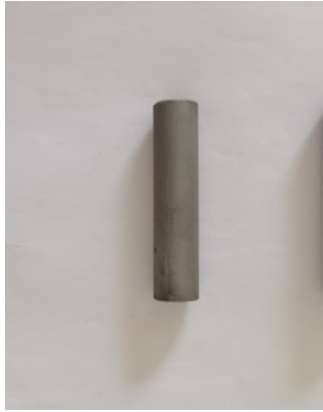
Figure 4. Q235B material without molten infiltration coating.

Figures 4 and 5 show the macroscopic morphologies of Q235B samples (diameter 10 mm × length 100 mm) with and without molten infiltration coating. As observed, the Q235B material maintains a certain metallic luster after surface derusting. In contrast, after high-temperature molten infiltration coating treatment, the surface is evidently covered with a gray-white coating, completely losing its metallic luster, with visible traces of high-temperature interdiffusion.

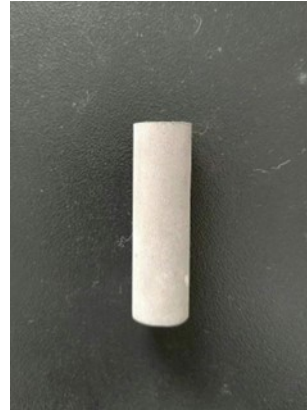
Figure 5. Q235B material with molten infiltration coating.

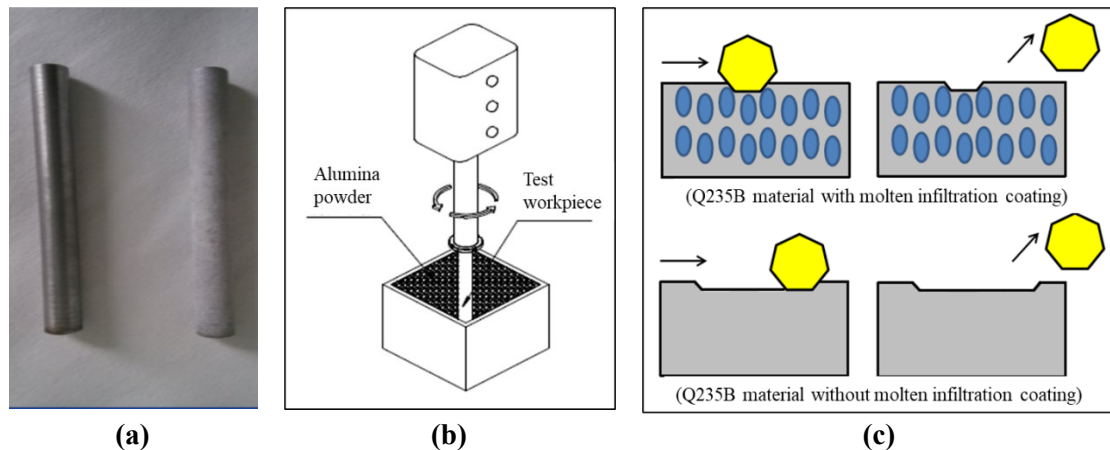
Figure 11. Schematic diagram of abrasive wear. (a) Test samples. (b) Abrasive wear testing equipment. (c) Sample wear process.

Since the anode stubs inevitably undergo long-term contact and friction with alumina materials, resulting in wear damage characterized by low-stress scratching abrasion, enhancing the wear resistance of the stubs is also a critical indicator for their protection. In this test, a circumferential abrasive wear test was selected to evaluate the wear resistance. The test samples were processed into cylindrical rods and placed in the equipment, with industrial granular alumina used as the abrasive counterpart. The test was conducted at a rotational speed of 60 r/min for 24 hours. A schematic diagram of the abrasive wear is shown in Figure 11. According to the friction and wear test results, the Q235B material sample without molten infiltration coating demonstrated poor wear resistance, with a weight loss of 0.68 g. In contrast, the Q235B material sample with molten infiltration coating demonstrated excellent wear resistance, showing a weight loss of only 0.04 g, 17 times better than that of the Q235B material. This superior performance is attributed to the uniform distribution of high-hardness Fe-X alloy phases on the surface of the molten infiltration coating. These phases prevent the embedding of alumina particle tips into the substrate during friction, thereby hindering the sliding of abrasive particles across the surface and reducing the abrasive wear caused by the extrusion of alumina particles on the Q235B substrate. In comparison, the surface of the Q235B substrate lacks reinforcing phases, resulting in inferior wear resistance. As the wear duration increases, localized wear pits enlarge, leading to progressive material loss [9].

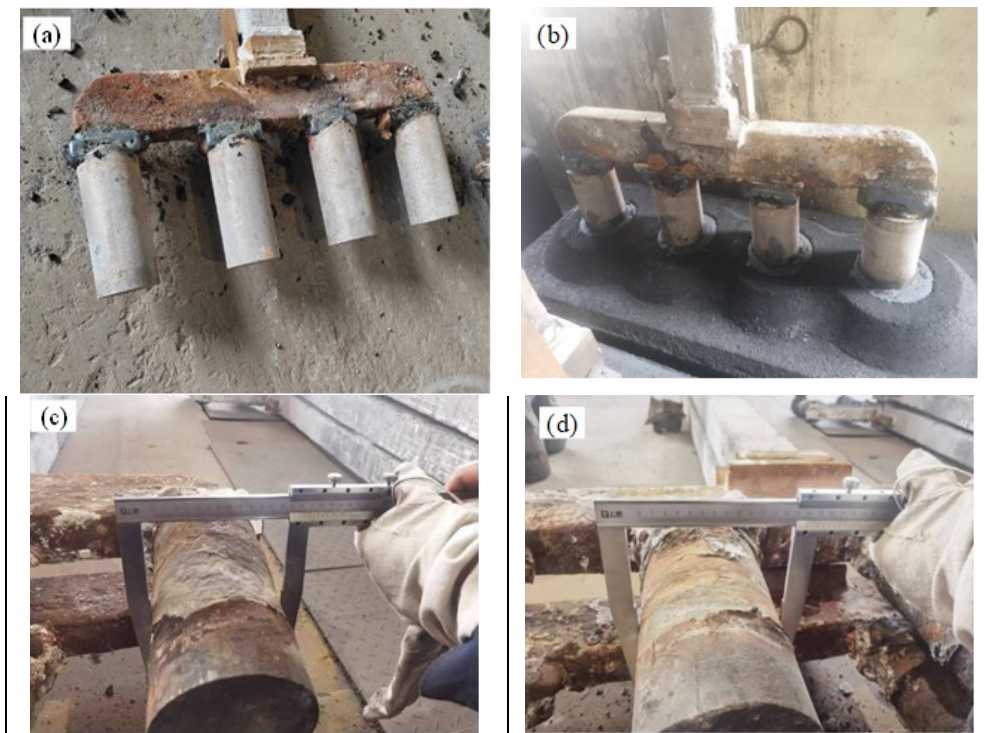
Figure 12. Industrial application scenarios. (a) Welding of oxidation-resistant stubs. (b) Casting of oxidation-resistant stubs. (c) Wear condition of conventional stubs. (d) Wear condition of oxidation-resistant stubs.

Using Q235B section steel as the substrate, oxidation-resistant anode stubs were prepared by coating the molten infiltration method. Industrial tests were conducted on a 200 kA potline cell at a Chinese aluminium smelter, with the industrial application scenarios shown in Figure 12. The welding and casting methods for oxidation-resistant stubs are the same as those for conventional stubs, requiring no additional treatment. After four cycles of use, the average wear rate of conventional stubs was 2.35 mm/cycle, while that of oxidation-resistant stubs was 0.21 mm/cycle, demonstrating significant antioxidant effects. By adopting oxidation-resistant anode stubs, the service life can be extended from 3 to 4.5 years. For a 300 kt/y-capacity potline, it is projected to generate annual economic benefits of approximately RMB 3.94 million (545 kUSD/y approx.).
