Use of Barrier Material to Reduce Sodium Penetration to the Sub-Cathodic Lining of Electrolytic Cells

Emirates Global Aluminium, Jebel Ali, Dubai, United Arab Emirates

Abstract

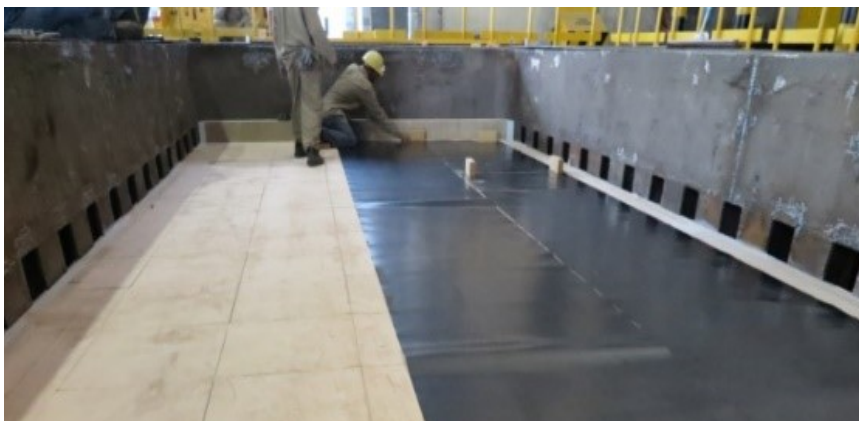
Figure 1. Cell construction using graphite foil.

A controlled test of bottom lining material was conducted at EGA to evaluate the use of graphite foil as a barrier protective layer to stop sodium penetration to sub-cathodic lining materials. A graphite foil of 0.5 mm thickness was used in the test cell. A double layer of the foil was placed on the top of firebricks, under the cathode block, throughout the cell, while keeping other materials with no change. Five test cell were built: three cells in CD20 technology and two in D20 technology.

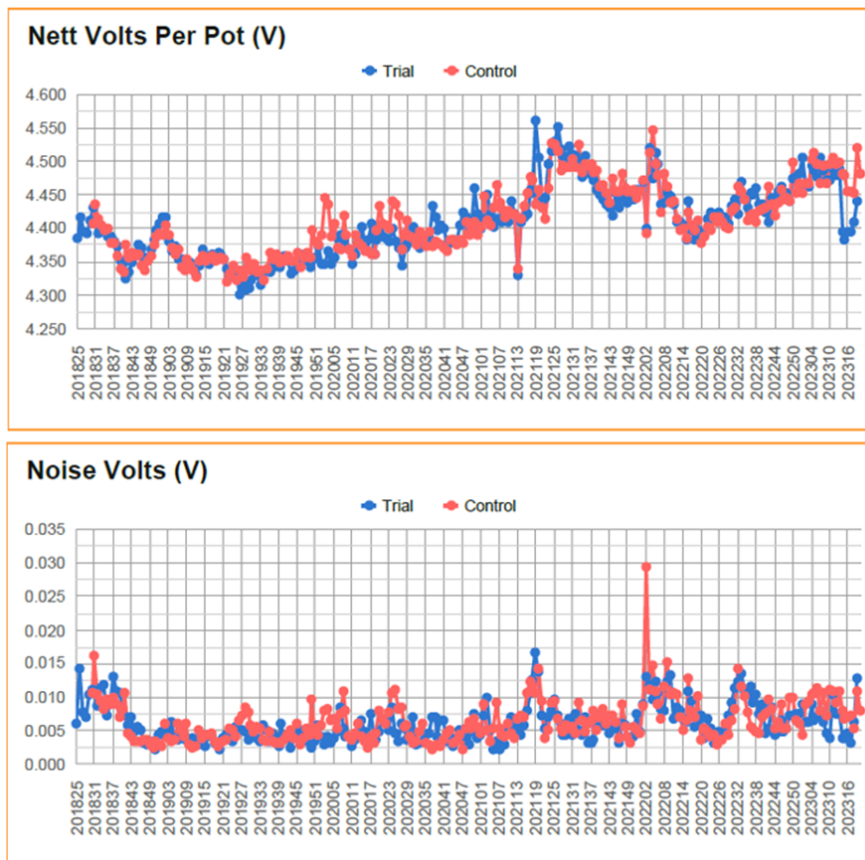
Figure 2. Operational performance trend of trial cells using graphite foil.

with similar cell age and standard lining materials. Figure 2 shows the comparison over 5 years. Table 1 gives average values over the duration of the tests.

The net cell voltage of trial cells was comparable with the control cells. The cathode lining drop was 5–10 mV higher than in control cells, though it was within measurement error. The cell stability was normal with noise and bath temperature similar in test cells and control cells.

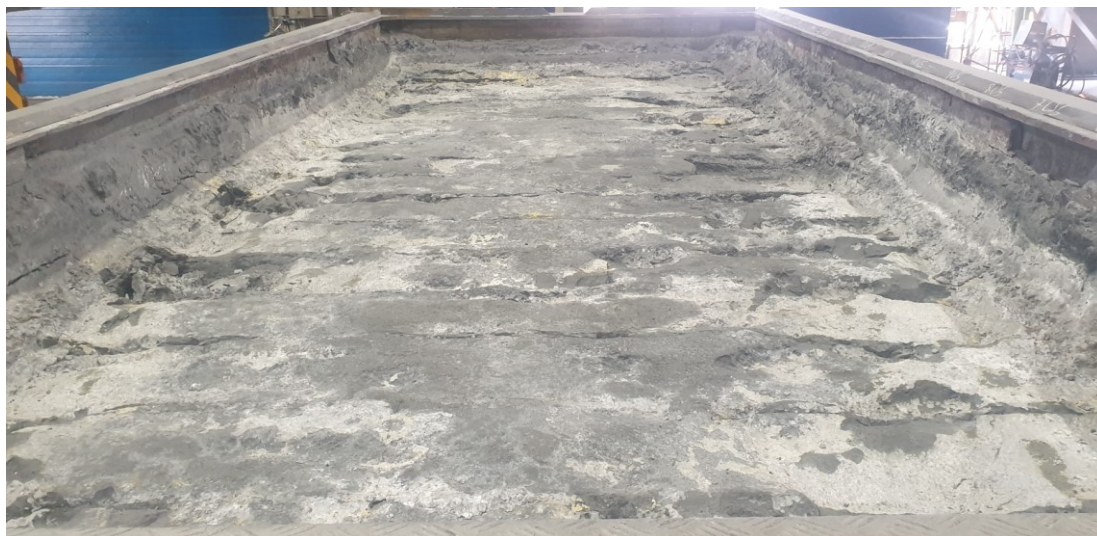
Figure 3. Test I, view of the cathode block surface.

A detailed cell autopsy was made for one trial cell. The selected cell was cutout due to early tap out at 1208 days. The surface cavity inspection showed typical erosion pattern with deepest point measured above collector bar #16 at the upstream location. The cathode surface is shown in Figure 3.

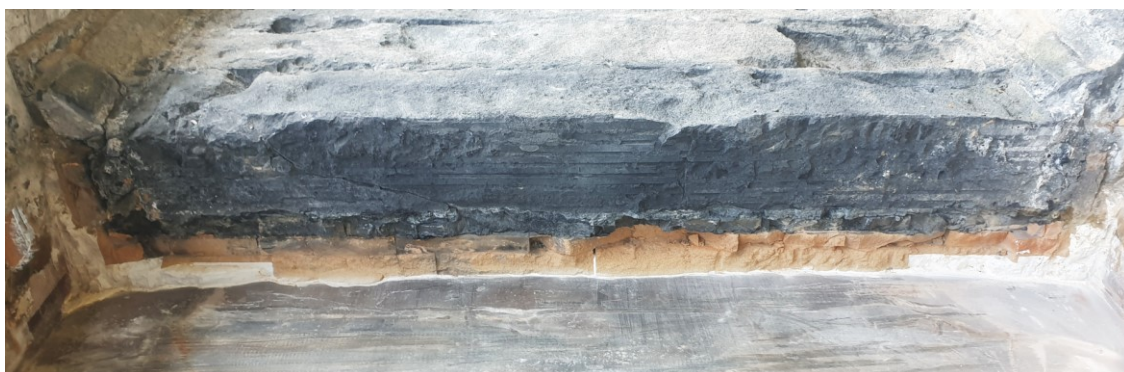
Figure 4. Test I, slice view (1).

Further inspection was made with cell autopsy. The blocks were removed at several locations to the shell bottom surface to verify the condition of sub-cathodic lining materials (Figures 4 and 5). The effectiveness of the graphite foil material could not be confirmed. The graphite foil was found at a few locations as a thin black layer, but the material was degraded in many places. The sodium penetration occurred through the sub-cathodic materials with the reaction zone boundary at expected location without the foil. The cell had no cathode heaving or major cracks and this was comparable to the control cells with similar lining design.

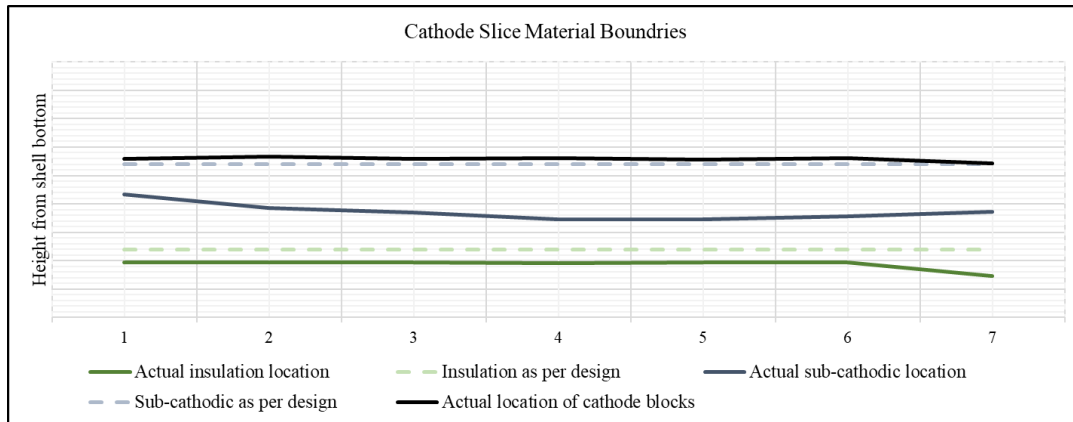
Figure 6. Test I, cathode slice measurements.

Cavity measurements and autopsy slice measurements were made in the tested cell. Figure 6 shows the sub-cathodic profile of materials along a cathode block, across the cell width. It

confirms that the cell did not have any heaving since the cathode block bottom location is aligned with the initial construction of the sub-cathodic course of the cell. The middle line shows the boundary of the reaction front. The insulation layer was slightly compressed.

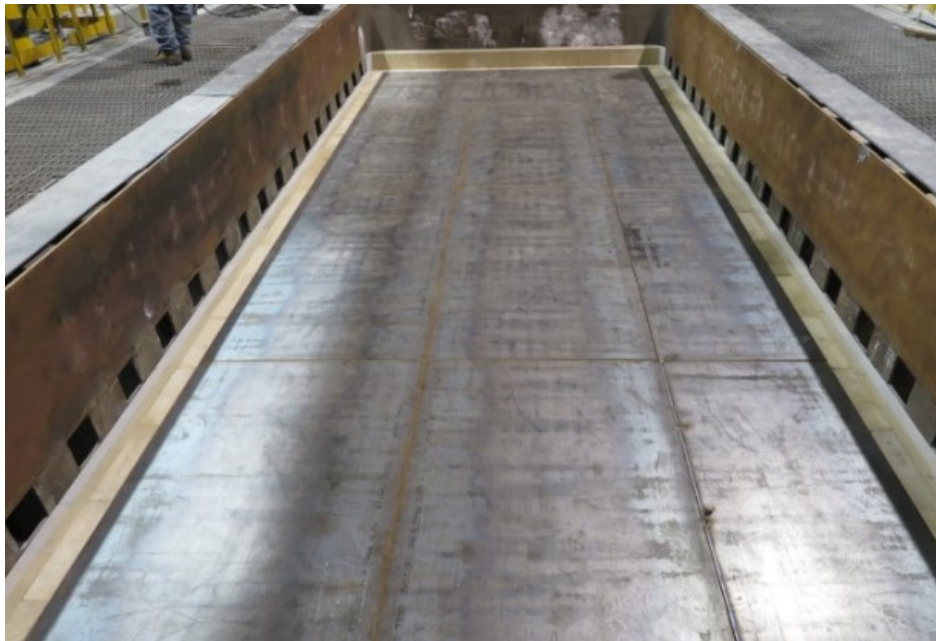
Figure 7. Cell construction using steel plate

Using similar approach as in Test I, a steel plate of 20 mm thickness was installed as barrier layer. Initially, three cells were built and installed in D20 technology. The plate was installed just below cathode blocks on top of the firebrick layer. Figure 7 shows the installed plate.

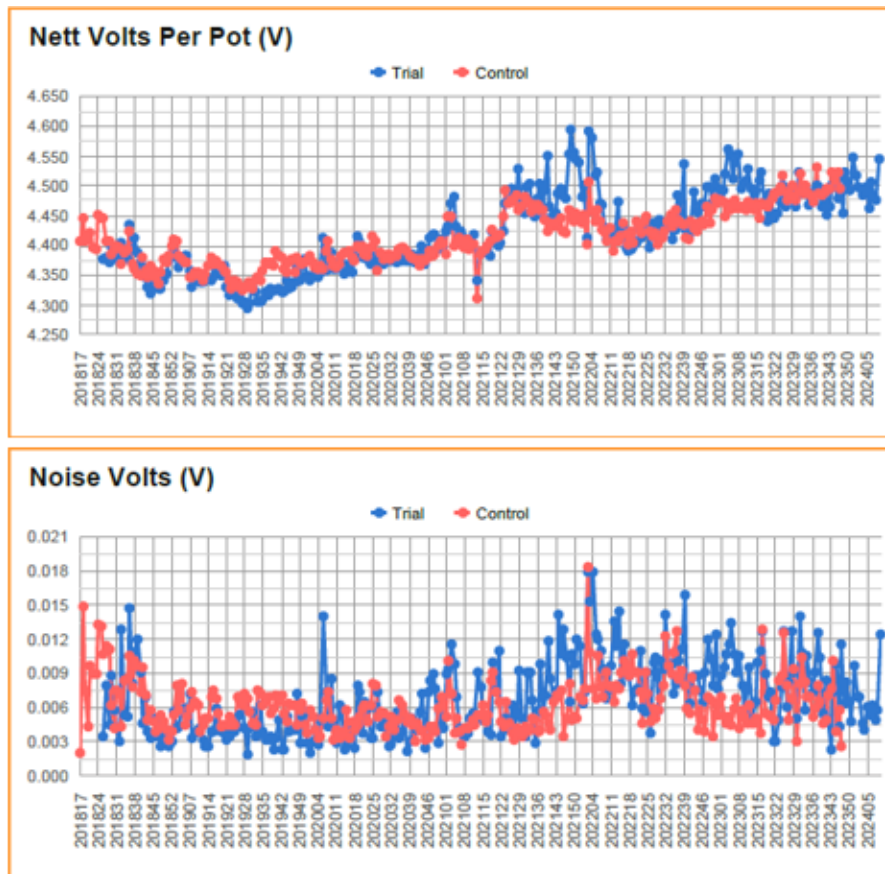
Figure 8. Operational performance trends of trial cells using steel plate.

The trial cells were monitored and evaluated through the entire cell life from bath up to failure. The trial cells' current efficiency, specific energy consumption and cathode voltage drop (lining

dop) were comparable with control cells. Figure 8 shows the graphs, and Table 2 gives average values.

Overall trial and refence cells were operating with similar operating window and showed similar performance.

The cell showed abnormal longitudinal cracks along the cathode blocks. The observation was confirmed through the autopsy slice at several locations. Since the steel plate was installed in direct contact with the steel collector bars, it might have caused the bottom of the cathode block to be colder due to higher lateral heat dissipation. This can explain the cell operation with high bath temperature fluctuation seen in Figure 8.

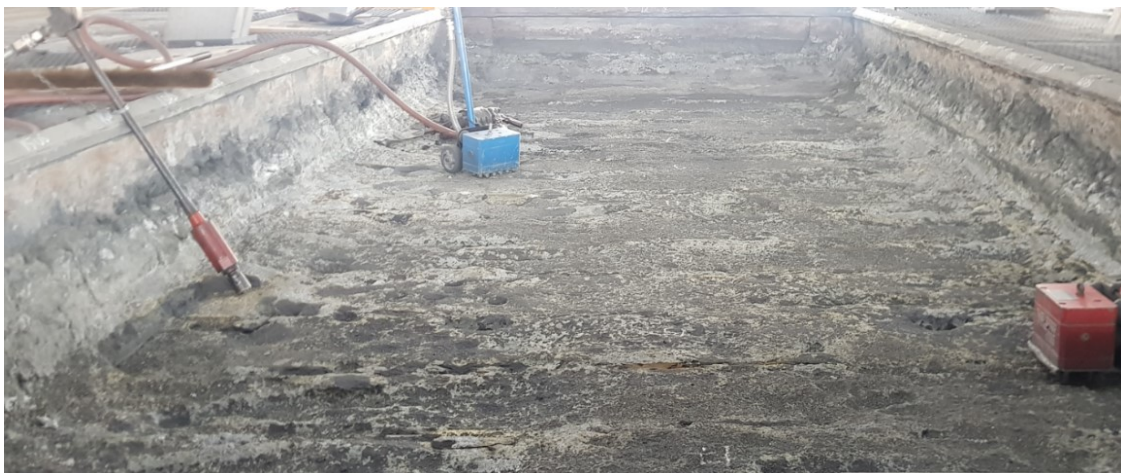
Figure 9. Test II, view of the cathode block surface at the age of 972 days.

The cell cavity inspection was made during a power outage at cell age of 972 days. The surface inspection showed no presence of any abnormality and the cavity measurement, including the erosion measurement, was comparable to control cells with similar lining. After the inspection, the cell was restarted.

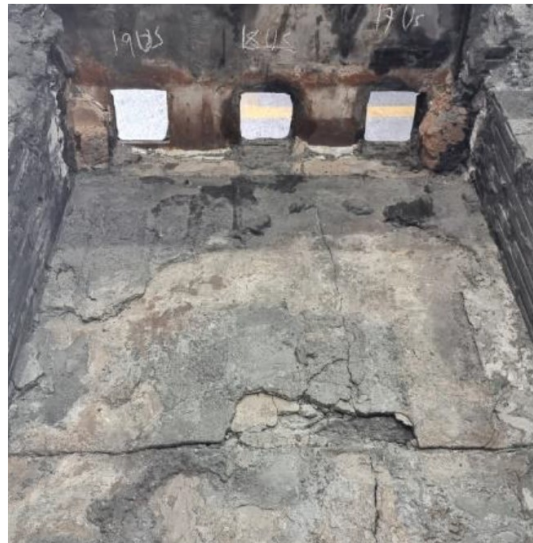
Figure 10. Steel plate during cell autopsy.

After the restart, the cell failed at age of 1163 days due to iron attack, at a restart age of 191 days. A detailed autopsy was conducted and the steel plate was found in good condition. Minor heaving in the centre of the block was observed and confirmed by measurement.

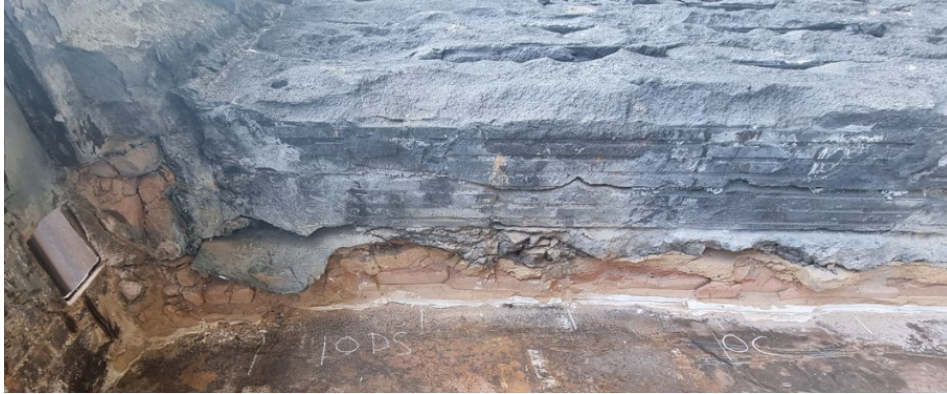
Figure 12. Test II, slice view (2).

The steel plate was effective in stopping the sodium penetration and reaction of the bottom firebricks. Therefore, the sodium reaction layer was found at the steel plate. The sub-cathodic lining materials were unreacted and in good condition.

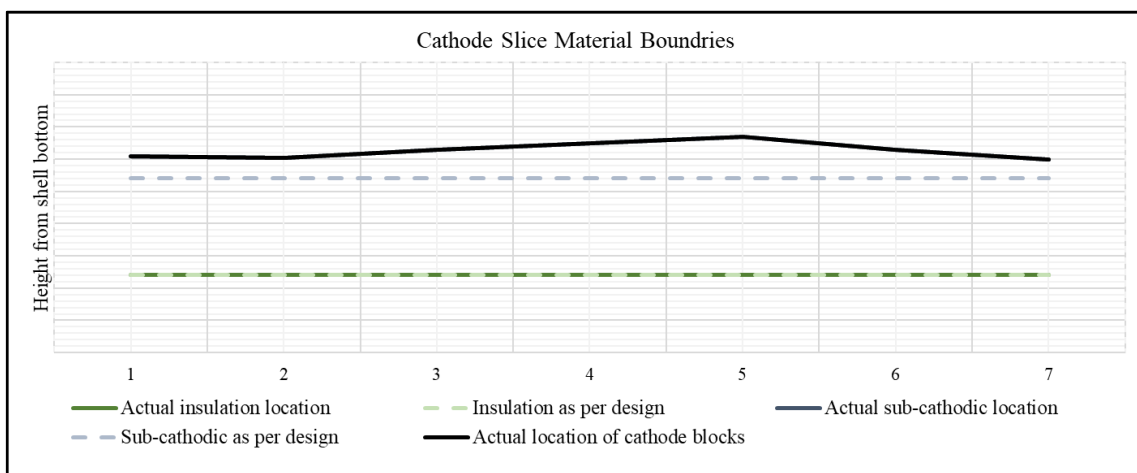
Figure 14. Test II, cross-section measurements.

Figure 14 shows the sub-cathodic measurements of the autopsied cell. The actual sub-cathodic location exactly matches with the cathode block bottom, which clearly indicates that the reaction zone stops at the cathode block bottom at the steel plate location.
