## Pitting on Carbon Cathodes in Aluminium Electrolysis Cells

Samuel Senanu<sup>1</sup>, Tor Grande<sup>2</sup> and Arne Petter Ratvik<sup>3</sup>

Department of Material Science and Engineering, NTNU Norwegian University of Science and Technology, NO-7491 Trondheim, Norway

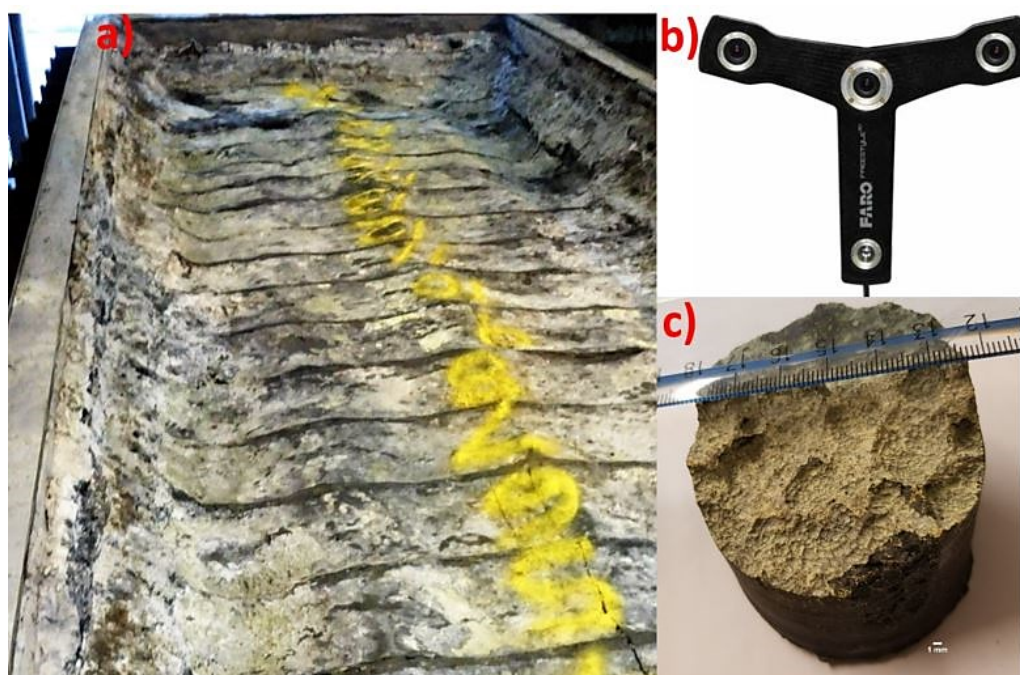
**Figure 1. Autopsy of spent potlining. a) Image of the cathode surface after vacuum cleaning. b) Freestyle Handheld 3D scanner for surface profile measurements. c) Autopsy sample drilled from the spent potlining for analysis.**
