Pot Blasting Abnormality Control at Balco

Bharat Aluminium Company, Korba, India

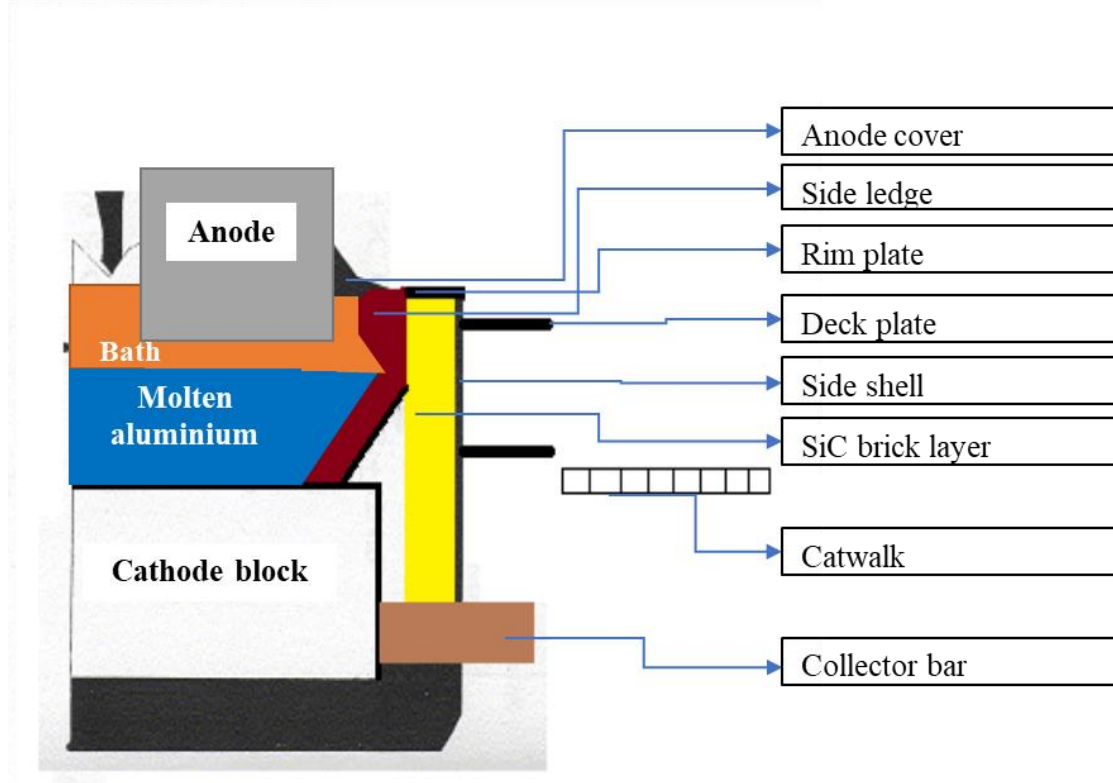
With reference to Table 1, the frequency of pot tap-out is 24 % (12/50 pots), which is very high. When pot blasting happens unexpectedly, there is a generation of intense energy in the cell, which initially damages to pot hood, rim and deck plate (Figure 1). The potshell starts getting hot spots which may result in pot tap-out (Figure 7). There is also risk of a complete potline failure through an open circuit, earthing faults or busbar damage.

Figure 1. Partial cross-sectional view of pot and nomenclature (area related to blasting).

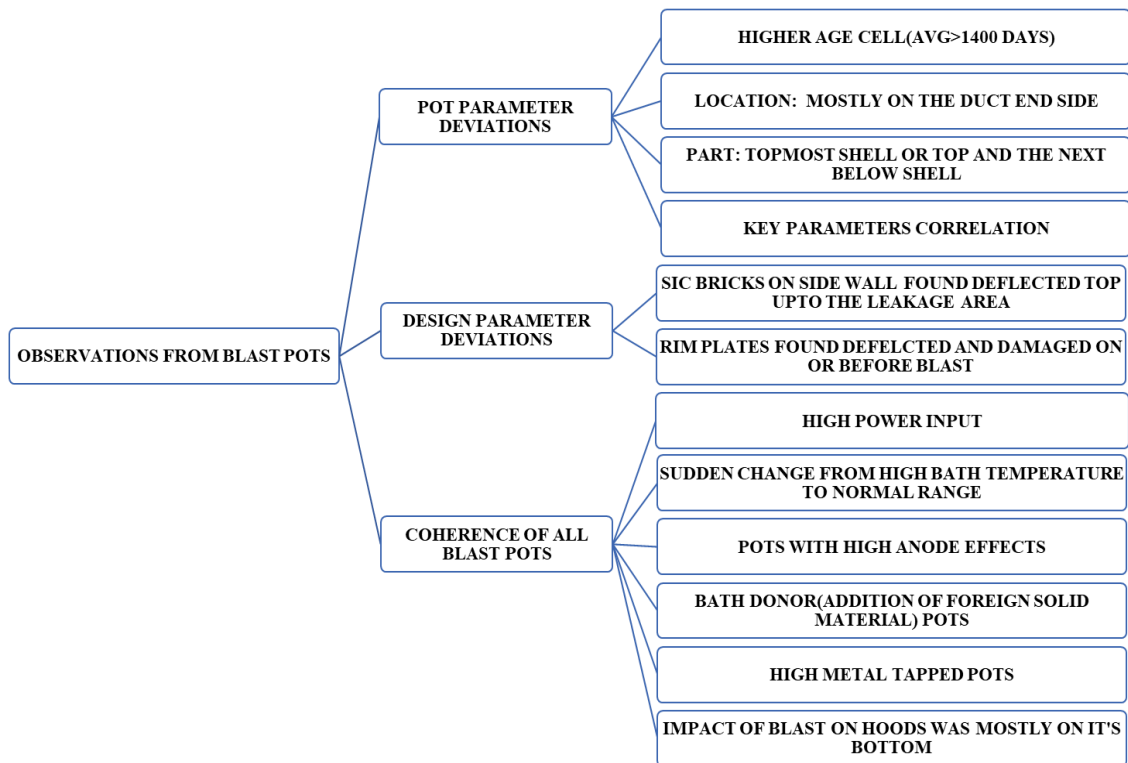
The analysis approach is shown in Figure 2. This analysis followed a review of a few pertinent papers [1-2], but no such abnormality was found in the literature.

Figure 2. Observations for a blast pot.

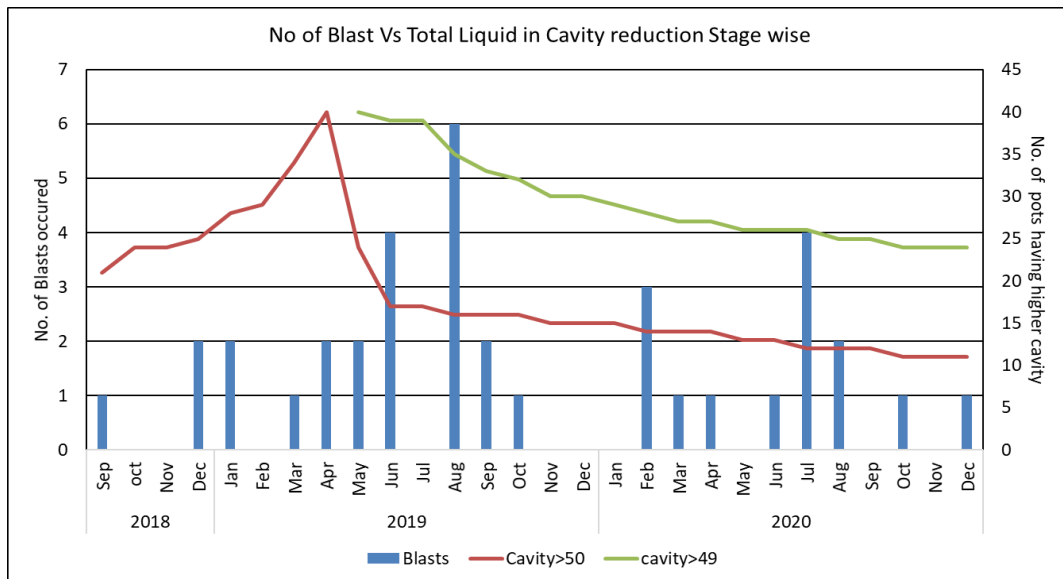
Blasting peaked at BALCO in August 2019 when the number of pots with high liquid levels also peaked (Figure 8), despite the number of pots older than 1200 days being relatively low. This data explains high correlation between high liquid levels in pot and blasting rather than just bath level (Figure 9). In due course we realized that the cause for blasting were high liquid levels in the pot cavity rather than just the high bath level.

Figure 8. Trends of the number of blasts occurred and stage-wise reduction of total liquid level in pot cavity.

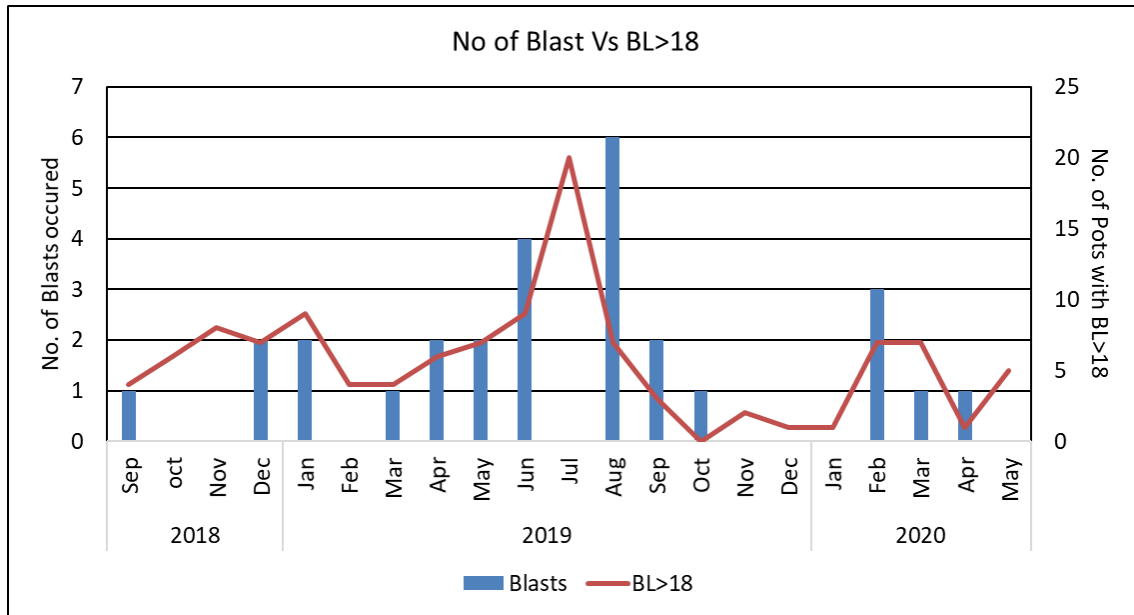
Figure 9. Trends of number of blasts and pots with high bath levels (BL) in cm.

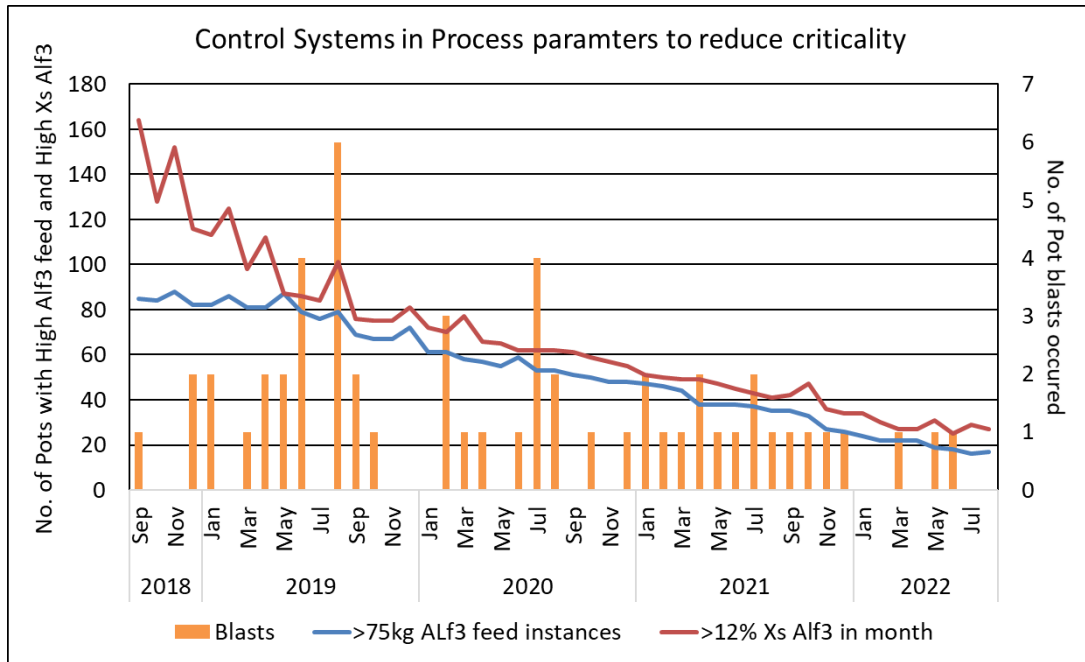
Figure 10. Trends of AlF₃ feed and excess AlF₃ parameters deviation control on course of action.

3. Revise the AlF_3 addition practices. It was noted that several pots were high in % excess AlF_3 and AlF_3 was still being added when they blasted (Figure 10). AlF_3 addition table should be revised periodically and tracked on daily basis. Also, raw material specifications should be optimized to reduce incorrect AlF_3 feeding.

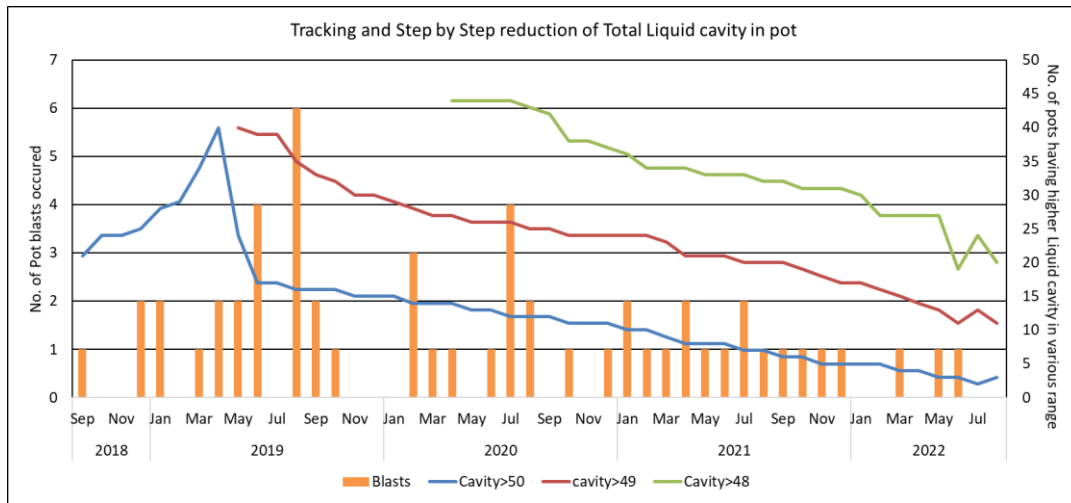
Figure 11. Tracker for total liquid cavity in various stages to controlled Pot Blast instances.

5. The next action was controlled step-wise reduction of the total liquid level (Figure 11) so that it was maintained below the design pot cavity depth. Initially, the reduction was by 5 cm making total liquid level target < 50 cm (by November 2018) on daily liquid level measurement. Later by June 2019 the target was further revised to maintain < 49 cm of total liquid height, and this helped considerably the reduction of blasting frequency. The liquid level was finalized to a target of < 48 cm from July 2020. This helped to prevent the penetration of liquid bath into the gap between the shell and the SiC block, if it formed. This journey of reducing the total liquid height by 7 cm helped controlling pot blasts. The observation from 2017 and its step-by-step learning and control helped BALCO in reducing the abnormality by 2021, during which the number of old age pots increased (Figure 12).

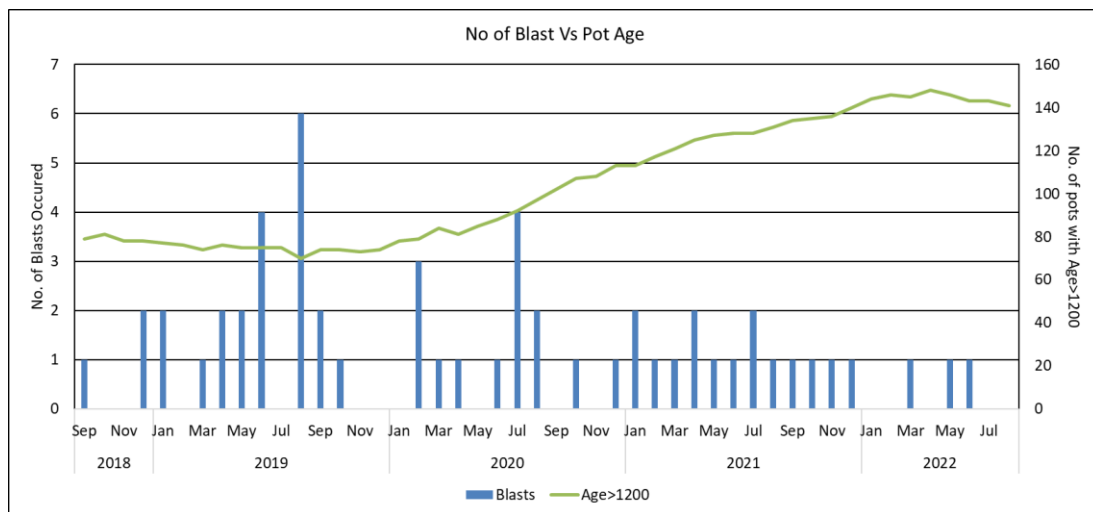
Data on the above table (Table 3) show that the number of blasting significantly reduced in pots having age < 1850 days, over a period of last 3-4 years. However, in older age pots the number instances were still prevailing due to deformed rim plate gaps that could not be repaired once it

Figure 12. Trend of Pot Blast with Number of pots with age > 1200.
