## Challenges of Prolonging Life of Aged Anode Baking Furnace-1 at Aluminum Bahrain (ALBA)

Aluminum Bahrain, Manama, Kingdom of Bahrain  
Corresponding author: bhoopesh.jain@alba.com.bh

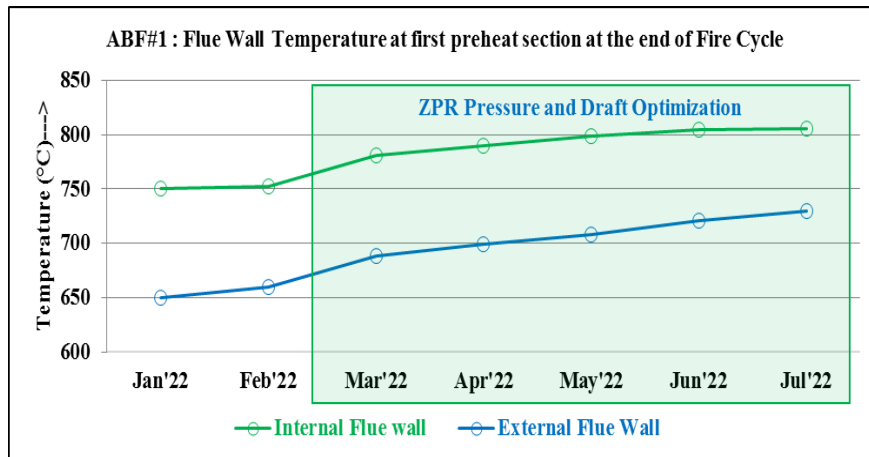
During the baking process, pitch volatiles are released from the anodes. These pitch volatiles must burn inside the flue wall. To ensure complete combustion of pitch volatiles, sufficient flue wall temperature ( $> 700\text{ }^{\circ}\text{C}$ ) and oxygen content in the carrier gas (10-12 %) are required on preheating section 1. This combustion of the pitch volatiles contributes to maintaining the correct temperature inside the anode baking furnace. The optimum settings of zero pressure ramps ensure adequate blowing of preheated air from the blower and good draft ensures pulling of heat from the burner to maintain adequate temperature for pitch volatiles to burn.

Figure 9. Flue wall temperature at first preheat section.

To obtain this the zero pressure set point was increased from 15 Pa to 22 Pa and minimum blower speed was fixed to 20 % of maximum speed. The minimum draft limit has also been increased from 50 Pa to 60 Pa. These measures have considerably reduced the tar generation. The exhaust ramp was found clean after each fire cycle. Better process control was also reflected in the increase of the flue wall temperature as can be seen in Figure 9.

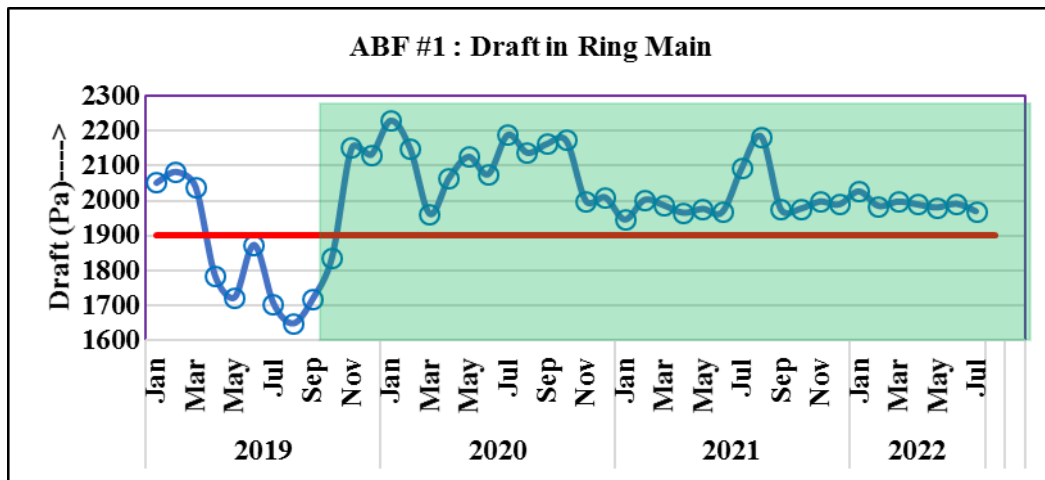
The Ring main draft has been maintained above the minimum target consistently since 2020 as shown in the Figure 10. The data in the Figure reflects the fume treatment plant performance and adequate draft availability at exhaust manifolds of fires at all times. As can be seen from Figure 10, the draft was kept on the higher end during 2020, compared to 2021 due to refractory maintenance and optimization. During 2021, a majority of this maintenance and optimization work was finalized and the process and draft stabilized.

Figure 10. Draft in ring main in ABF # 1.

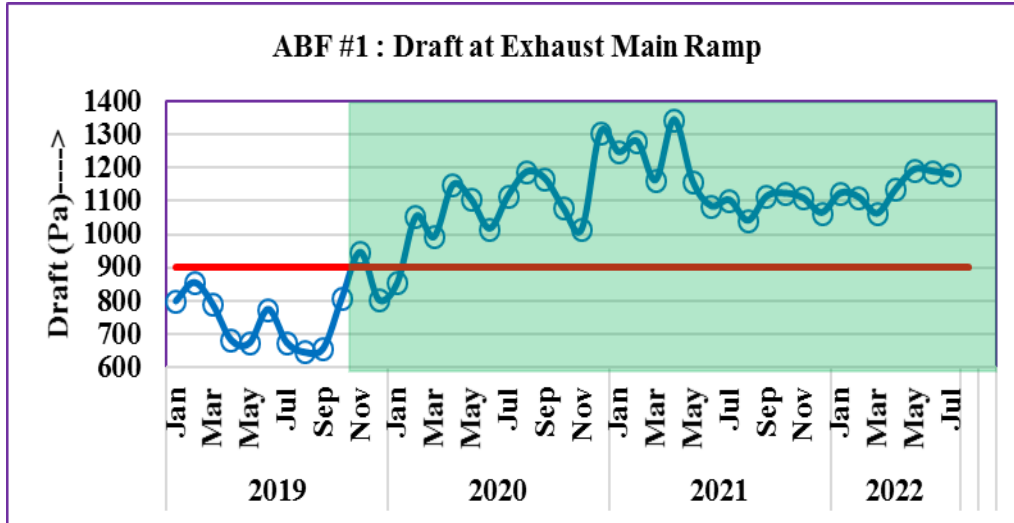
The draft at the exhaust manifolds have improved and have been maintained consistently above the minimum target since 2020 as shown in Figure 11. It has enabled better thermal profiles in the flue wall and thus ensuring good baking process.

Figure 11. Draft at exhaust main ramp in ABF # 1.

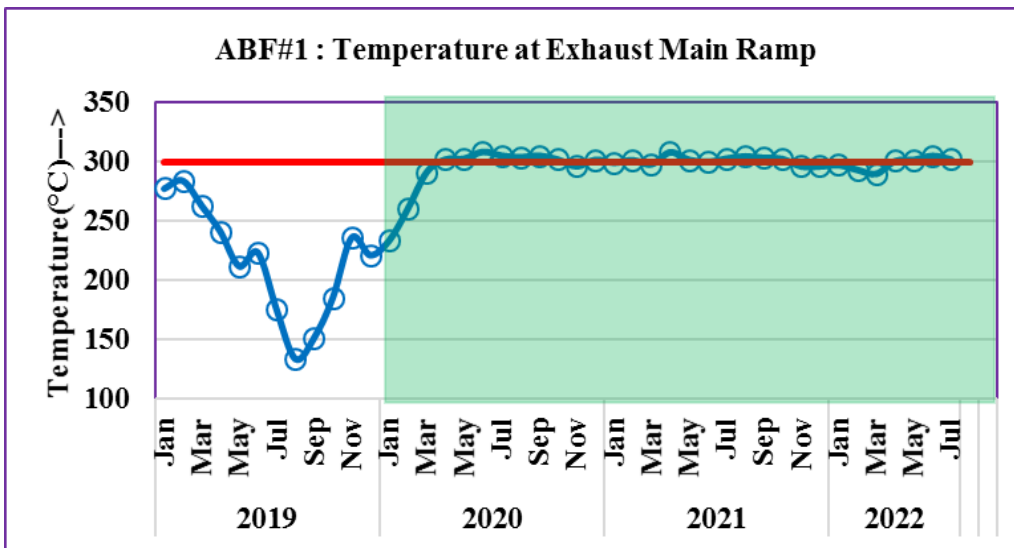
It is consistently maintained close to 300 °C as seen in Figure 12. This is the reflection of good pitch burning and a tar free baking process

Figure 12. Temperature at exhaust main ramp in ABF # 1.

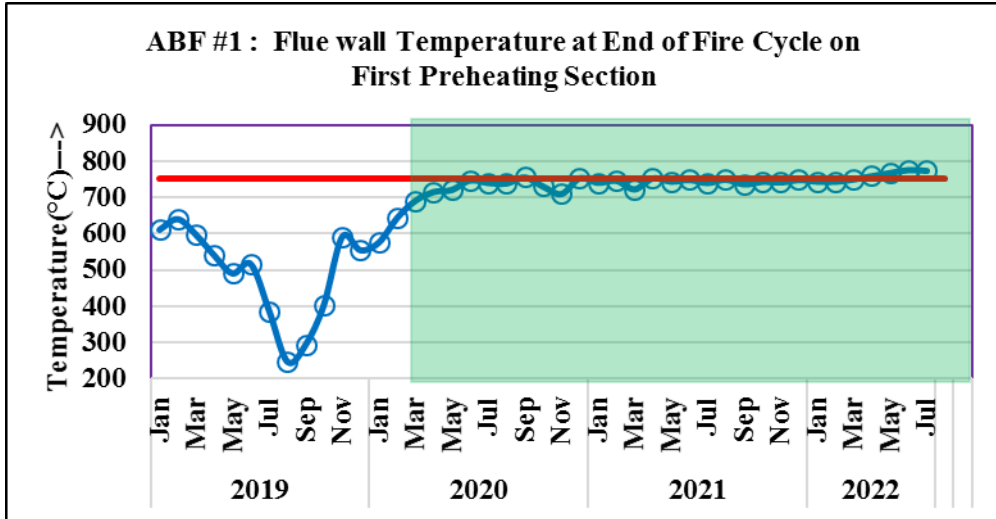
The preheating baking curve was optimized and this has enabled better conditions for pitch burning. The need for duct cleaning has been significantly reduced. The overall performance of the furnace and FTP has improved dramatically. It has also resulted in better work environment.

Figure 13. Flue wall temperature at end of fire cycle on first preheating section.

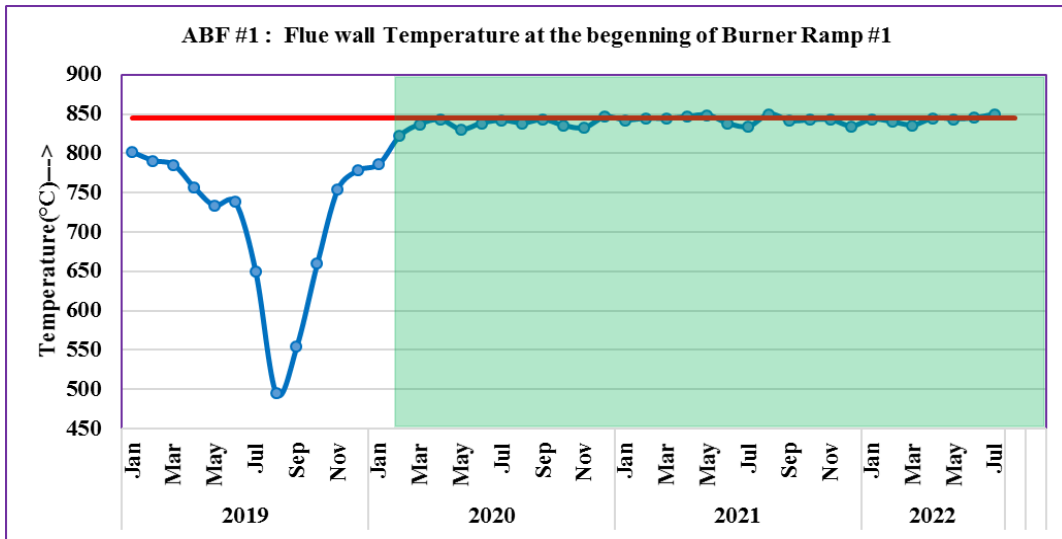
This is another parameter reflecting good pitch burning. The improvement in burner ramp # 1 start temperature is due to heat recovered from pitch volatiles. This is shown in Figure 14. A higher startup temperature of burner ramp 1, requires less gas injection need. Thus, it will further help pitch burning

Figure 14. Flue wall temperature at the beginning of burner ramp # 1.

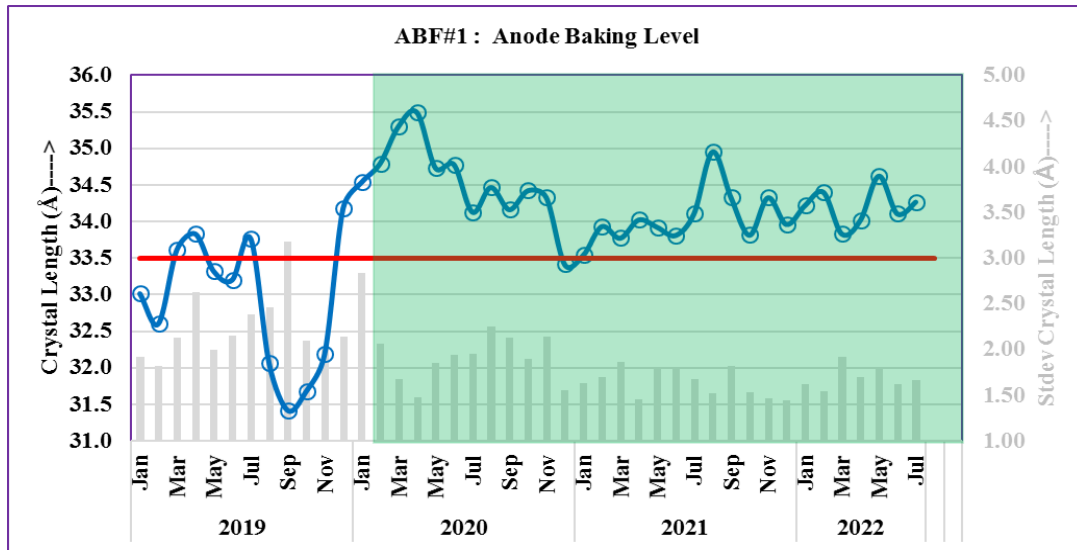
As a results of the improved baking process, anode baking level measured as a function of  $L_C$ , has been improved greatly as can be seen in Figure 15.  $L_C$  is a measure of the degree of graphitization during calcination of the anode coke. It has improved the  $CO_2$  reactivity residue and air reactivity residue as seen in Figures 16 and 17. Improved baked anode quality is reflected in better anode performance in potline and a reduction in spikes and anode incidents, as seen in Figure 18.

Figure 15. Trend of anode baking level (LC) and standard deviation.

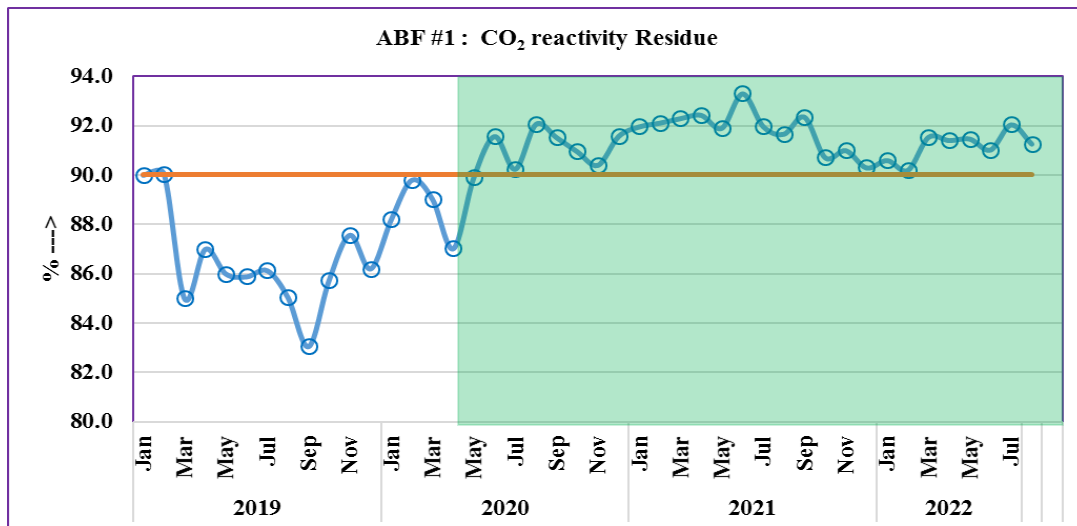
Figure 16. Average CO<sub>2</sub> reactivity residue of the anodes.

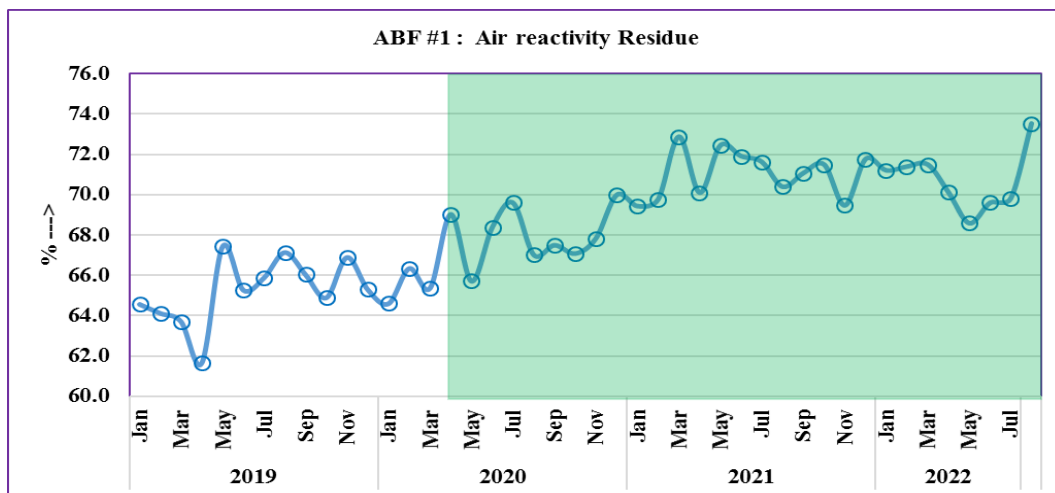
Figure 17. Average air reactivity residue of the anodes.

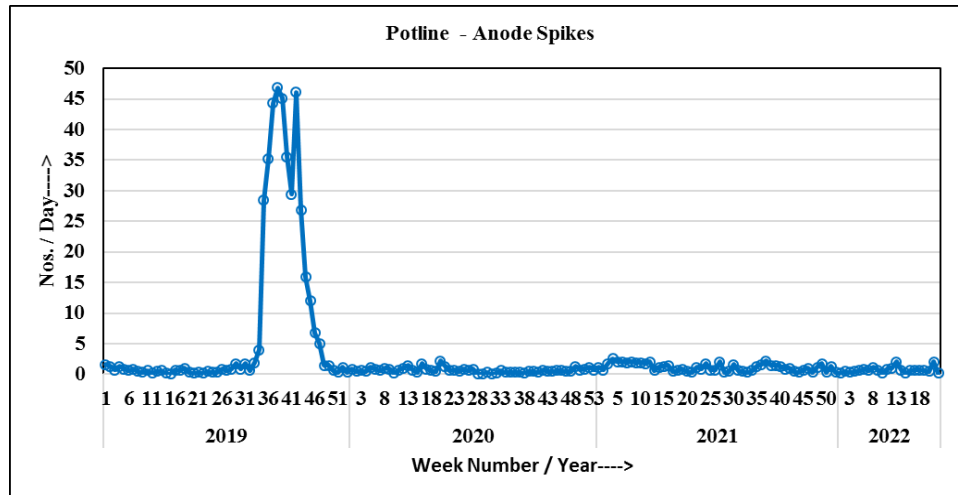
Figure 18. Anode spike trend in potline.
