Ma'aden Reduction Potline Partial Failure Incident and Recovery

Ma'aden Aluminium Company, Ras Al-Khair, Saudi Arabia

Keywords: Potline crisis, Potline recovery, Amperage increase, Anode failures, Pot relining.

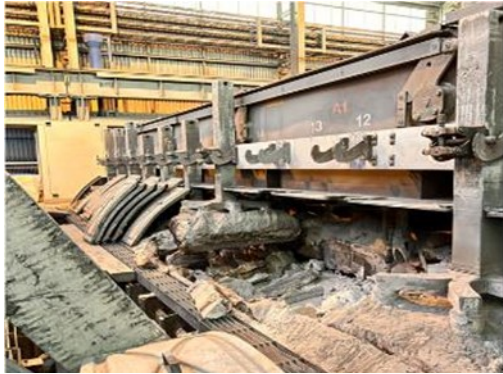
Figure 13. Pot identification.

When it comes to repairing pots, the age of the pots is a significant factor to consider. Older pots lining tends to have more deterioration over time. Therefore, a thorough assessment of the pot's condition is crucial before starting any repair work. The technical department examined and evaluated pots in different locations based on their age and performance history to determine which ones should undergo repairs or relining (Figure 13).

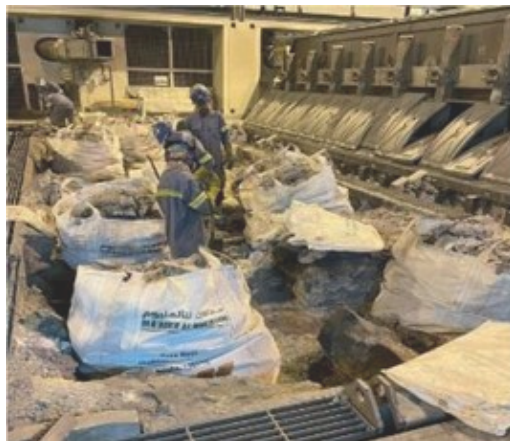
Figure 15. Manual cleaning.

A group consisting of 6 to 8 individuals initiated the process of extracting loose materials from the pot and transferring them into bags for transportation to the designated storage zone. This cleaning operation was executed by means of shovels, aimed at gathering any loose materials present. The bags were then relocated utilizing the overhead crane and carefully positioned onto wooden pallets in preparation for transport to the assigned lay down area, utilizing a forklift.

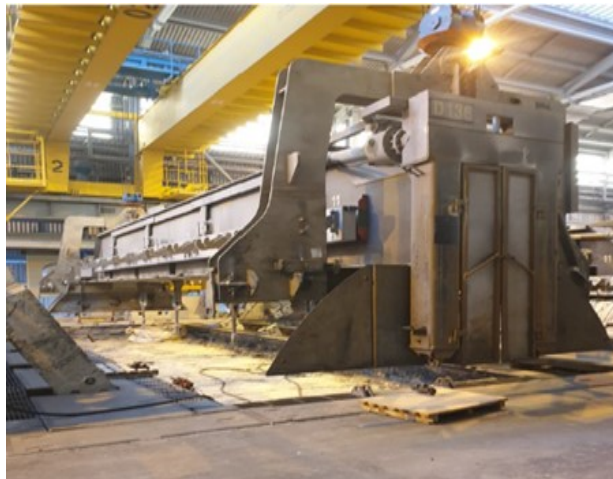
Figure 17. Removal of superstructure.

A specialized team was assigned to detach the anode superstructure from the ducting, electrical connections, and risers before preparing it to be removed (Figure 17). Subsequently, a street crane equipped with custom-built lifting frames was utilized for the transportation of the superstructure to a designated temporary location.

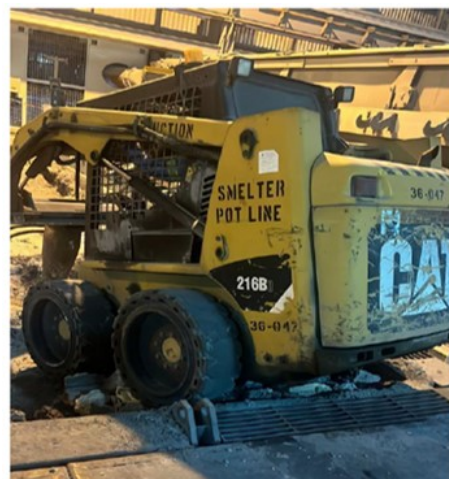
Figure 18. Use of bobcat to detach anode and metal.

When required on denser metal surfaces, the bobcat, equipped with a pneumatic hammer chisel, was utilized to detach anodes from the metal (Figure 18). It also helped in the separation of the metal from the cathodes.

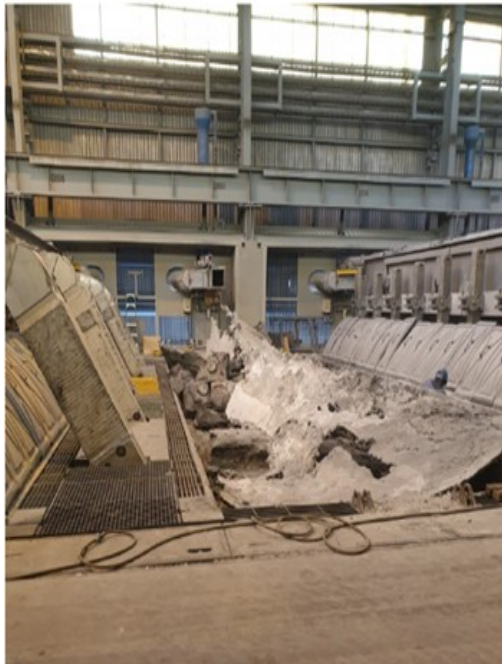
Figure 19. Lancing metal pad.

The process entails using oxygen lances to divide large metal pads into smaller, easier-to-handle sections (Figure 19). This undertaking necessitates a team of at least three individuals, comprising a proficient lancer operator, a fire watch, and a standby stationed near the cylinder cage.

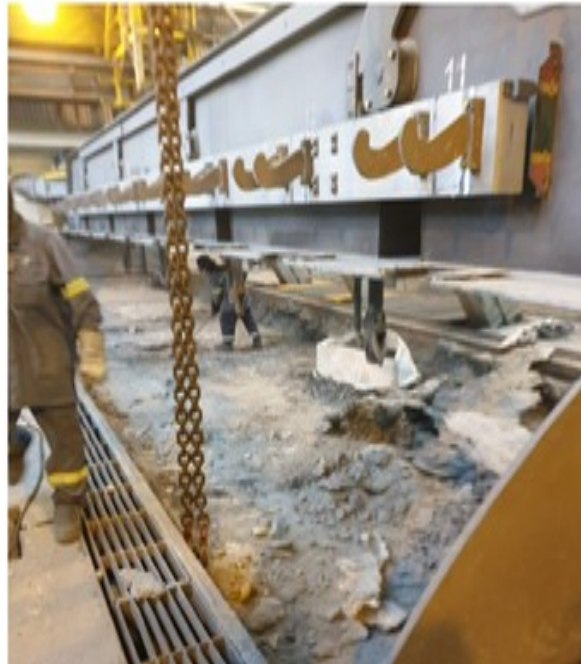
Figure 20. Removal of anodes and metal.

A crane with a capacity of 28 tonnes was employed, along with a chain sling, to extract metal from the pot effectively, guaranteeing adherence to safety protocols (Figure 20). The metal was carefully arranged on wooden pallets, facilitating its smooth and secure transportation to the designated storage area using a forklift.

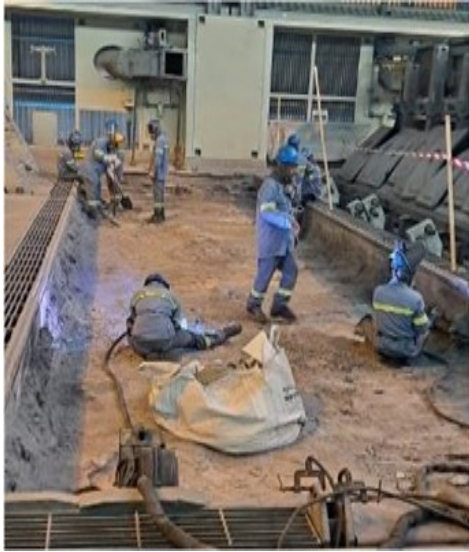
Figure 21. Second-stage cleaning.

The process of manual cleaning persisted in eliminating any remaining loose material and carefully removing any material present on the cathode surface to adequately prepare it for technical inspection (Figure 21).
