Laterrière Smelter Experience During Low Amperage Operation Due to Rectifier Problems

Abstract

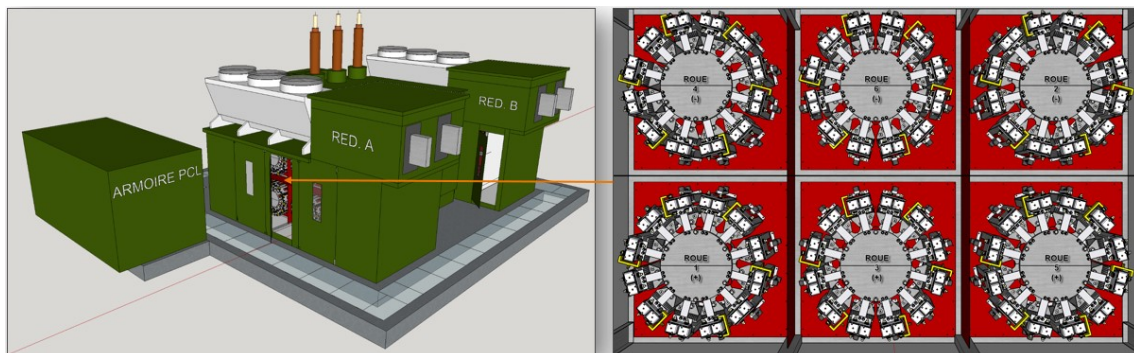
The investigation of the breakdown failures of the two rectifiers demonstrated that operation temperature inside the equipment was above the maximum recommended by the supplier. An underperforming cooling system of the units was found to be the root cause of the diode failures in the equipment (Figure 2).

Figure 2. Illustration of the type of damage found in the rectifiers due to overheating.

Each half-rectifier has 6 wheels of 12 diodes (total 72) and the substation has 16 half-rectifiers for a total of 1152 diodes to replace. It was found during the inspection that the break-down failure of an old diode impacts the life of a new diode. The project had to improve the air circulation of the 16 half-rectifiers. The illustration of a rectifier and its 6 diodes wheels is presented in Figure 3.
