Operational Excellence in Rodding Plant - A Path to Control Sodium in Anode Butts

Mohammad AlShaibani¹ and Zobida Farzanah²

2. General Superintendent - Process Control, Carbon and Port
Emirates Global Aluminium, Abu Dhabi, United Arab Emirates

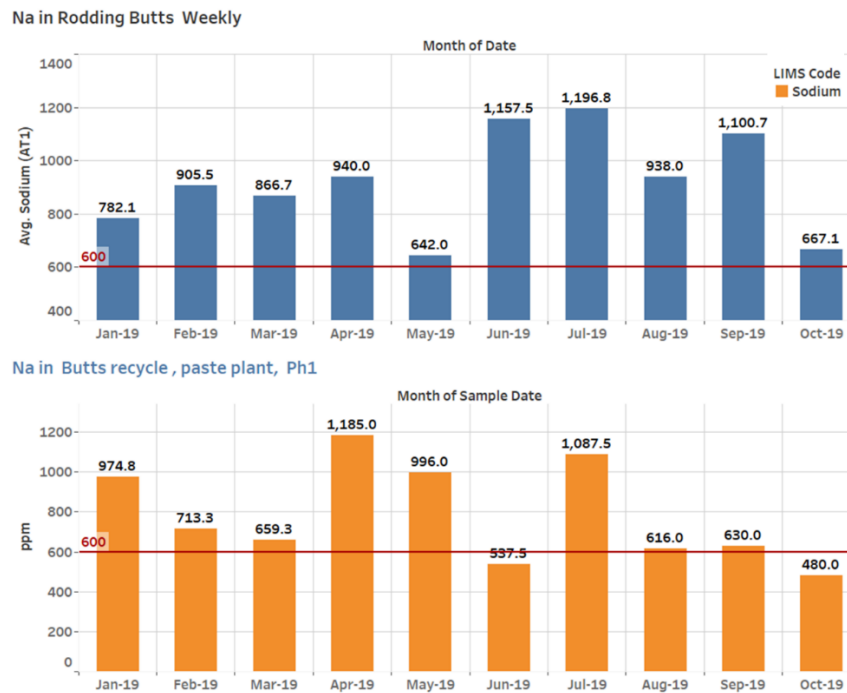
Figure 1. Sodium levels in recycled butts.

Contaminants such as sodium in recycled anode butts can lead to operational challenges in the manufacturing process of prebaked anodes [1]. In 2019, at the Al Taweelah Plant rodding, one operation involved receiving butts from potlines for a multi-stage cleaning process. This process comprised an initial Hot Bath Removal Facility, followed by manual cleaning, and subsequently treatment in a Butt Shot Blasting Machine designed to remove residual fine bath layers from the top surface of the butts. As per operational quality standards, the cleaned butts were required to achieve a sodium (Na) content of 600 ppm or less. However, performance data from 2019 showed that, on average, 360 butts were processed per shift, with only 50 % meeting the specified Na content requirement. The remaining 50 % had elevated sodium levels, averaging 920 ppm, thus failing to comply with the acceptable limit (Figure 1). These findings indicate a substantial performance deficiency within the existing cleaning process and suggest the need for further evaluation of process parameters, equipment effectiveness, and operational controls to enhance cleaning efficiency and improve product quality outcomes.

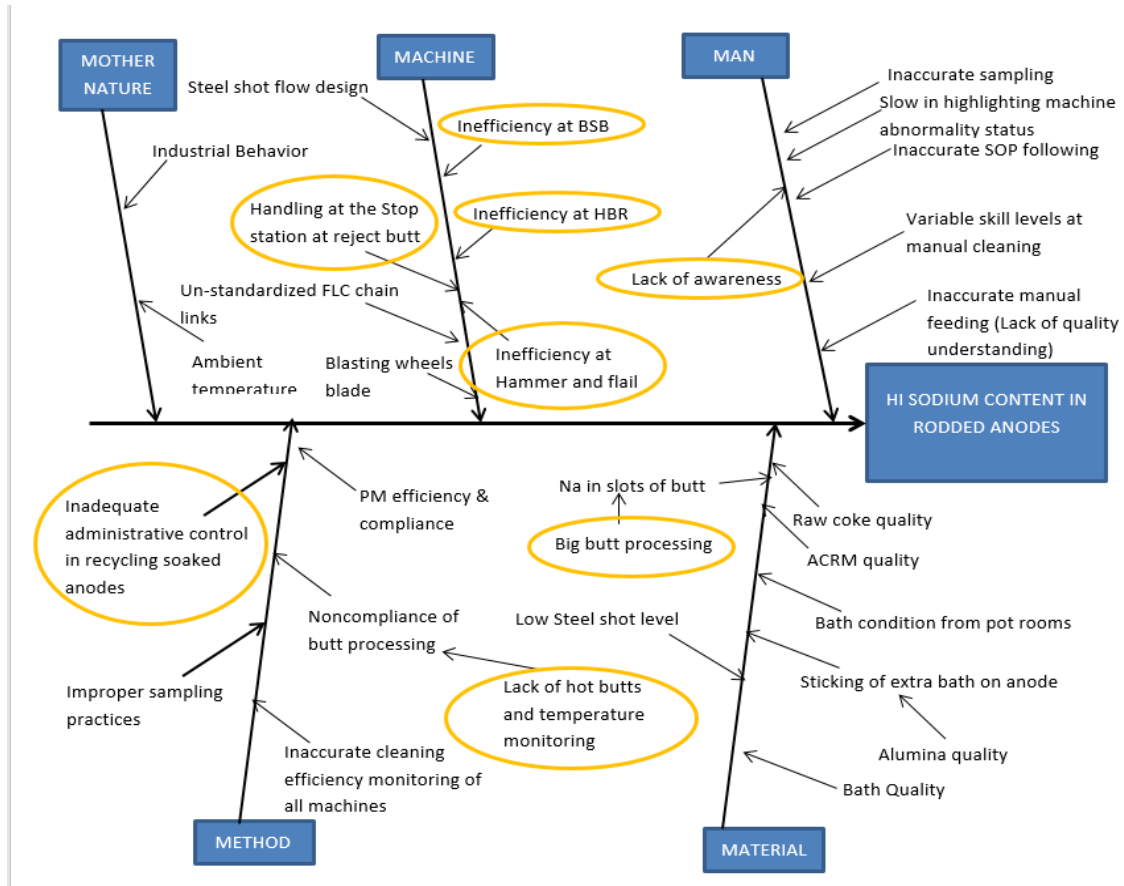
Figure 3. Fishbone diagram for root-cause analysis.

A cross-disciplinary team, comprising personnel from Operations, Process, Maintenance, and the Potline department, was assembled to investigate and identify the contributing factors to elevated sodium content and inadequate butt cleaning performance. As part of this root cause analysis, a Fishbone (Ishikawa) diagram was developed to systematically classify the potential causes, as shown in Figure 3.

The objective of this study was to enhance the cleaning efficiency by 80 % while reducing the manual cleaning process by 80 % and reduce the average Na content in cleaned butts from 920 ppm to 600 ppm (Figure 4). Through a structured root cause analysis, the primary contributing factors to elevated sodium levels were identified and categorised, as illustrated in the Fishbone (Ishikawa) diagram presented in Figure 3.

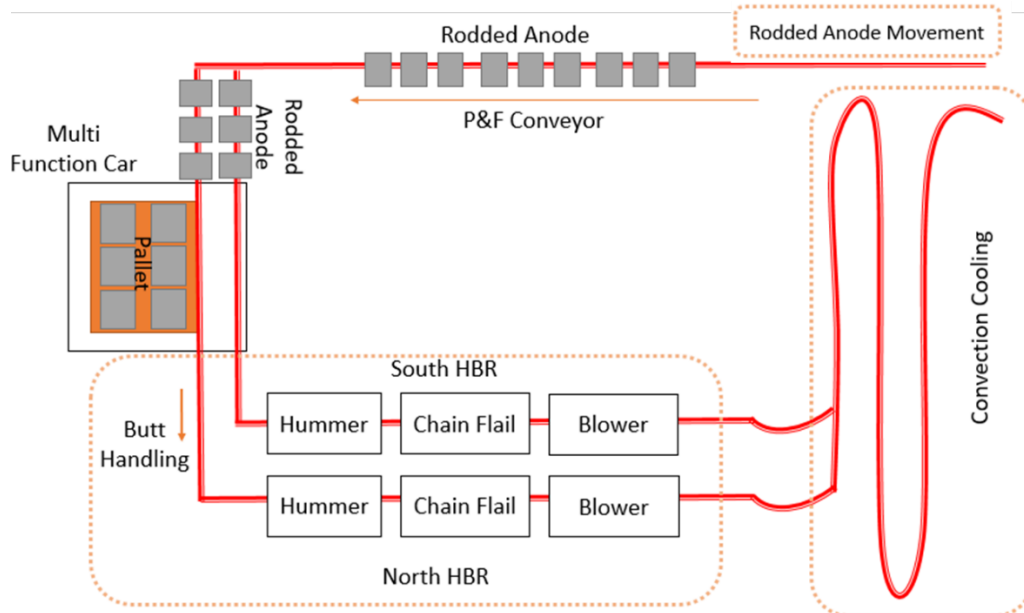
Figure 5. Hot Bath Removal (HBR) facility.

Prior to the primary cleaning stage at the Hot Bath Removal (HBR) facility, as shown in Figure 5, butts were inspected to assess their initial condition. The HBR process consists of three sequential cleaning steps: hammering, chain flailing, and air blowing. Observations revealed that significant bath residue remained adhered to the butt surfaces following this stage, as presented in Figure 6.

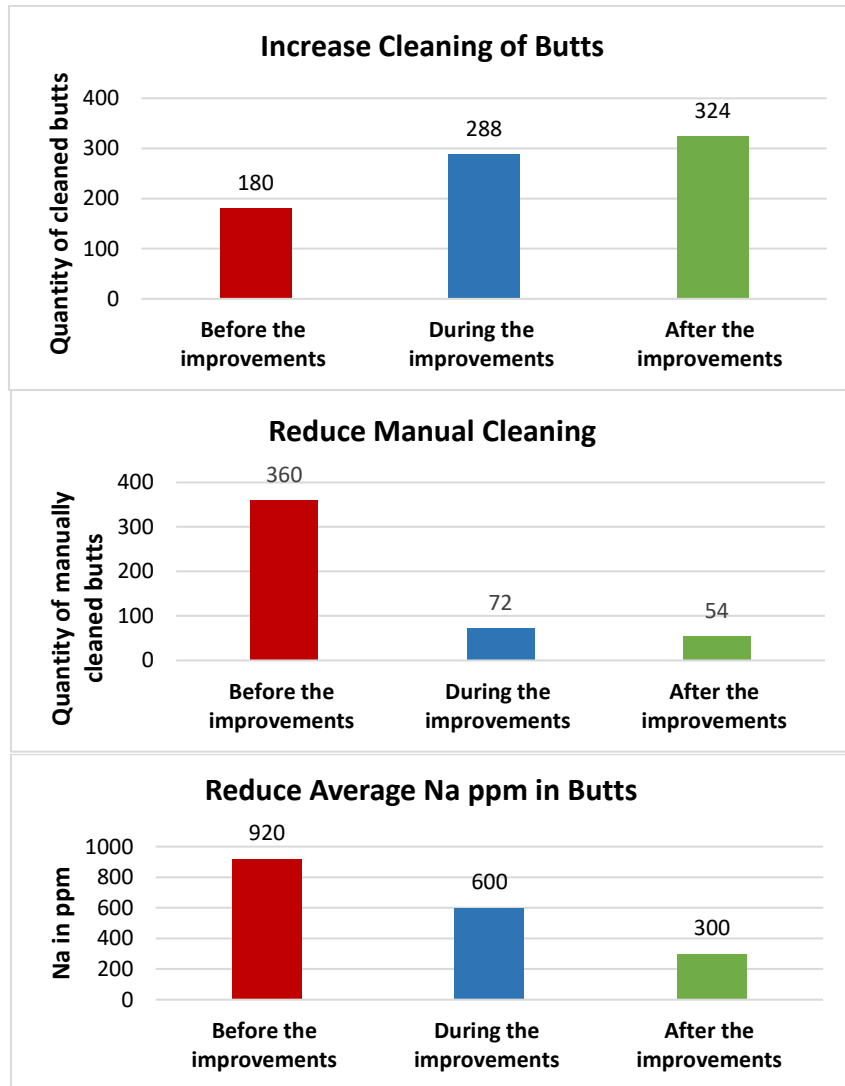
Figure 14. Metrics of success of the improvements.

To sustain these improvements, updated operating standards and continuous shop floor awareness have been embedded into daily practices. Since 2019, close monitoring has ensured sodium levels in the butts remain consistently below 600 ppm, supporting ongoing optimisation of the anode butt cleaning process. Success metrics of this development are shown in Figure 14.

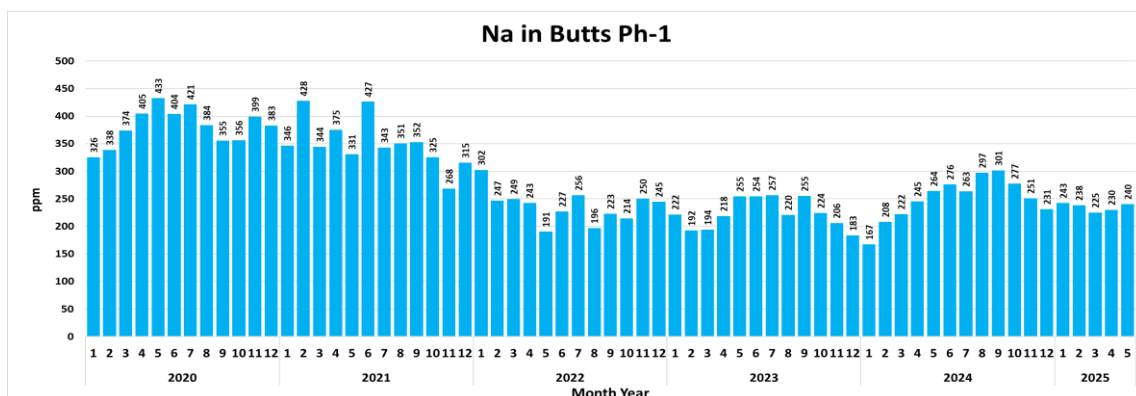
Figure 15. Reduction in Na levels in butts.

After applying the experimental practices, a steady reduction in sodium (Na) levels was recorded, as shown in Figure 15. These actions successfully lowered the sodium content in the anodes, improving process and product quality. The experience gained during this work also helped the team better understand how sodium contamination occurs and how to manage it in the future.

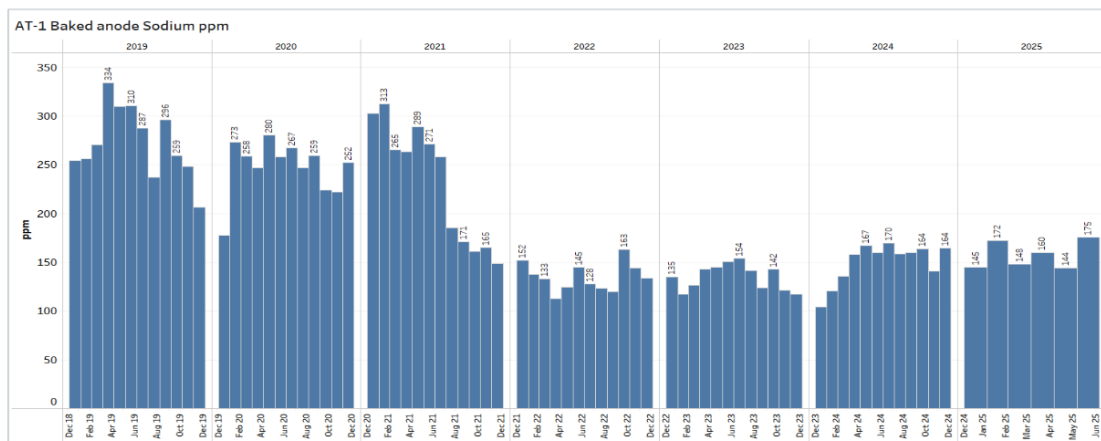
Figure 16. Reduction in Na levels in Baked Anodes

To support this improvement, an online chemical analyser was installed to continuously measure sodium levels. This tool makes sure that only broken butts with low sodium content are sent to the paste plant, helping to keep the process stable and the product consistent. Overall, this study showed the value of regular monitoring and specific process changes in maintaining good anode performance by ensuring the Na in baked anode is improved and maintained as low as possible < 250 ppm as it is shown in Figure 16. which contributed to a significant reduction in CO₂ reactivity and better anode performance [1, 2].
