Power Supply Outages to Cells in Aluminium Smelters

Abstract

The need for the reliability of power supply to the cells in the aluminium reduction process is well known. However, there was a peak of outages in the period 2008 to 2011 coinciding with the start up of new large smelters and the reliability of supply to Western smelters is still not improving. Readily available data over the last fifteen years is provided. This data is used to develop a high level root cause analysis, which is used to provide suggestions for a way forward.

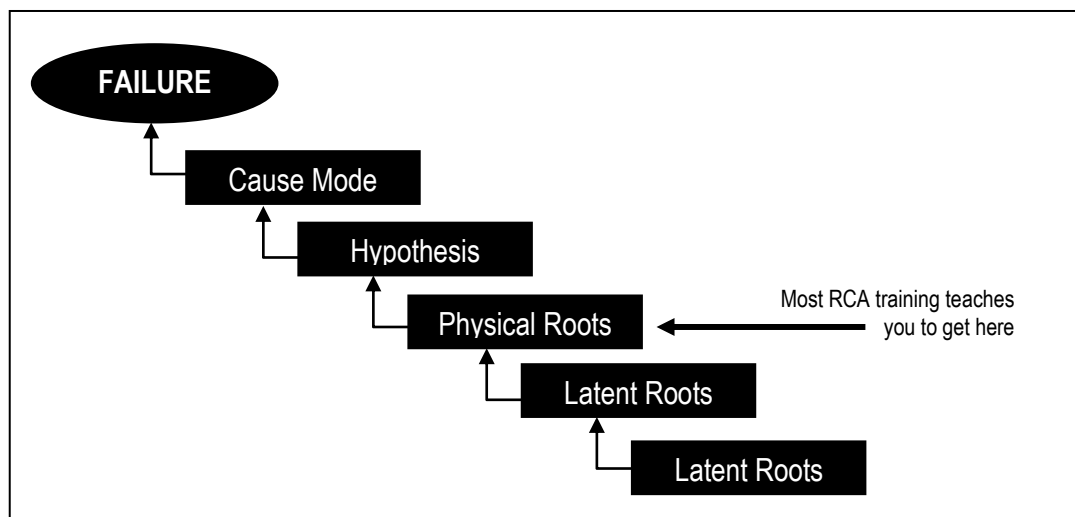
There is not enough data in the public domain to carry out a detailed Root Cause analysis (RCA) such as outlined in [46] and Figure 2. Nevertheless, it would be useful for individual outages to be investigated in detail by smelter operators.

Figure 2. Root Cause Analysis – Life Cycle Engineering.

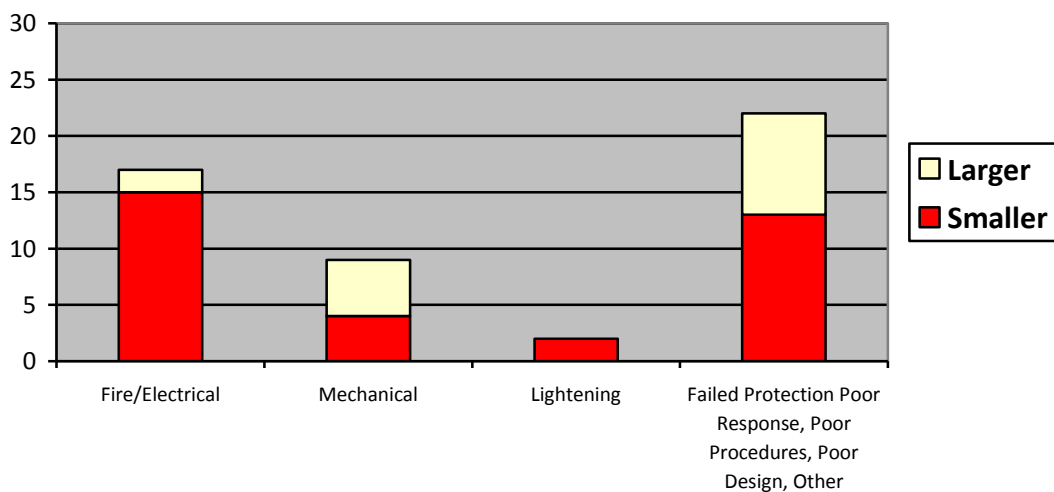
In Figure 6, outages are grouped into event/result of the failure.

Figure 6. Outages grouped into event /result of failure.

Again, the largest group involves systems engineering and operational management training.
